**CHICAGO PARK DISTRICT
&
CHICAGO DEPARTMENT OF TRANSPORTATION**

**LAKE MICHIGAN HIGH WATER LEVEL
SHORELINE ASSESSMENT**

FINAL REPORT

SMITHGROUP
35 E. Wacker Drive #900
Chicago, IL
Project Number: 12153

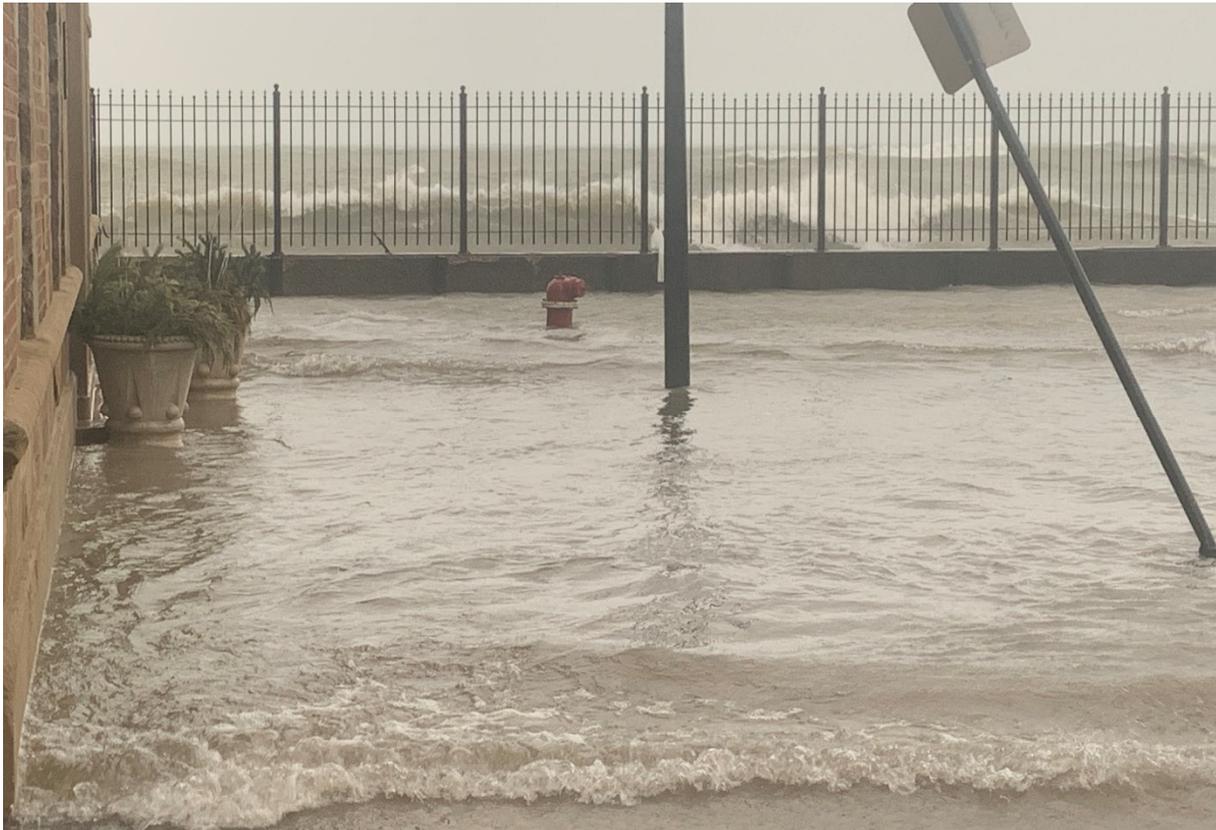
Photo 1 Street end flooding adjacent to private property during the January 11, 2020 storm

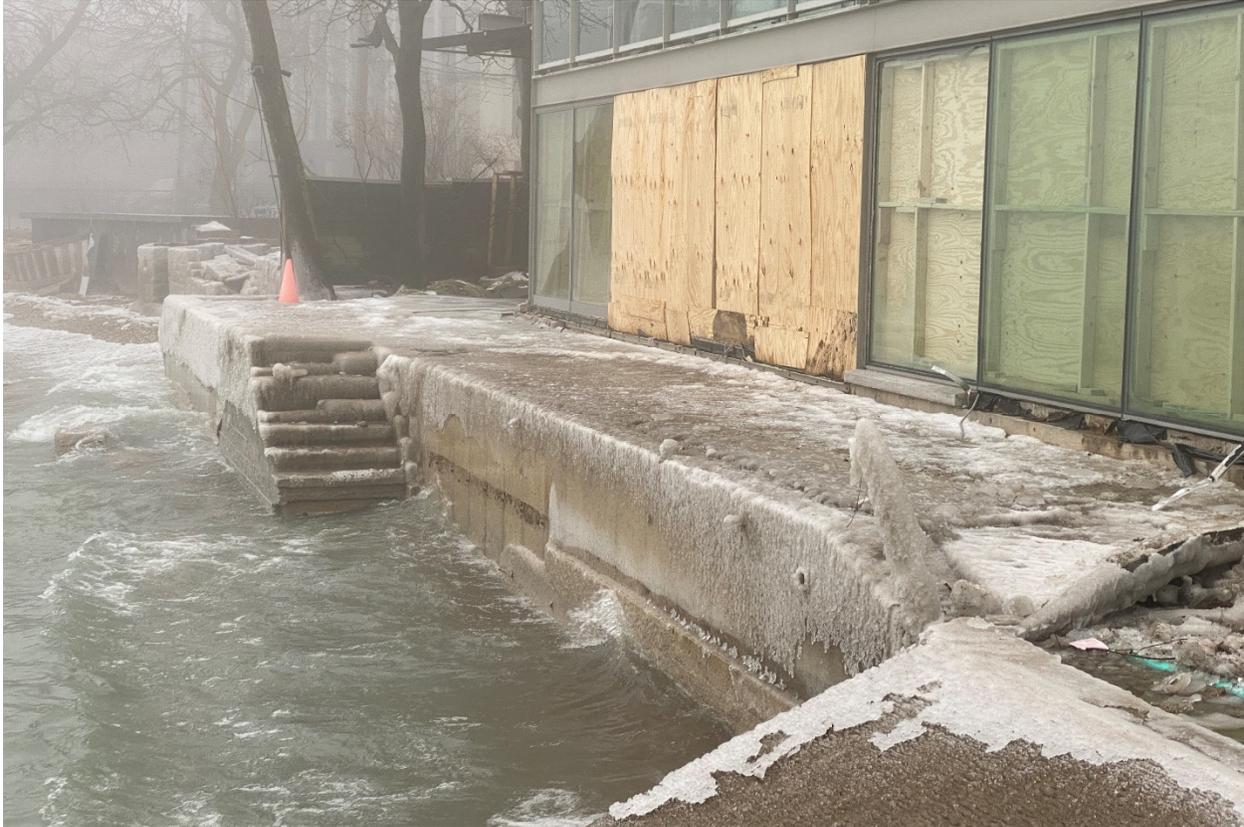
Photo 3 Storm damage to lakefront property, including broken windows, resulting in interior first floor flooding.

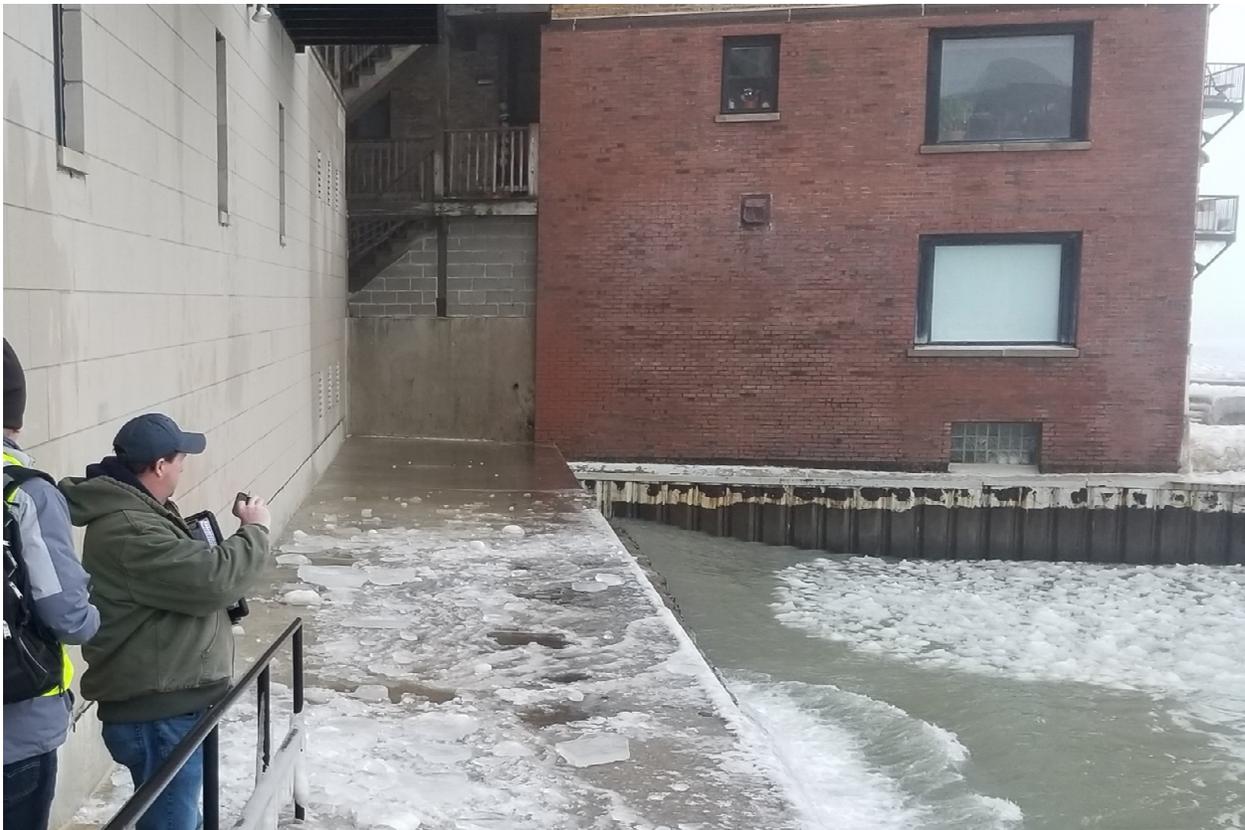
Photo 4 The building located on the left of this picture has louvers facing the lake, which could be a source of flooding.

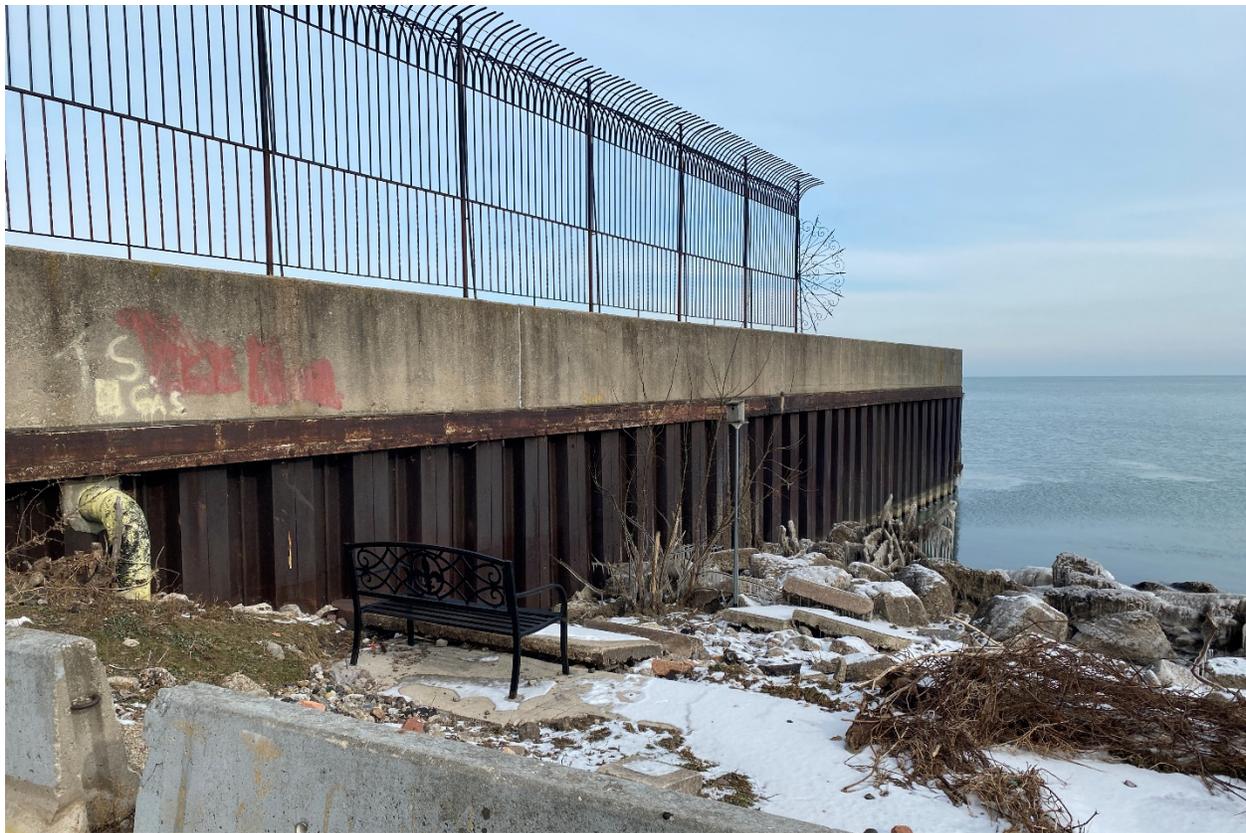
Photo 5 Steel sheet pile and concrete seawall, with rubblemound revetment in the foreground.

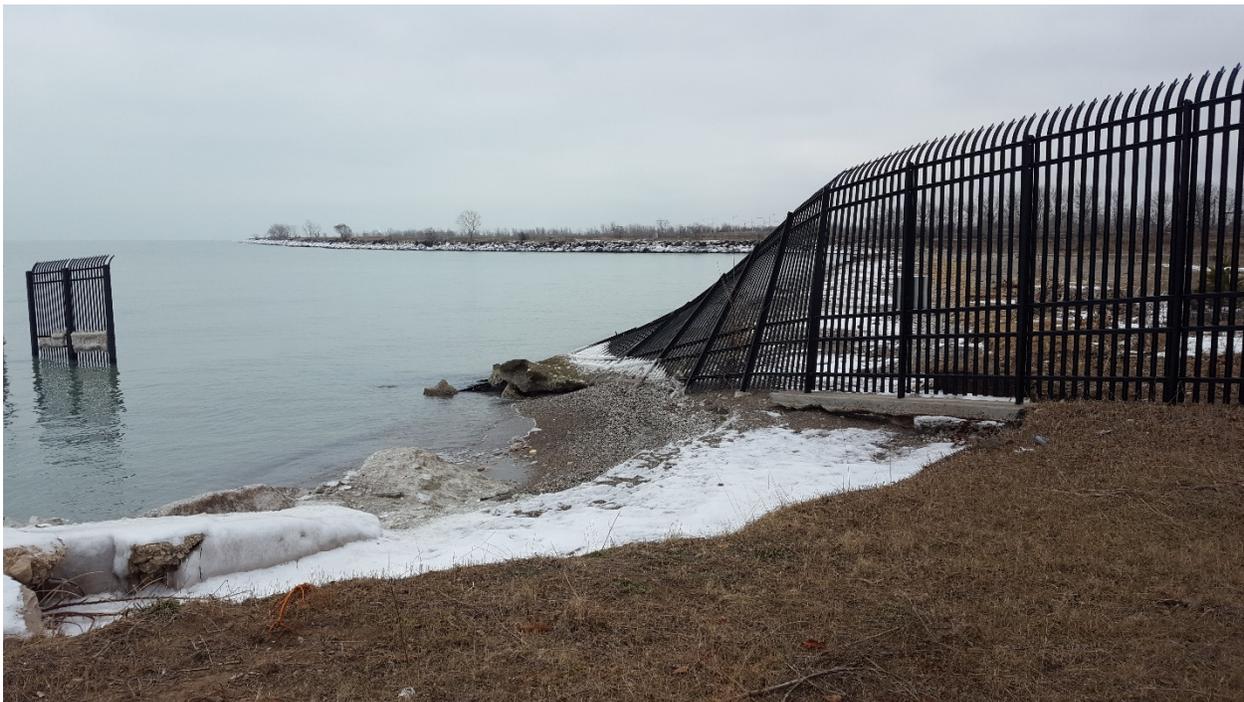
Both Water Purification Plants (WPP) are protected from some of the largest waves by offshore breakwaters. At Eugene Sawyer WPP the offshore breakwater is a rubblemound breakwater, which was recently rehabilitated (1997) as part of the Chicago Shoreline Protection Project and has been routinely inspected and maintained. Apart from erosion at the south west corner of the facility and damage to a security fence, the ESWPP appeared to fare relatively well during the January 11th storm.

Photo 6 Erosion and fence damage as a result of the January 11, 2020 storm adjacent to the Eugene Sawyer Water Purification Plant

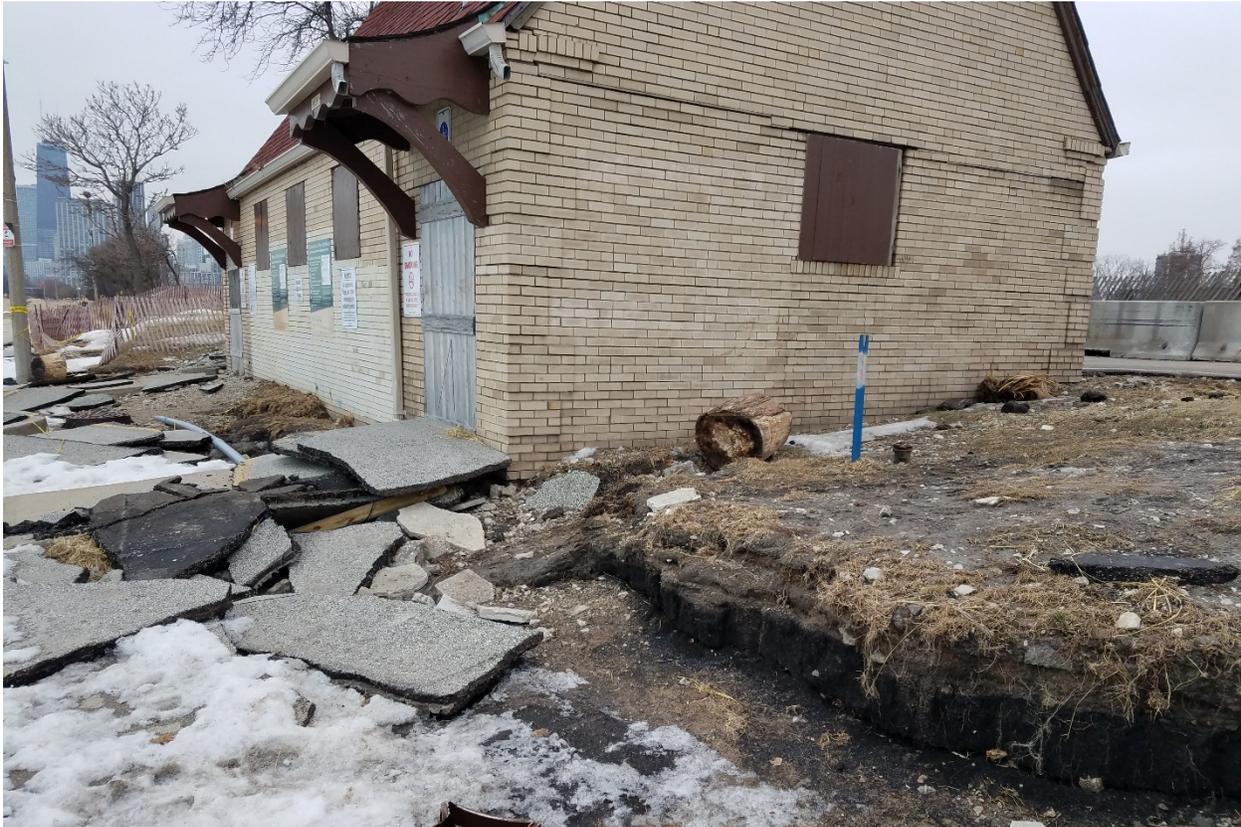
Photo 7 Erosion and storm damage to the lakefront trail at the historic North Avenue washroom facility.

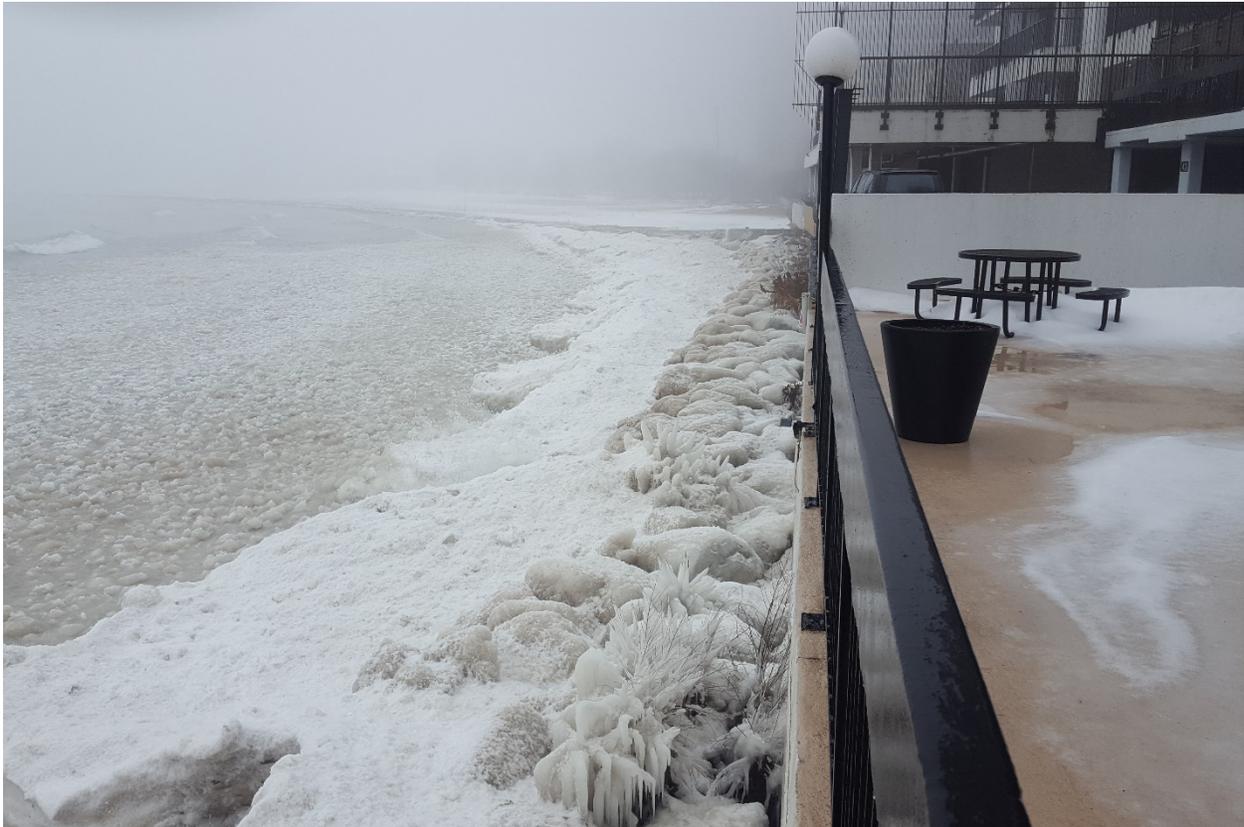
Photo 8 Building representatives at this 48th Ward property reported having recently completed a shore protection operation and maintenance inspection
