GII, LLC Explosion

2004542.000

July 16, 2020

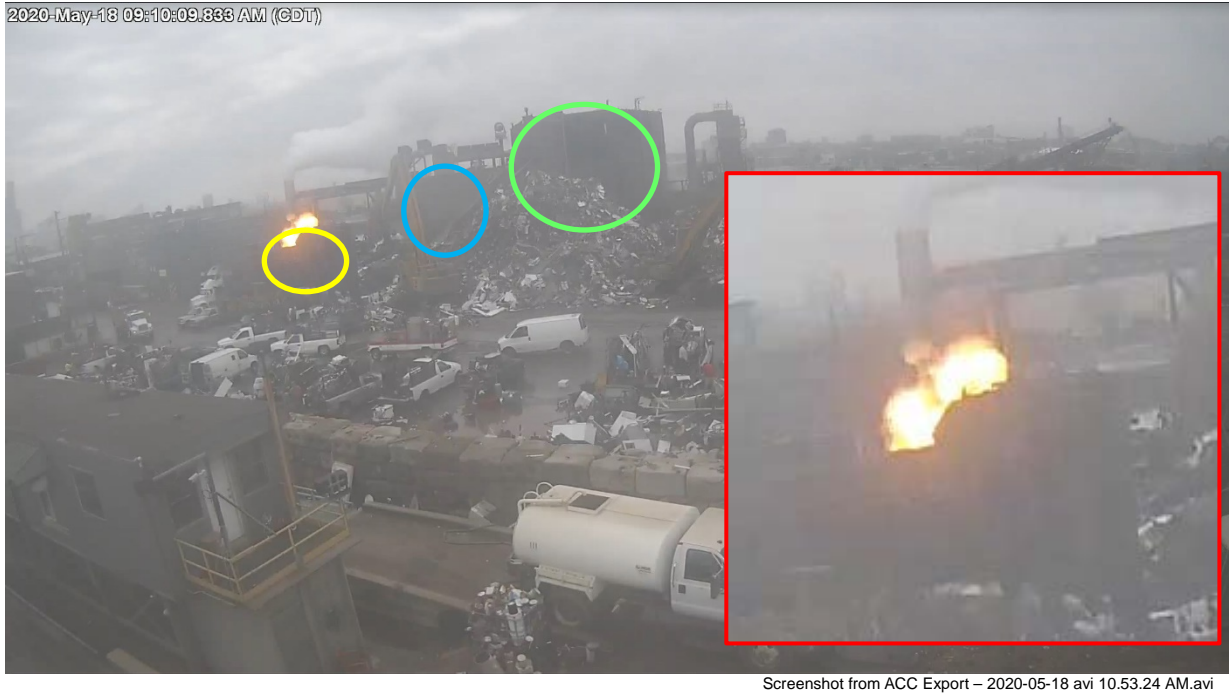
A video camera captured the incident and its approximate location is indicated in Figure 2. The first indication of explosion appeared to be located at or near the RTO as shown in Figure 3.

Figure 3. Screenshot from provided video at 9:10:09:833 AM. The approximate location of the RTO is circled in yellow, the filter in blue, and the shredder in green. A first appearance of flame above the RTO is visible in the enlarged inset outlined in red.

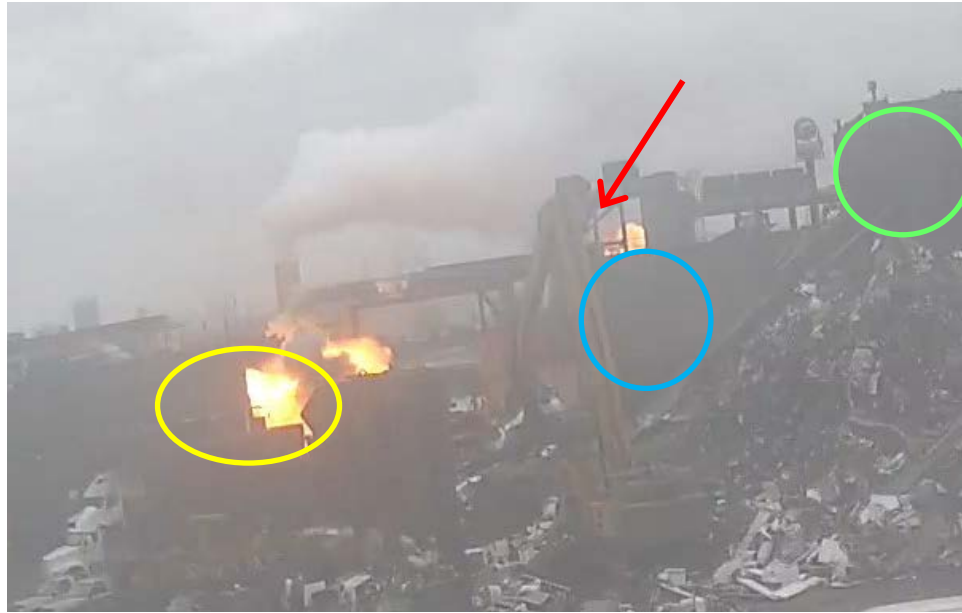
Shortly afterwards, a jet of flame was observed exiting the ductwork at the elbow down into the filter as shown in Figure 4. This was followed shortly thereafter by an explosion at the filter and visible clouds of dust or smoke emanating from the cyclone and adjacent ducting explosion vents.

Figure 4. Cropped screenshot from provided video at 9:10:10:033 AM. Jet of flame at the duct work elbow indicated with a red arrow. Approximate locations of the shredder (green), filter (blue), and RTO (yellow) are circled.

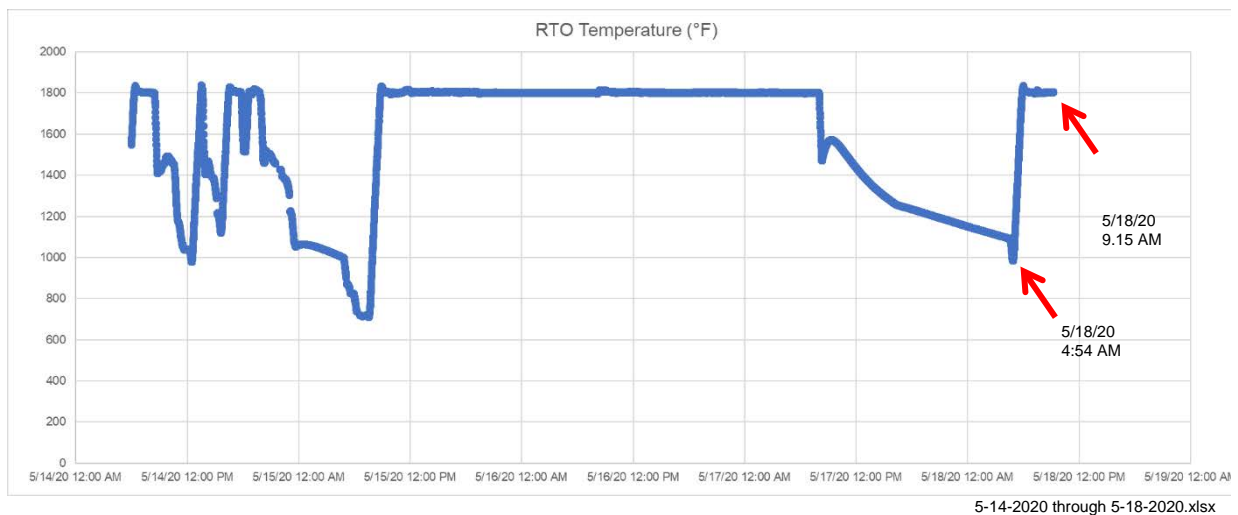
Before the new burner controller was installed, GII was able to restart the RTO on Friday morning. According to the provided data, shown in Figure 5, the RTO remained at its operating temperature, approximately 1800°F, from Friday, May 15, at 9 a.m. through Sunday, May 17, at 8 a.m. At 8 a.m. on Sunday, May 17, the RTO was apparently turned to the "bottle-up" setting and the temperature decreased until Monday morning.

Figure 5. Provided data for the RTO temperature from Thursday, May 14, 2020 through Monday, May 18, 2020.

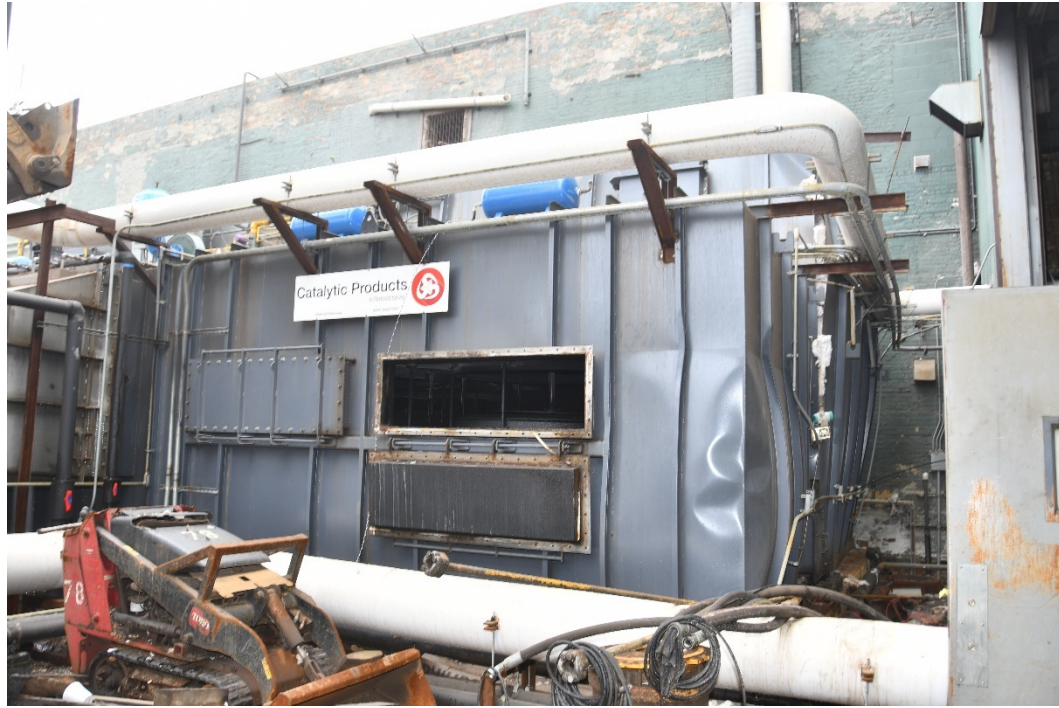
During Exponent's initial site examination on May 19, 2020, damage was observed to the RTO, roll-media filter, the blower adjacent to the RTO, and the ducting associated with these components. The RTO housing was deformed and damaged. The south end of the RTO is shown in Figure 6 and can be seen to be bulged outward.

Figure 6. Photograph of the south end of the RTO. Access door was opened after the incident.

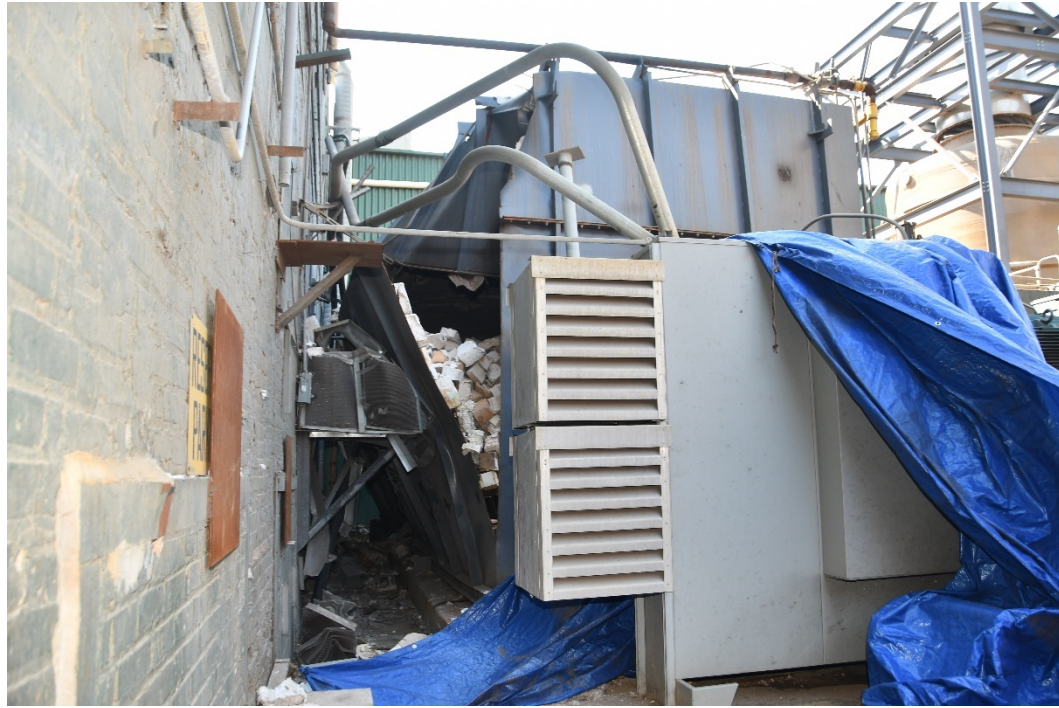
D18689-0061

The top of the RTO housing was also bulged outwards and the rear of the RTO housing was separated as shown in Figure 7.

Figure 7. Photograph of the north end of the RTO.

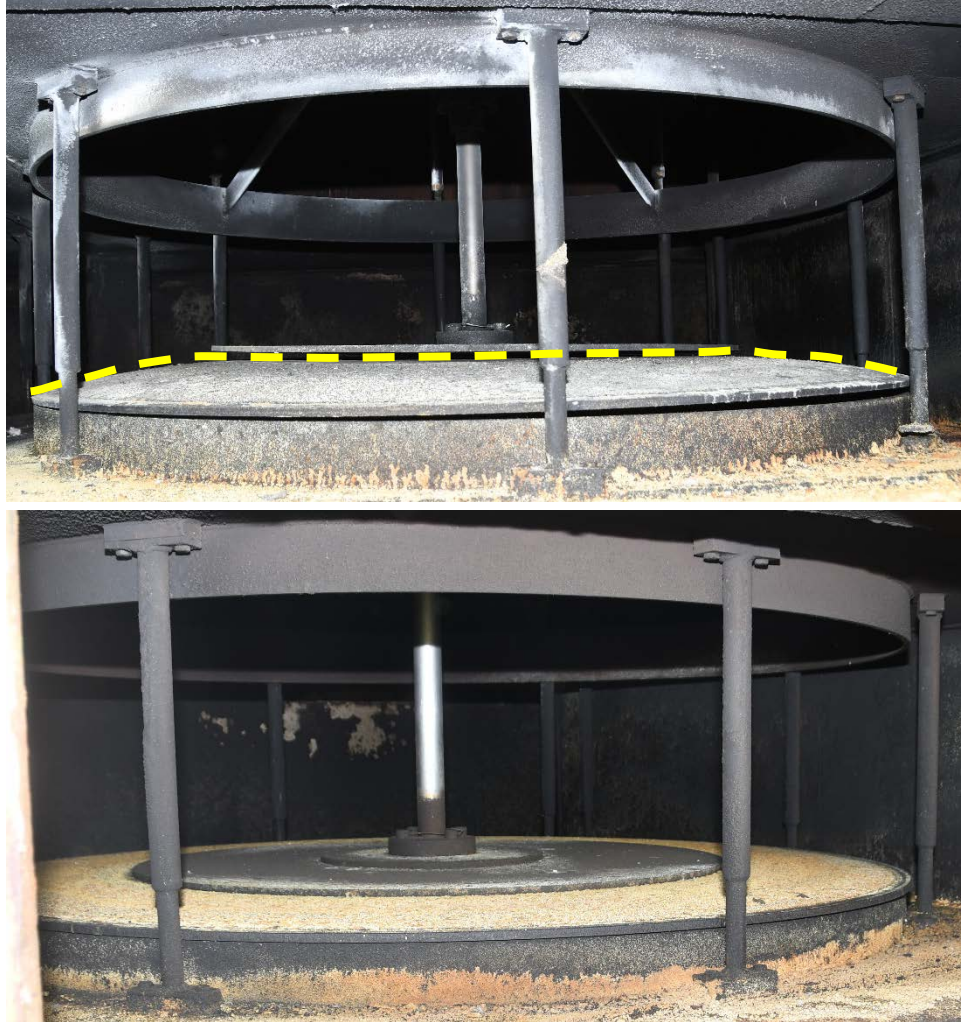
D18689-0030 (top, cropped) and D18689-0019 (bottom, cropped)

Two of the poppet actuators, originally located on the top of the south end of the RTO, were found on the ground nearby. Additionally, the two poppet valves on the south side of the RTO were observed to be domed as shown in Figure 8. When compared with the north poppet valves, it was evident that the south poppet valves had been deformed during the explosion. Based on the damage, it appeared that the south poppet valves were situated in the down position at the time of the explosion. The explosion forced the south poppet valves upwards, accelerating them, and ultimately causing them to contact the upper valve seat that resulted in the deformation. According to the principle of conservation of momentum, if an object is accelerated by a certain force over a given period of time, deceleration of the same object over a shorter period of time requires a proportionally larger force. Unlike the north poppet valves that only had the force of the gas pressure acting on them, the south poppet valves were subjected to a much larger force due to the rapid deceleration upon contact with the valve seat. This event also forced the two poppet actuators to be separated and propelled upwards.

Figure 8. Photographs of one of the south poppet valves (top) and one of the north poppet valves (bottom). The south poppet valve appears to be deformed as indicated by the dotted yellow line whereas the north poppet valve is flat.

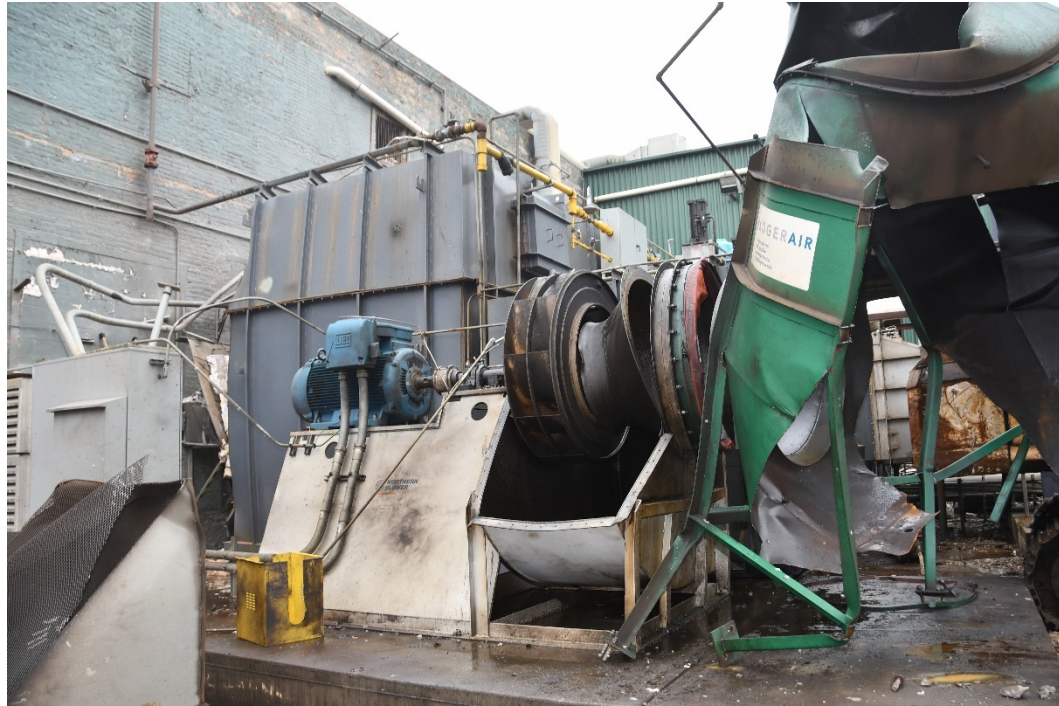
D18666-0013

The video also captured the top of the blower shrouding as it was projected from the area. Figure 9 depicts the damaged blower and the damage to the adjacent elbow in the ducting that connects to the filter.

Figure 9. Photograph of the blower adjacent to the RTO. The green ducting on the right was the elbow of the ducting connecting the filter and the RTO. The fresh air damper is visible in the bottom left corner of the image.

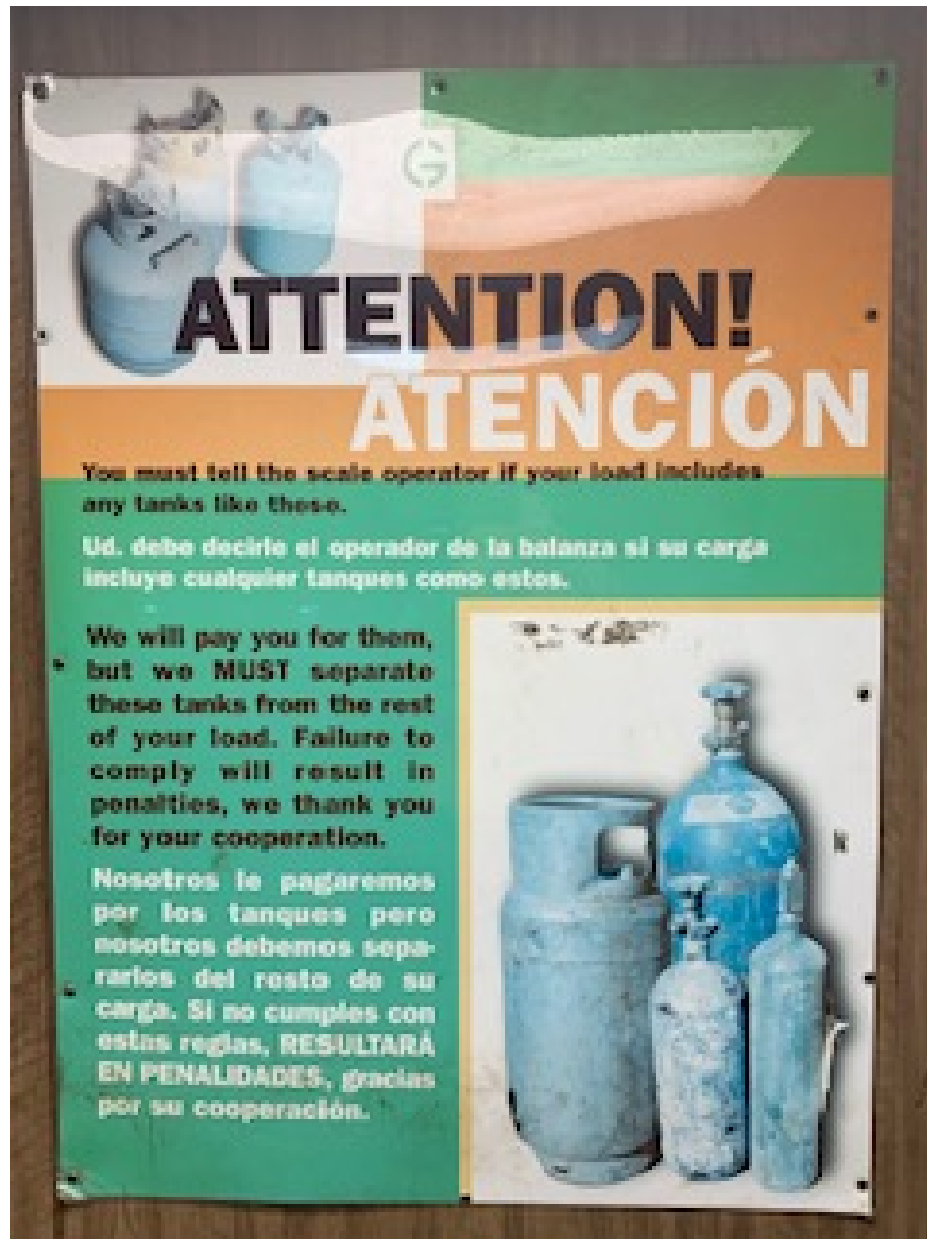
Figure 12. Signage from GII regarding compressed gas cylinders.

Administrative controls can be implemented to reduce the likelihood of introducing a flammable material into the shredder stream. The objective here is the prevention of flammable material containers from entering the shredder. This includes flammable pressurized liquids (propane), flammable gases (acetylene or other compressed gases), and flammable liquids (portable fuel containers for gasoline). GII already has a robust program to remove these materials from the shredder stream. The program includes efforts to educate suppliers, reward suppliers for compliance, notify suppliers for non-compliance, and the employment of inspectors to search the incoming stream for these materials. GII has found that accepting compressed gas containers separately incentivizes customers to indicate their location, as opposed to a refusal to accept, which may result in obfuscation. Signage, shown in Figure 12, identifies typical cylinder shapes and indicates that they will be paid for.
