Basement Floor Plan

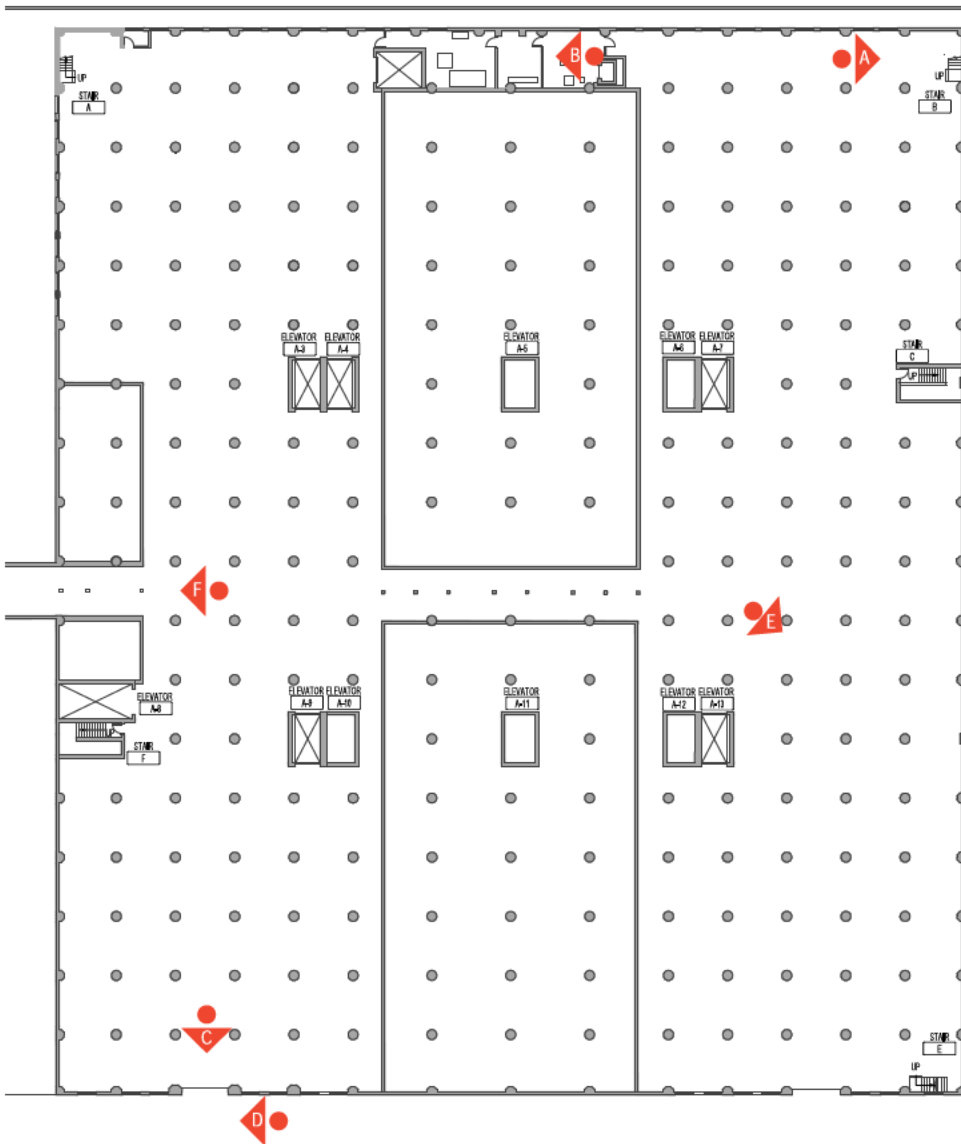
A - Stair B without enclosure

B - Pump Room

C - Utility Tunnel

D - Utility Tunnel

E - East of Basement

F - Tunnel to Central Building

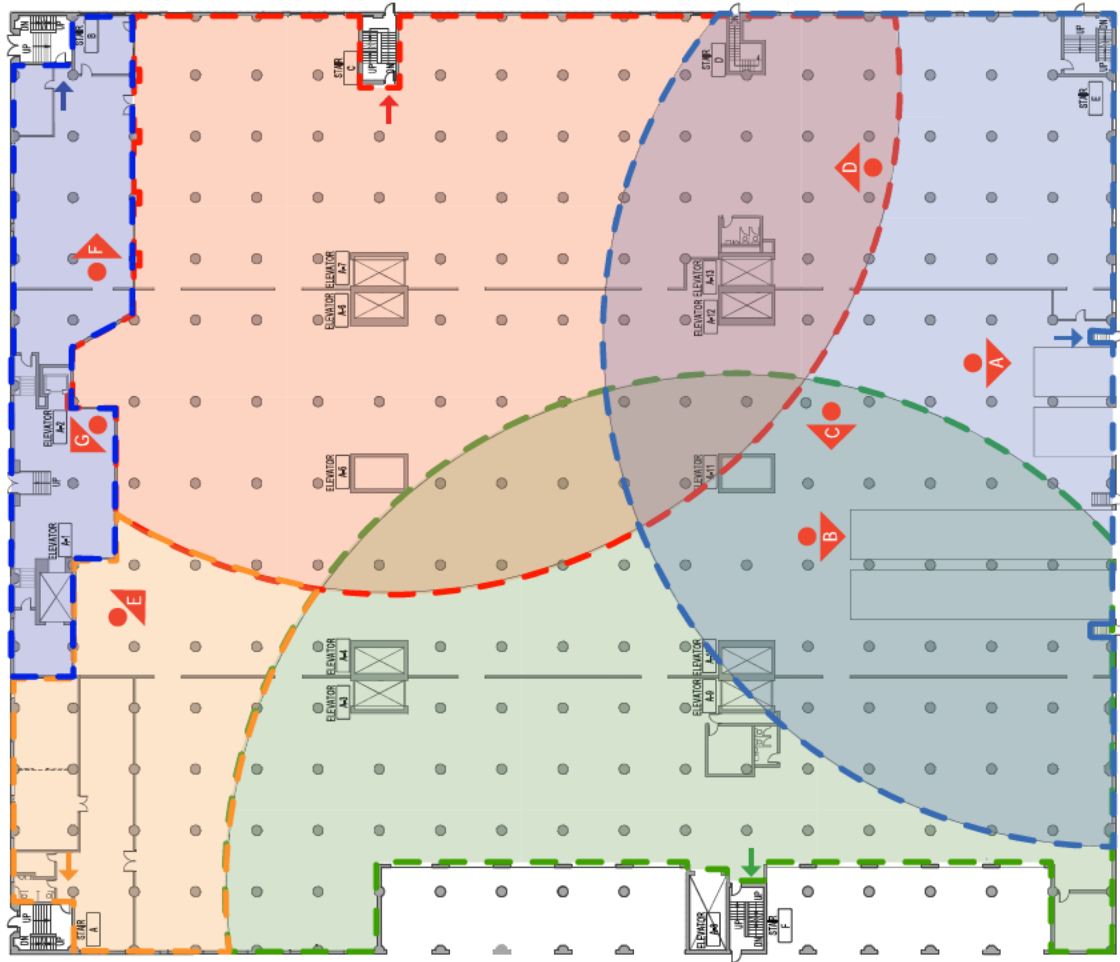
First Floor Plan

EXIT ZONES
150' TRAVEL DISTANCE PER SECTION 14X-12-1202.6.6

First Floor Existing Diagram: Section 14X-12-1202.6.6 Requires maximum 150' travel distance to an exit from any point on the ground floor. The diagram on the attached floor plan indicates that a total of 5 exits (Stair A, Stair B, Stair C, east exit at south elevation and Stair F) would need to be maintained for exiting from the building. The main entrance, center and east exits at the north side may be eliminated by modifying interior partitions. One exit would need to be maintained at building 'entrance'.

B - Rubbish at loading dock

D - Stored materials and rubbish at east side

F - Office bulbout with damaged finishes at the north of floor

B - Loading dock to south

C - Some bulbouts along at the center portion of the floor

E - Stored materials at the north of the floor

G - Center entrance to Pershing Road obstructed with plywood

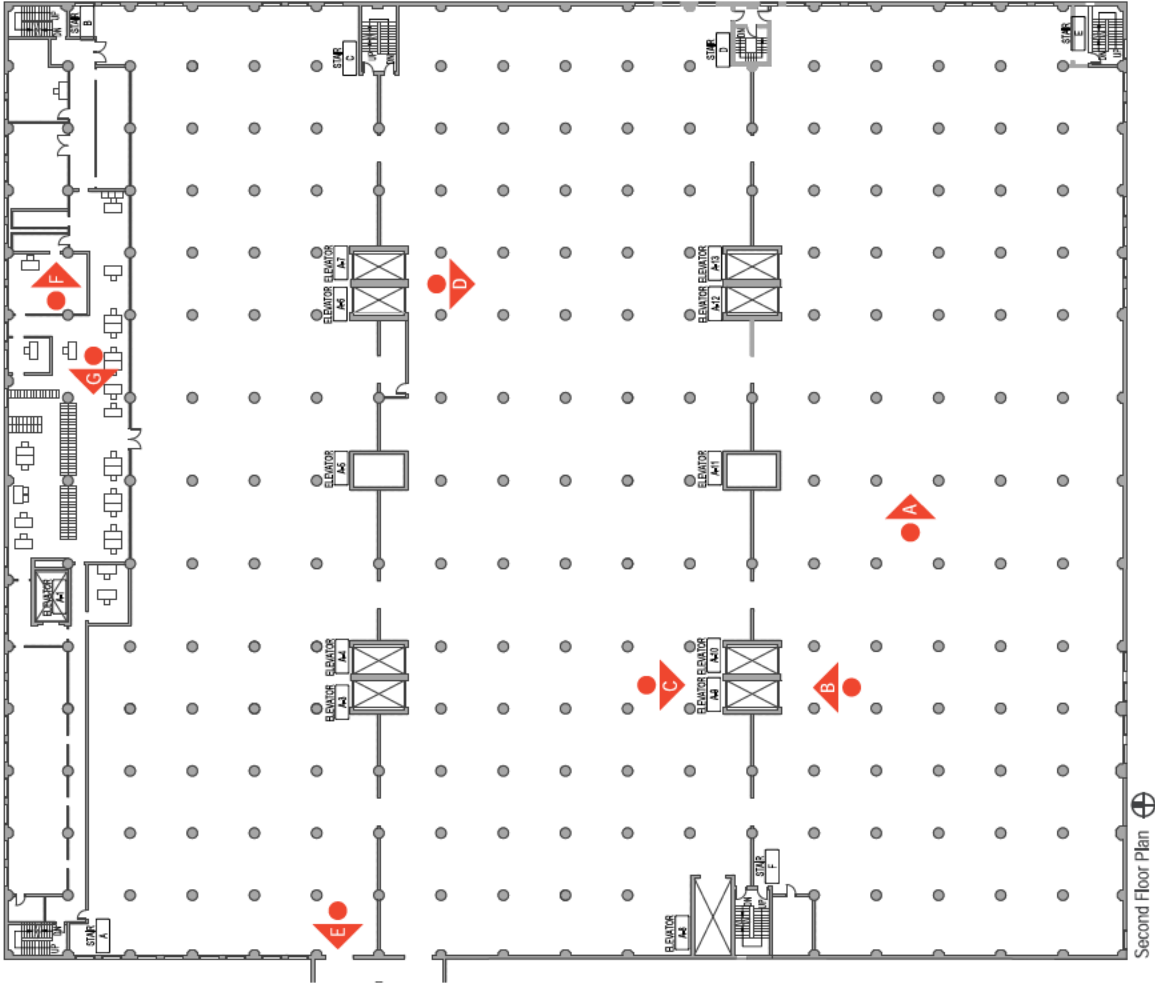
Second Floor Plan

A - South side of floor

B - Deteriorated Lintel Elevator 9

D - Chain Link Fenced Area and rubbish

F - Buildout at north of floor and rubbish

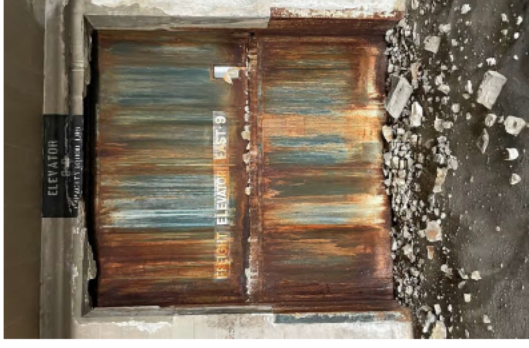
C - Deteriorated Lintel Elevator 9

E - Bridge to Central Building

E - Buildout at north of floor and rubbish

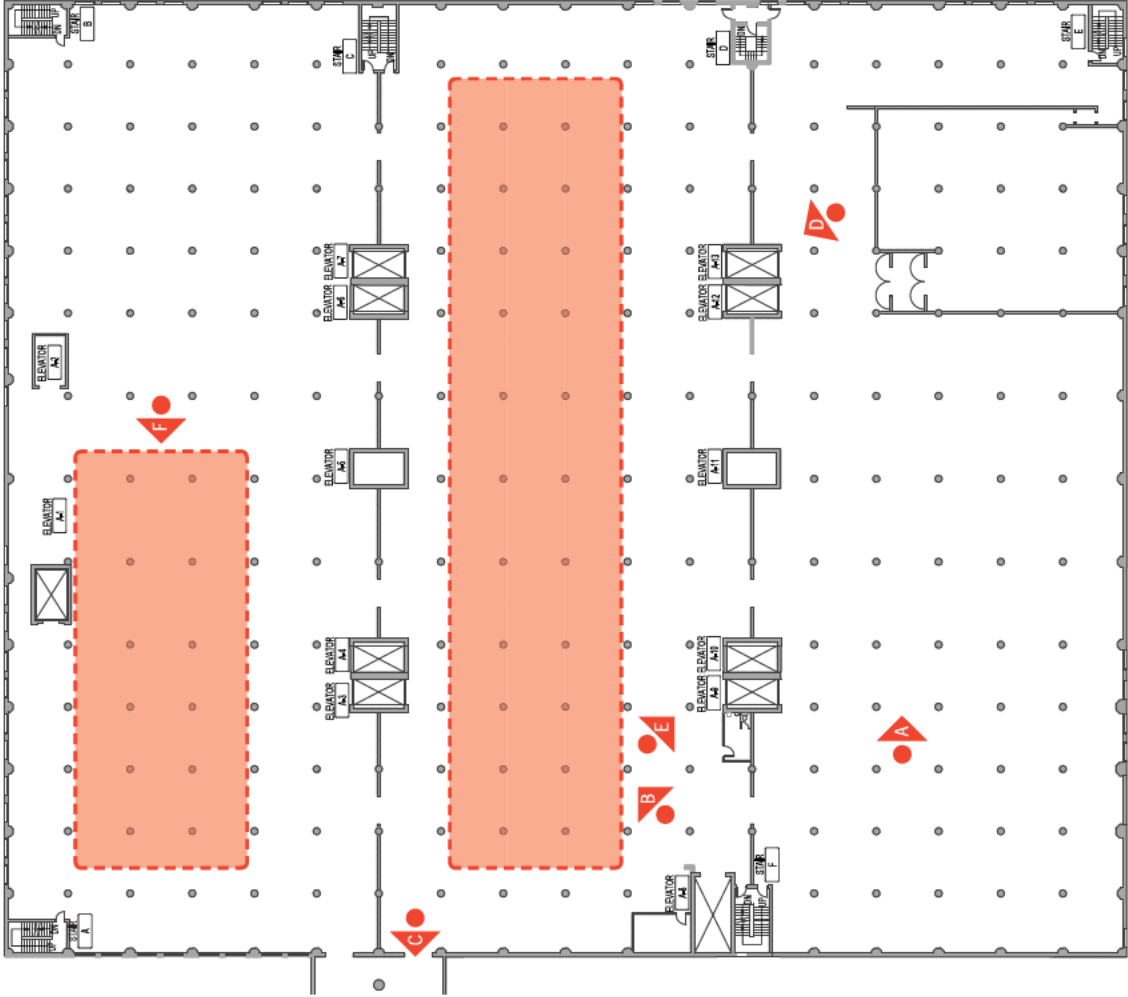
Third Floor Plan BOE Storage

A - South area of floor

B - BOE Storage center of building

C - BOE storage on the bridge to Central Building

D - Elevator Lintel Deterioration

E - Elevator Lintel Deterioration

F - BOE storage at north side of floor

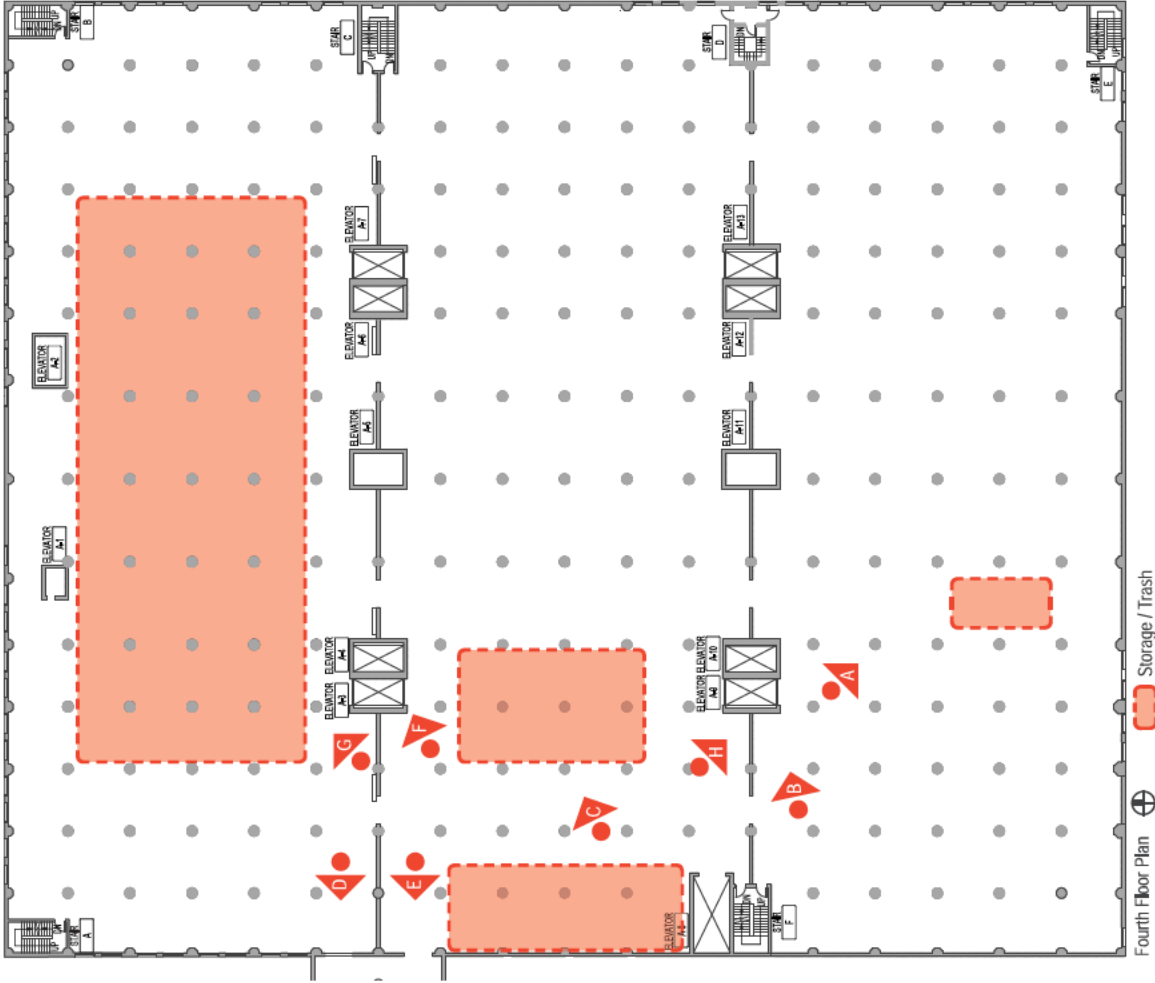
Fourth Floor Plan

A - Rubbish at south of floor

C - Trash at center portion of floor

E - Boarded up opening at the 1819 side of the bridge

G - Abandoned materials at north side of floor

B - Damaged elevator

D - Masonry fill at existing bridge

F - Abandoned freight elevator

H - Existing piping and plumbing fixtures

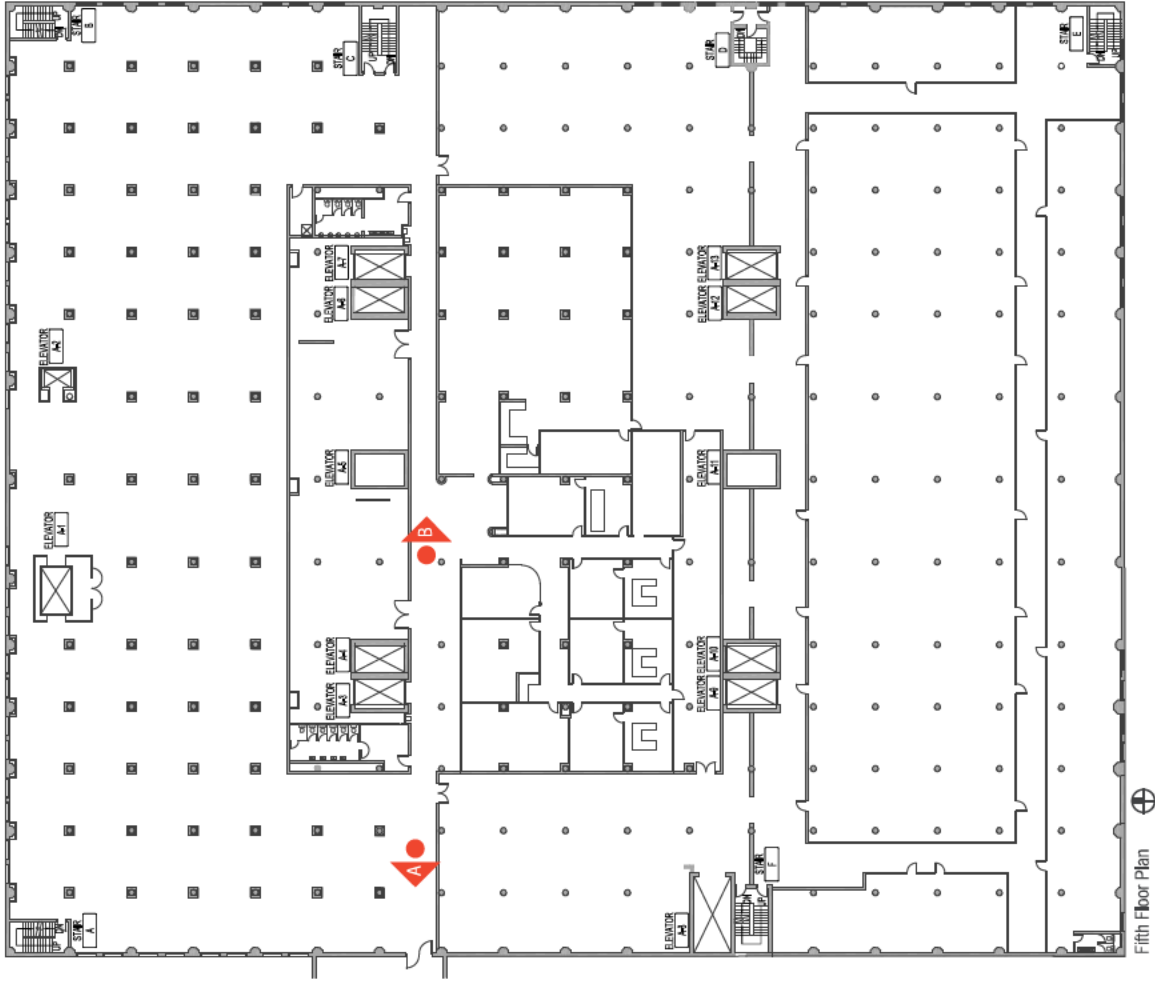
Fifth Floor Plan

A - Door to bridge connecting the East and Central Building

B - Interior Bulkheads and abandoned furnishings

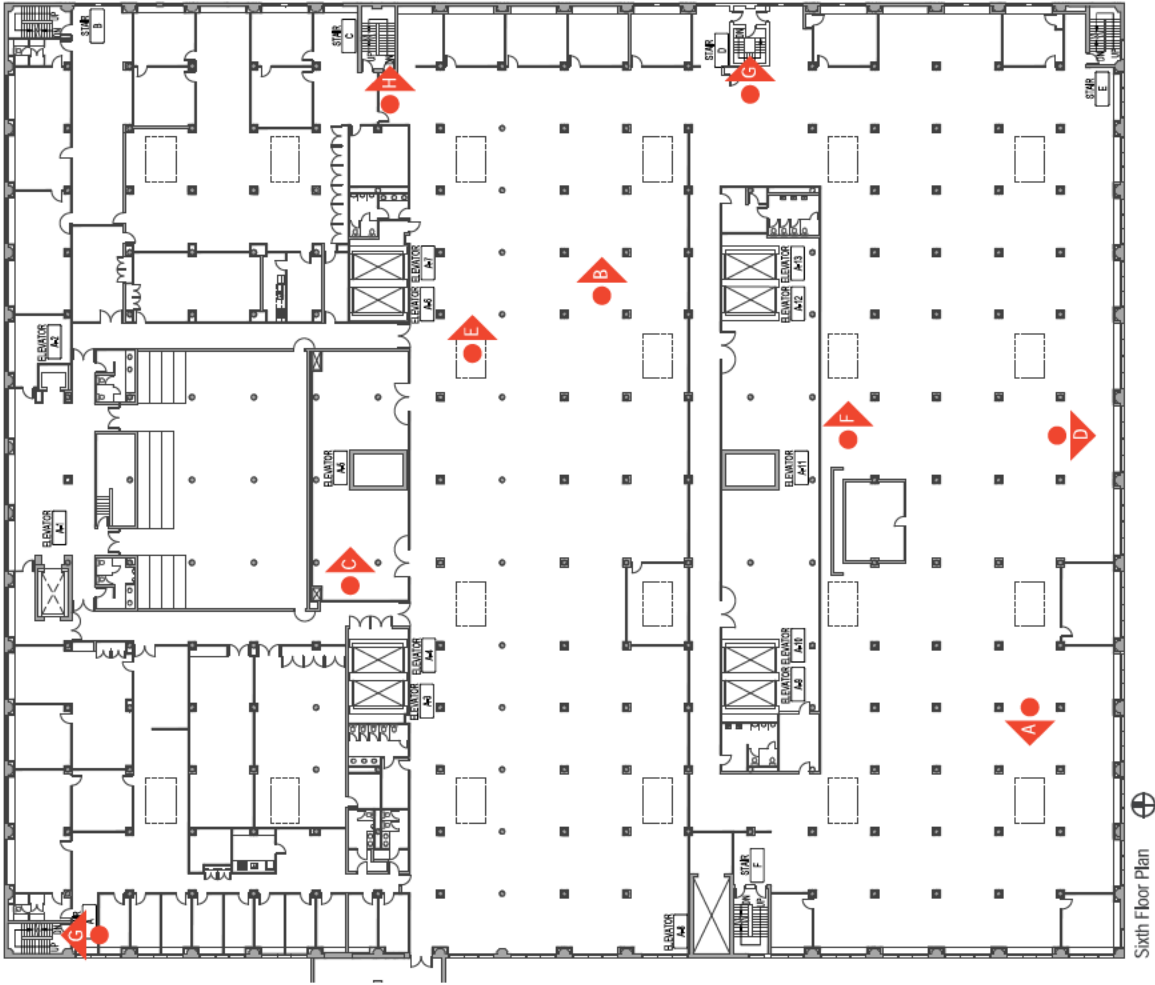
Sixth Floor Plan

A - Moss growing at floor areas below skylights

C - Abandoned mechanical units

E - Partition and bulkhead, abandoned equipment

G - Stair A with cage extended from the intermediate landing of 5th to 6th Floor

B - Interior built-outs and damaged materials

D - Deteriorated wall assembly

F - Concrete core built around freight elevator

H - Guardrail at Stair C
