CITY OF CHICAGO

DEPARTMENT OF FLEET AND FACILITY MANAGEMENT

ASSESSMENT OF 1769 & 1819 W. PERSHING ROAD

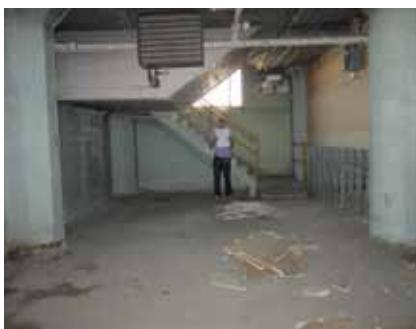
1. Unclosed southeast stair

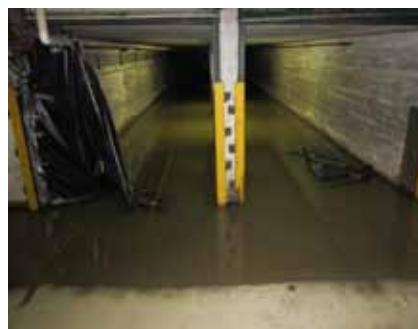
3. Access tunnel

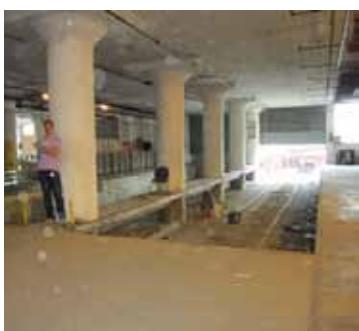
1. Rail freight dock

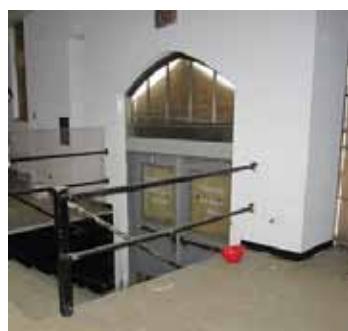
2. Main entrance

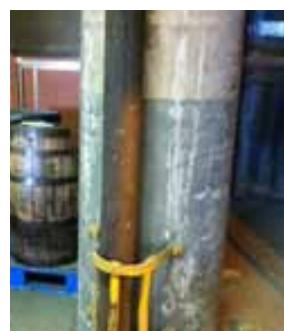
3. Corroded plumbing

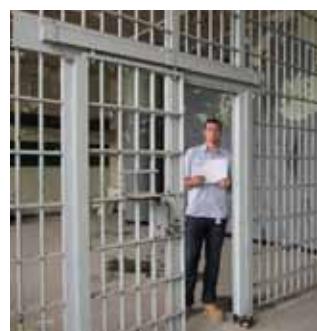
4. Detention center

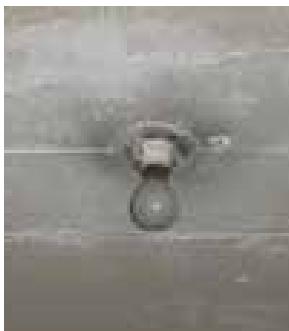
2. Typical lighting

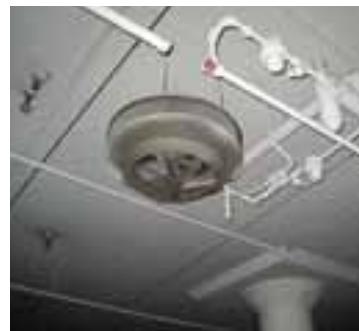
3. Exhaust fan

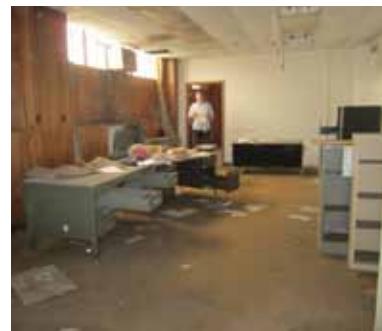
4. North side offices

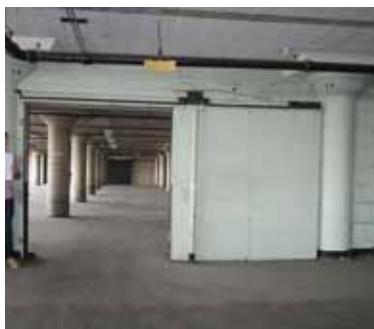
1. Sliding metal dividing doors

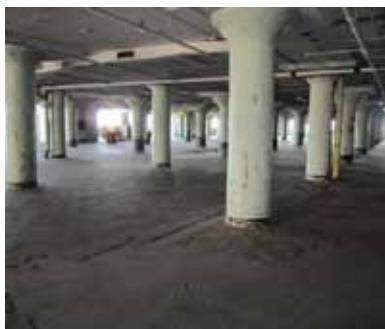
2. Typical area

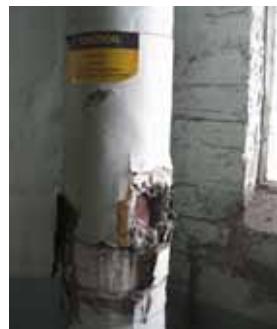
3. Suspected asbestos

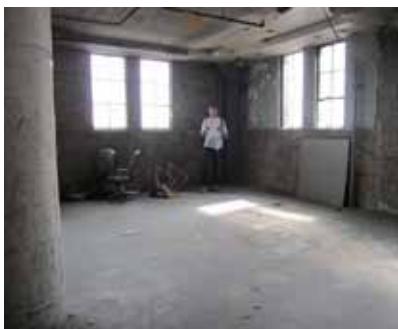
1. Southwest corner

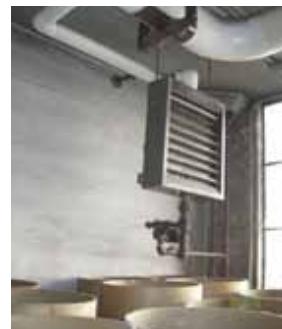
3. Ceiling heater

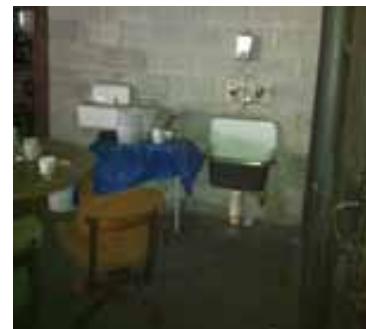
4. Plumbing fixtures

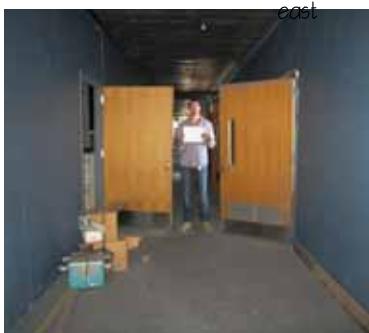
1. Corridor

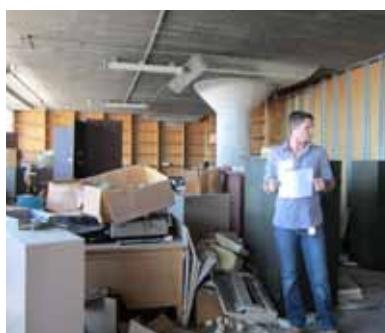
2. Typical south side room

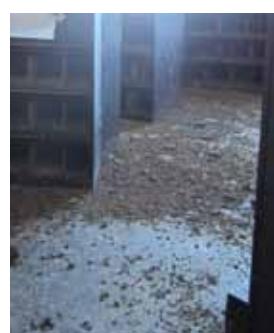
3. Bird guano

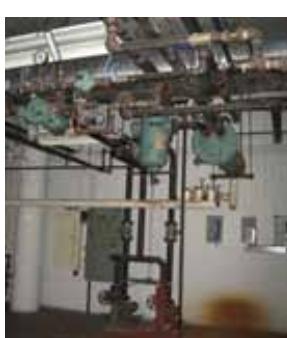
1. Mechanical unit

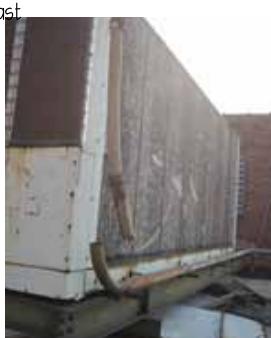
2. Disconnected roof top unit

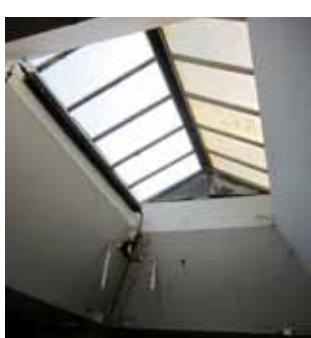
3. Typical skylight

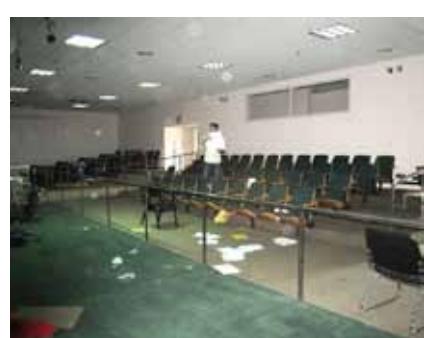
4. Board room with auditorium seating

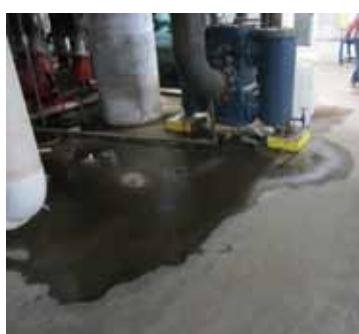
2. Standing water

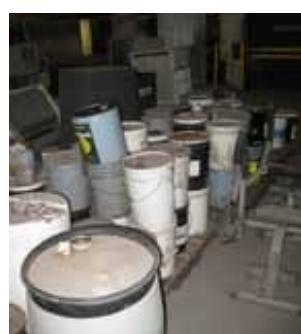
3. Chemical buckets/drums

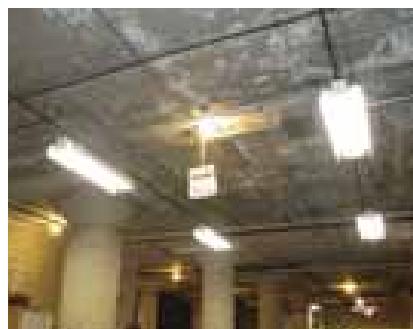
3. Typical lighting

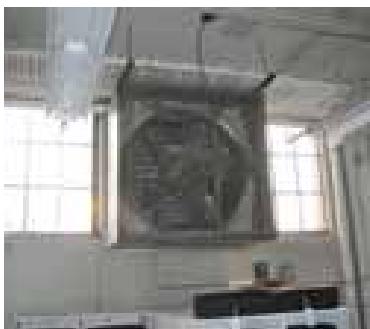
1. Exhaust fan

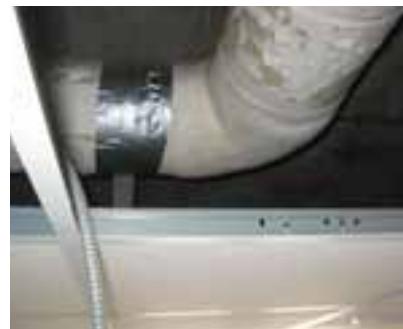
3. TSI pipe fitting

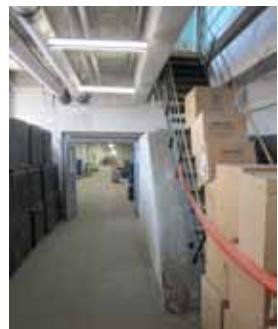
4. Stairs blocked at bridge

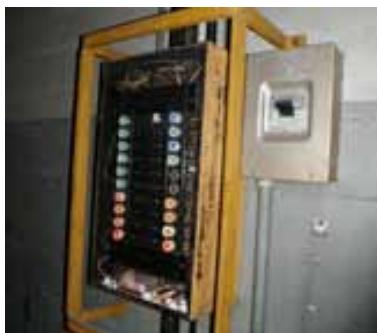
1. Branch circuit panel

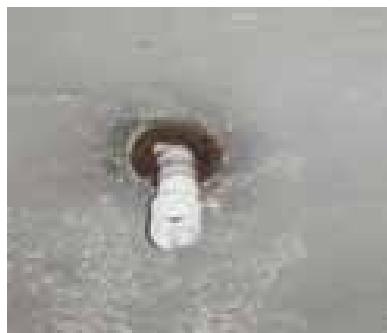
2. Typical light fixture

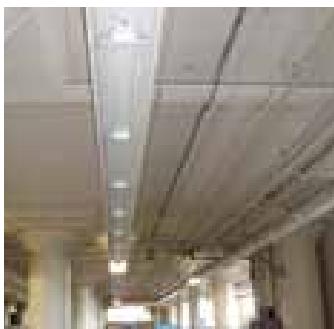
1. Typical lighting

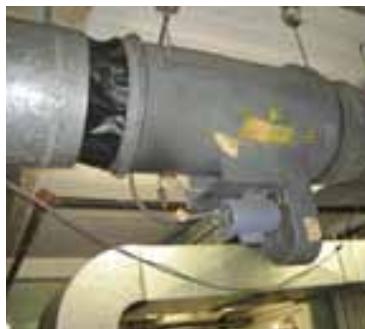
2. HVAC unit

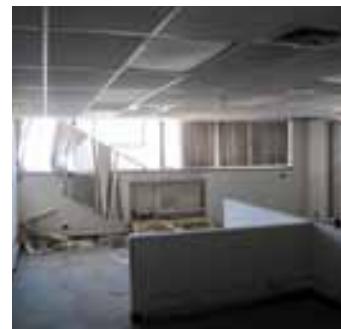
3. Inoperable recessed wall fin radiator units

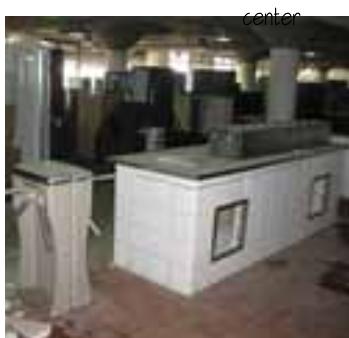
1. Cafeteria

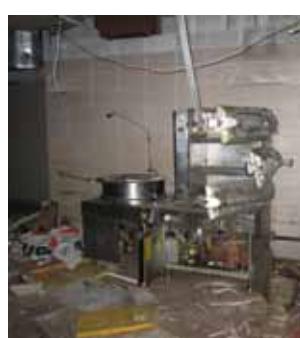
2. Kitchen

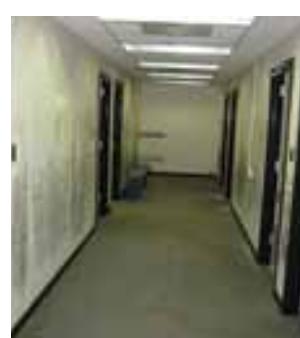
3. Suspected mold

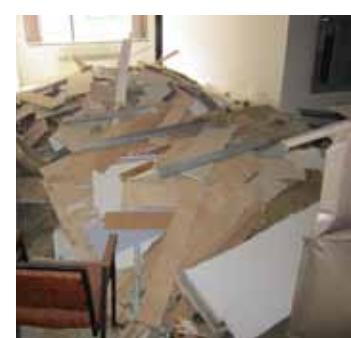
4. Blocked exit

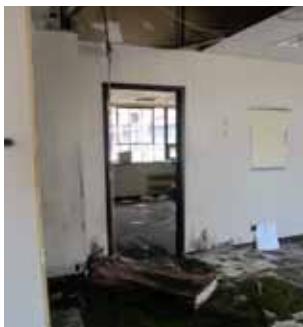
1. Leaking plumbing at bridge

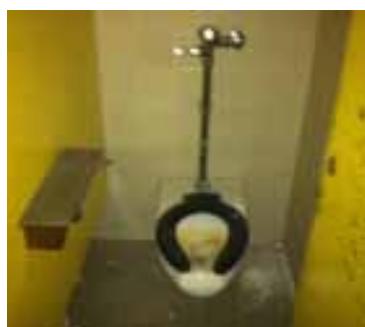
2. Plumbing fixture

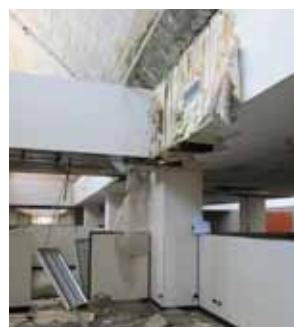
3. Moisture damage at skylight

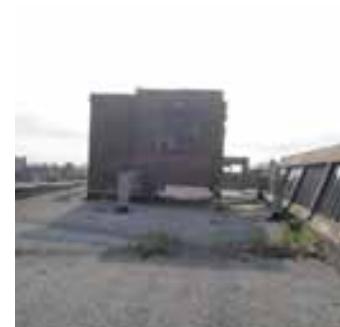
4. Skylight at roof
