## **Obama Presidential Center**

Jackson Park Tree Survey

# Obama Presidential Center Tree Inventory and Management Plan | 2018

Submitted by: Bartlett Tree Experts

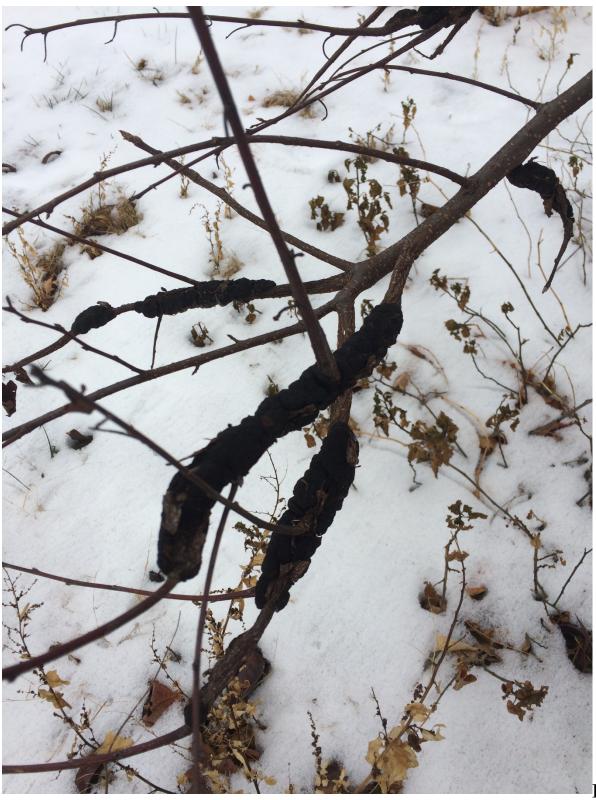
Tree #608 with black knot present.

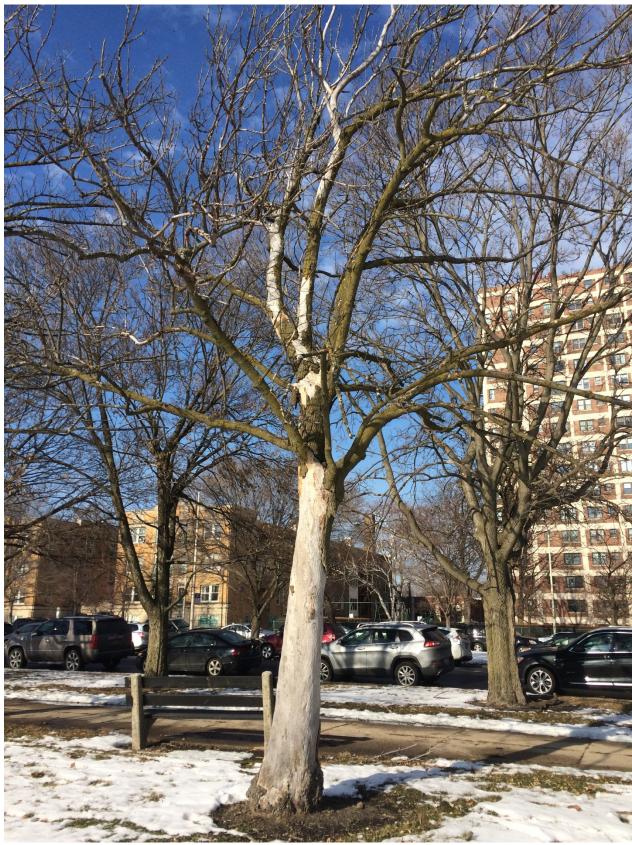
Tree #541 recommended for removal because of location and tree is dead.

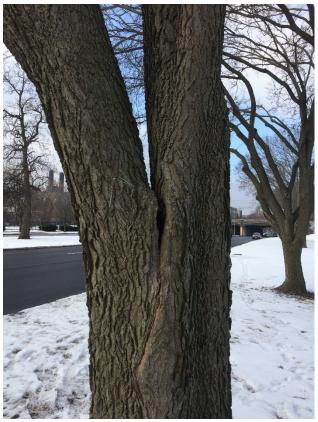
Stem crack and cavity on Tree #514 necessitates a *(Level 3) advanced assessment* to more thoroughly assess risk of failure.

In such cases, we may recommend (Level 3) advanced assessments of the roots, stem, or crown. These assessments may include climbing inspections, examination of the root system using a compressed-air tool (that avoids damage to roots and underground utilities), or one or more of the following: resistance drilling; using the resistograph (a precision drilling instrument that provides graphical output); or sonic tomography that produces a visual representation of internal conditions based on how sound moved through the tree. The goal is to use the appropriate method to evaluate impact of wood decay in stems and buttress roots that show potential for failure and to determine presence and condition of the root system.

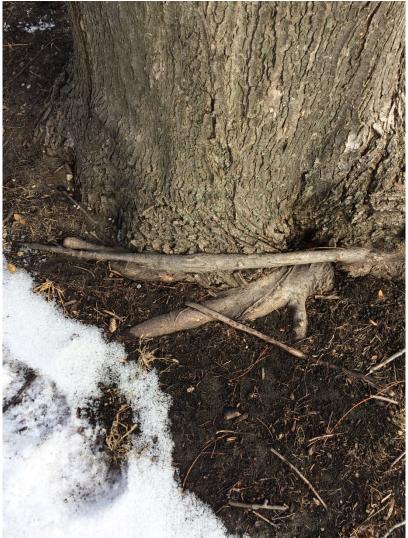
Tree #650 exhibiting girdling roots.
