**Former Crawford Power Generating Station, 3501 S. Pulaski  
Turbine Structure Demolition  
May 18, 2020**

**Frequently Asked Questions**

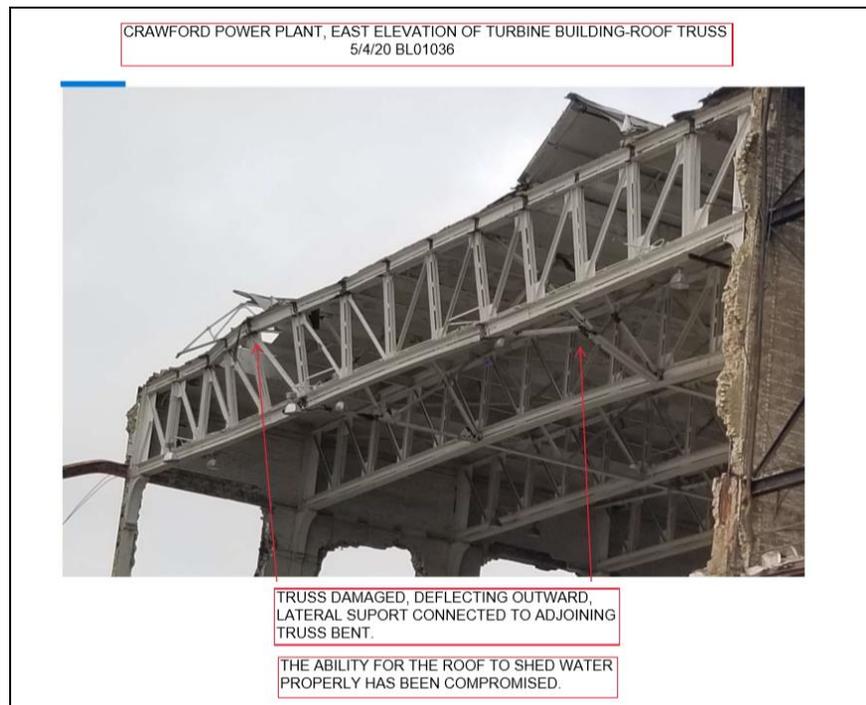
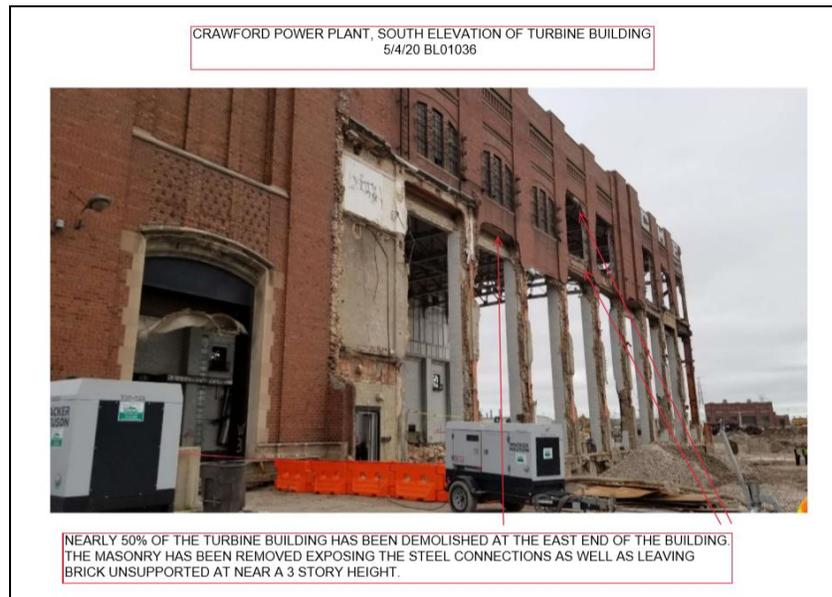
Per a thorough review and structural analysis, the building is dangerous for the following reasons:

- Steel columns are now exposed and unbraced in both dimensions.
- The adjacent building structure that originally provided lateral support to the steel columns has been removed.
- Large areas of exterior brick are currently unsupported and remain in place solely due to mortar adhesion, and the brick could collapse due to its own weight and wind pressure.
- Structural steel roof trusses are damaged. Deformation of trusses and cross bracing could get worse.
- The exposed steel makes the site an attractive nuisance to scappers who regularly trespass to scavenge the site.

Pictures illustrating the described conditions are included below:
