Comprehensive Site Investigation Report, Remediation Objectives Report, and Remedial Action Plan

North Kimball Brownfield Site
1807-1815 N. Kimball Avenue
Chicago, Illinois

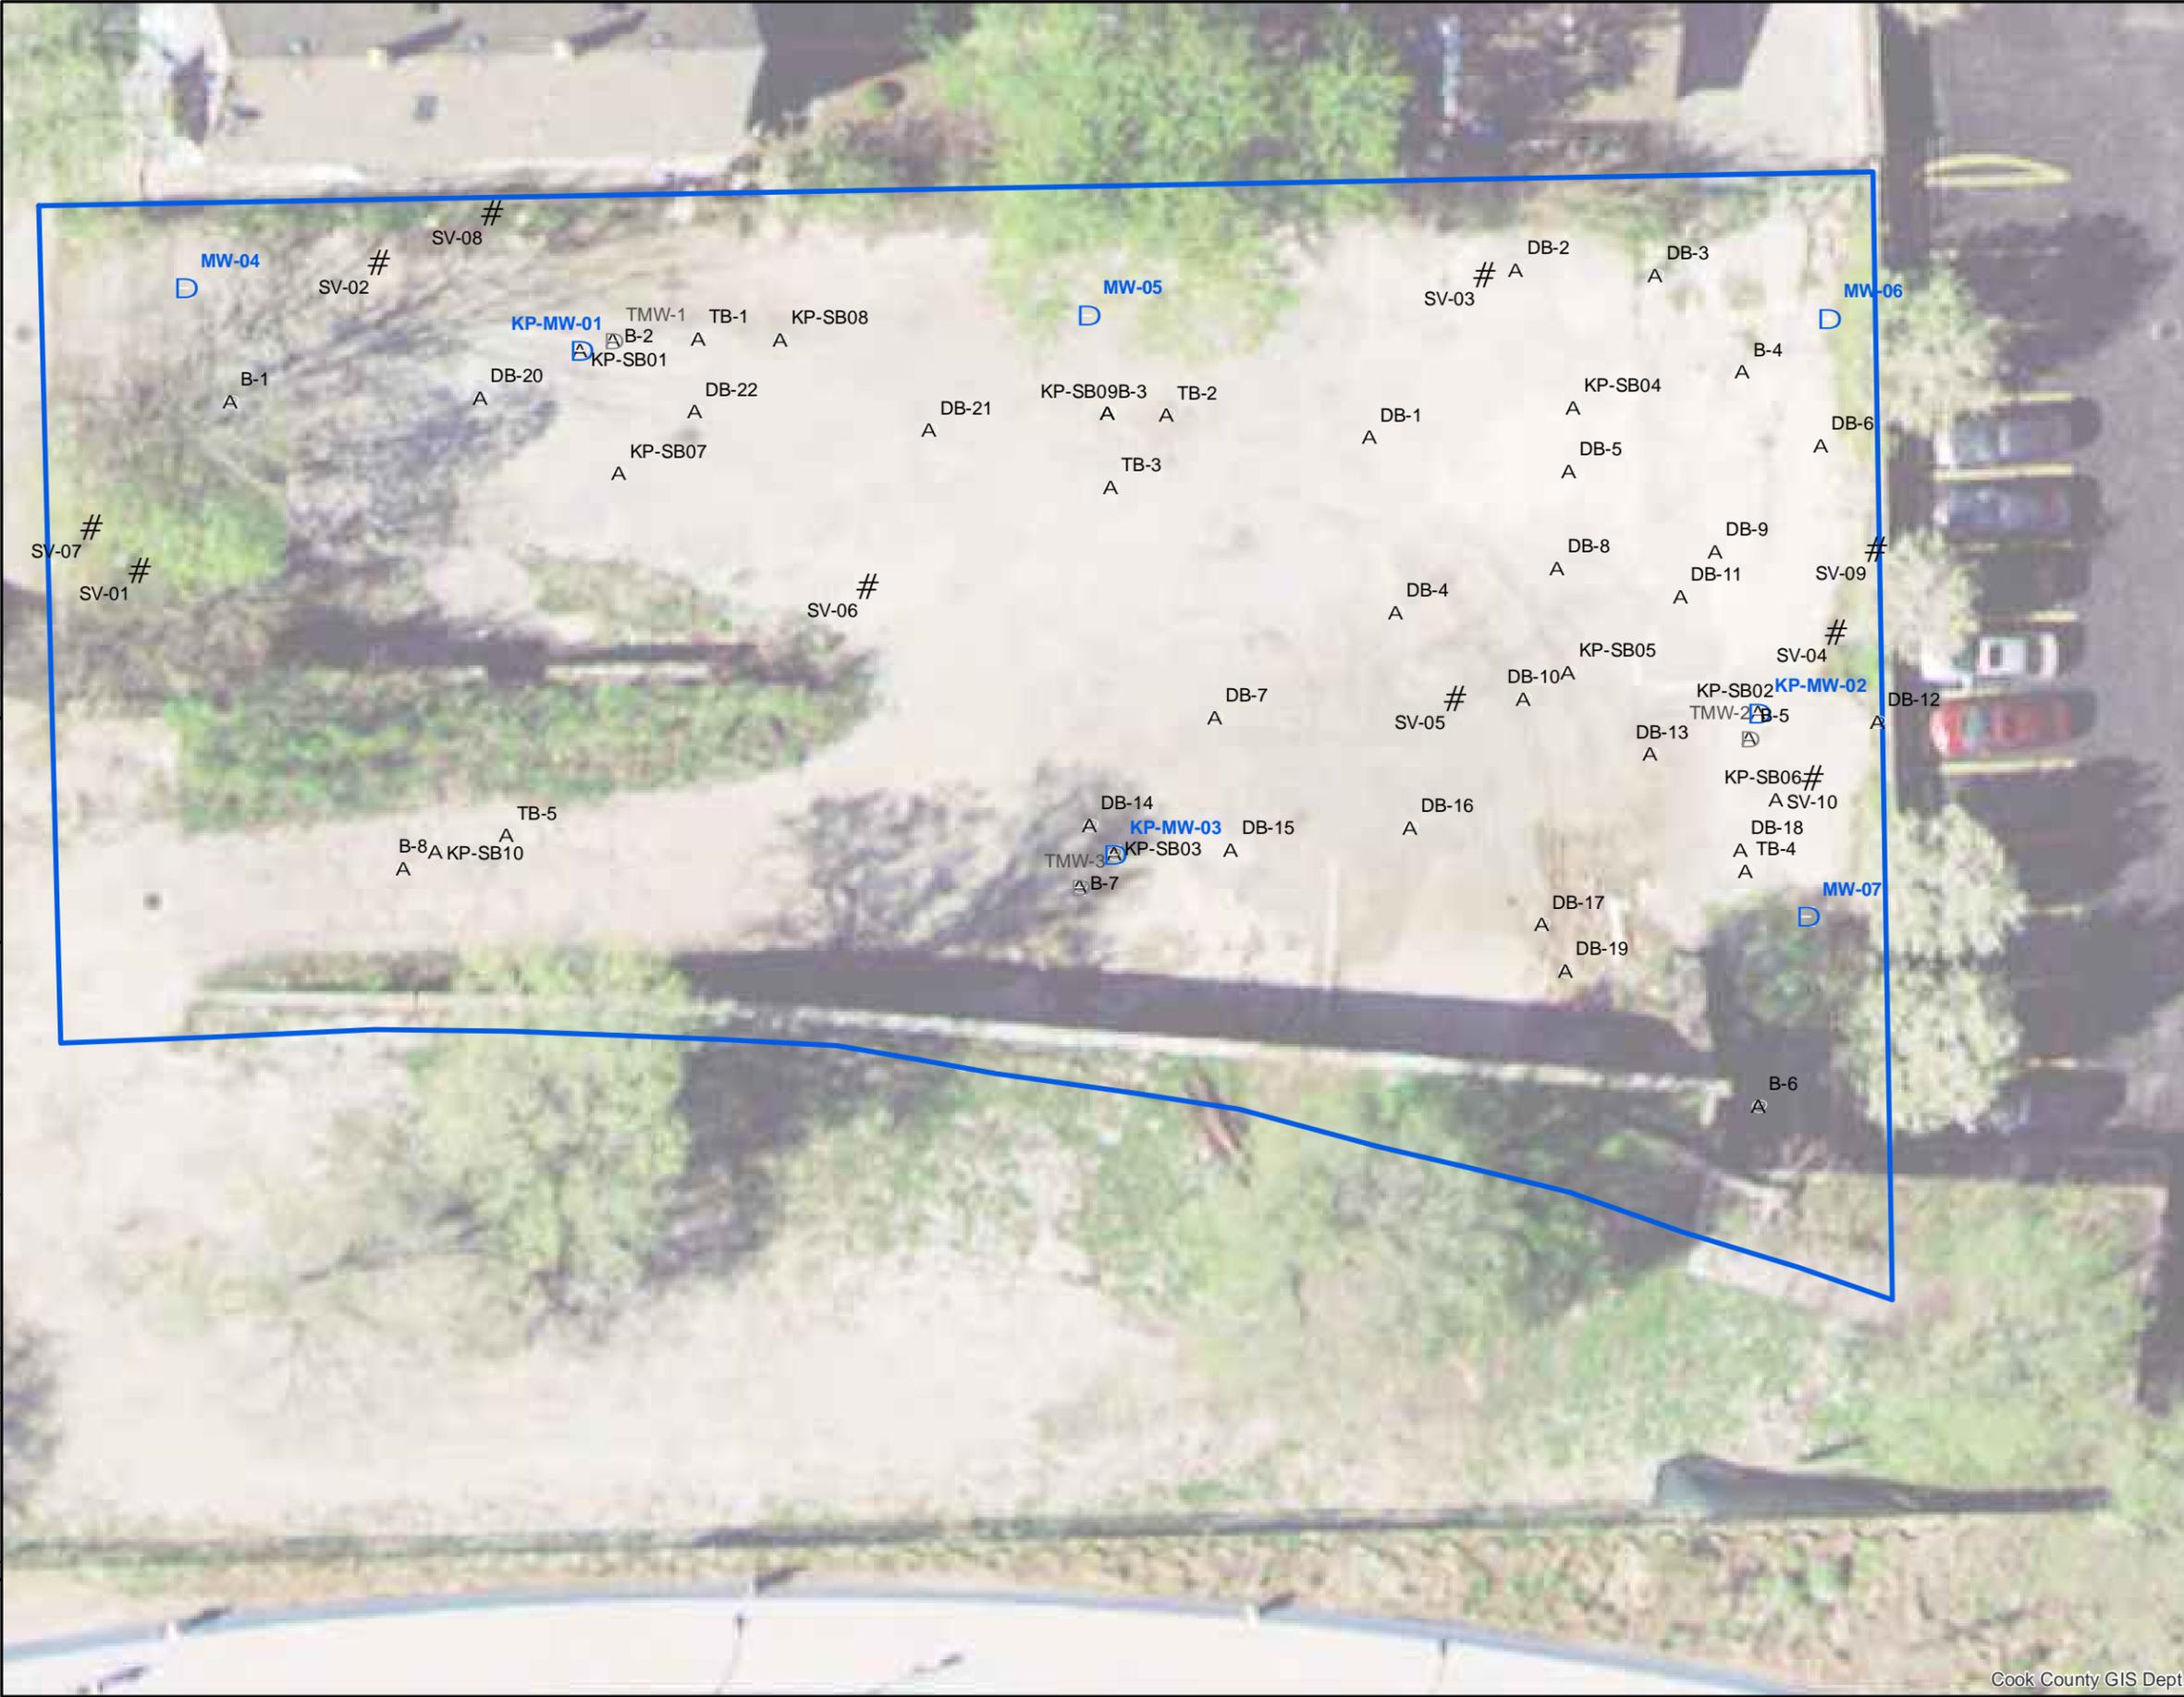
- Legend**
- A Soil Sample Location
 - # Soil Vapor Point
 - D Groundwater Monitoring Well
 - D Temporary Monitoring Well
 - Remediation Site Boundary

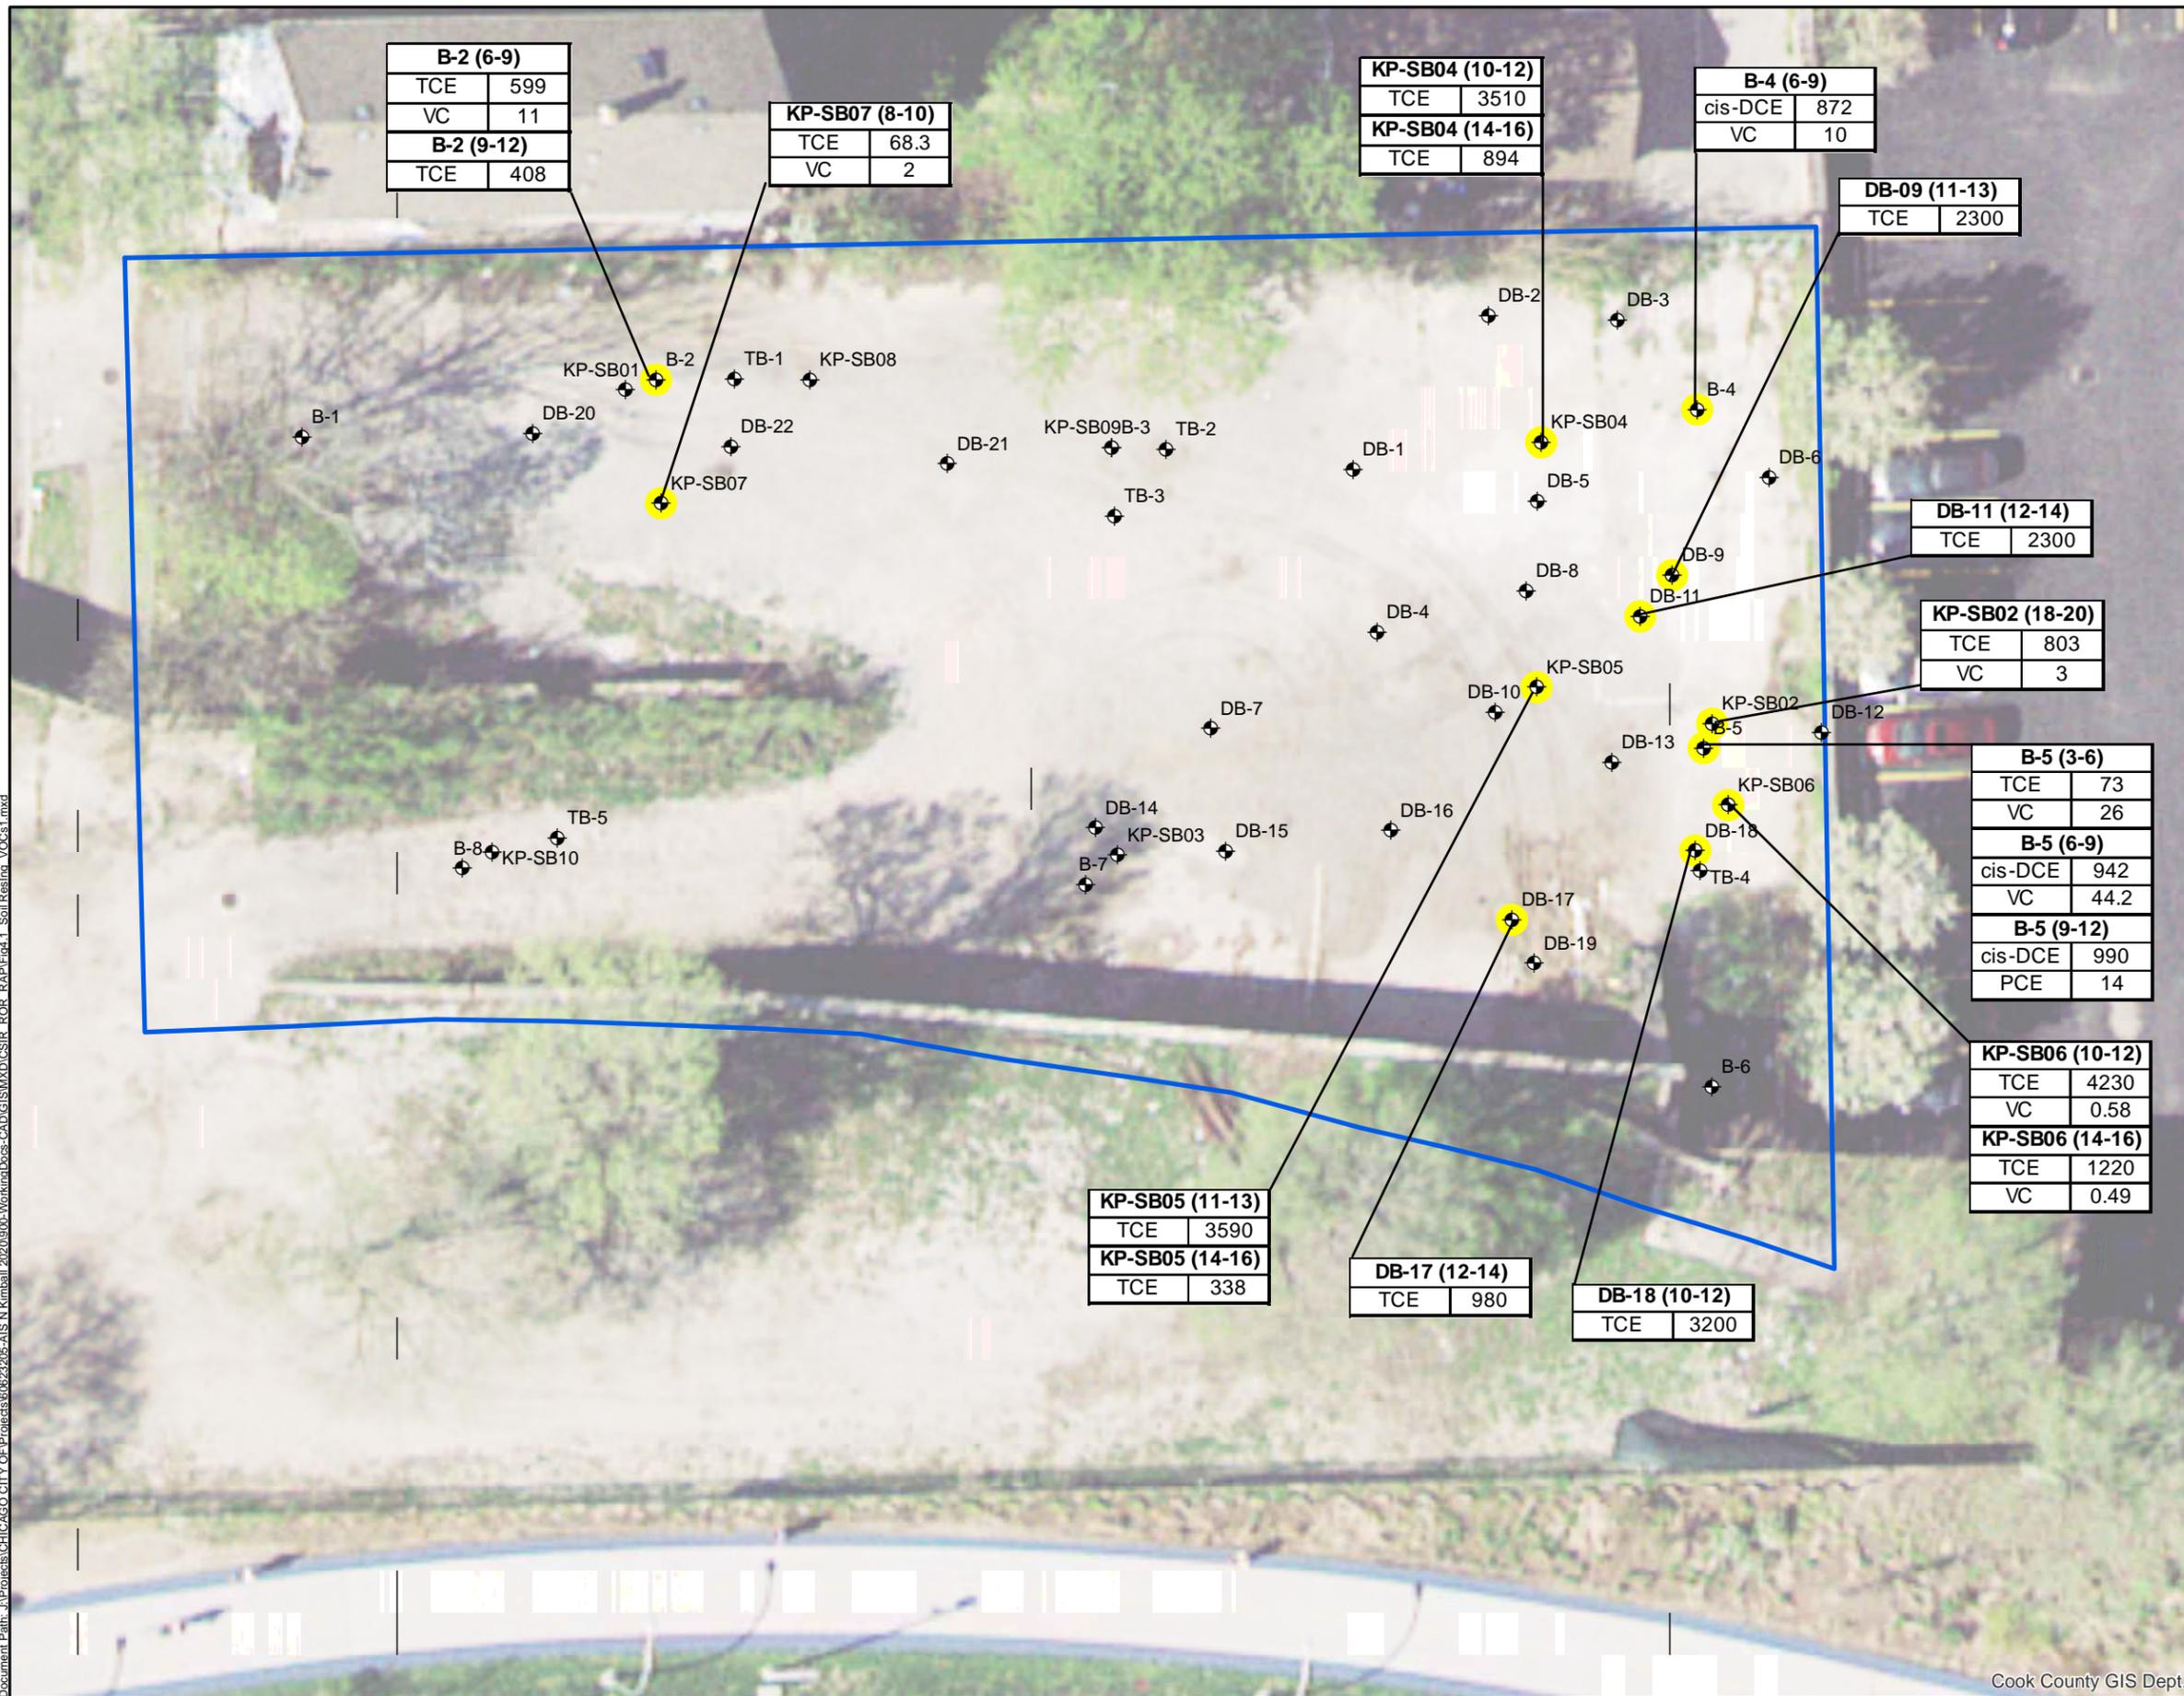
- Legend**
- Soil Sample Location
 - Deep (> 3 ft) Tier 1 Residential Ingestion SRO Exceedance: VOCs
 - Remediation Site Boundary

Notes:
 cis-DCE = cis-1,2-dichloroethene
 PCE = tetrachloroethene
 TCE = trichloroethene
 VC = vinyl chloride

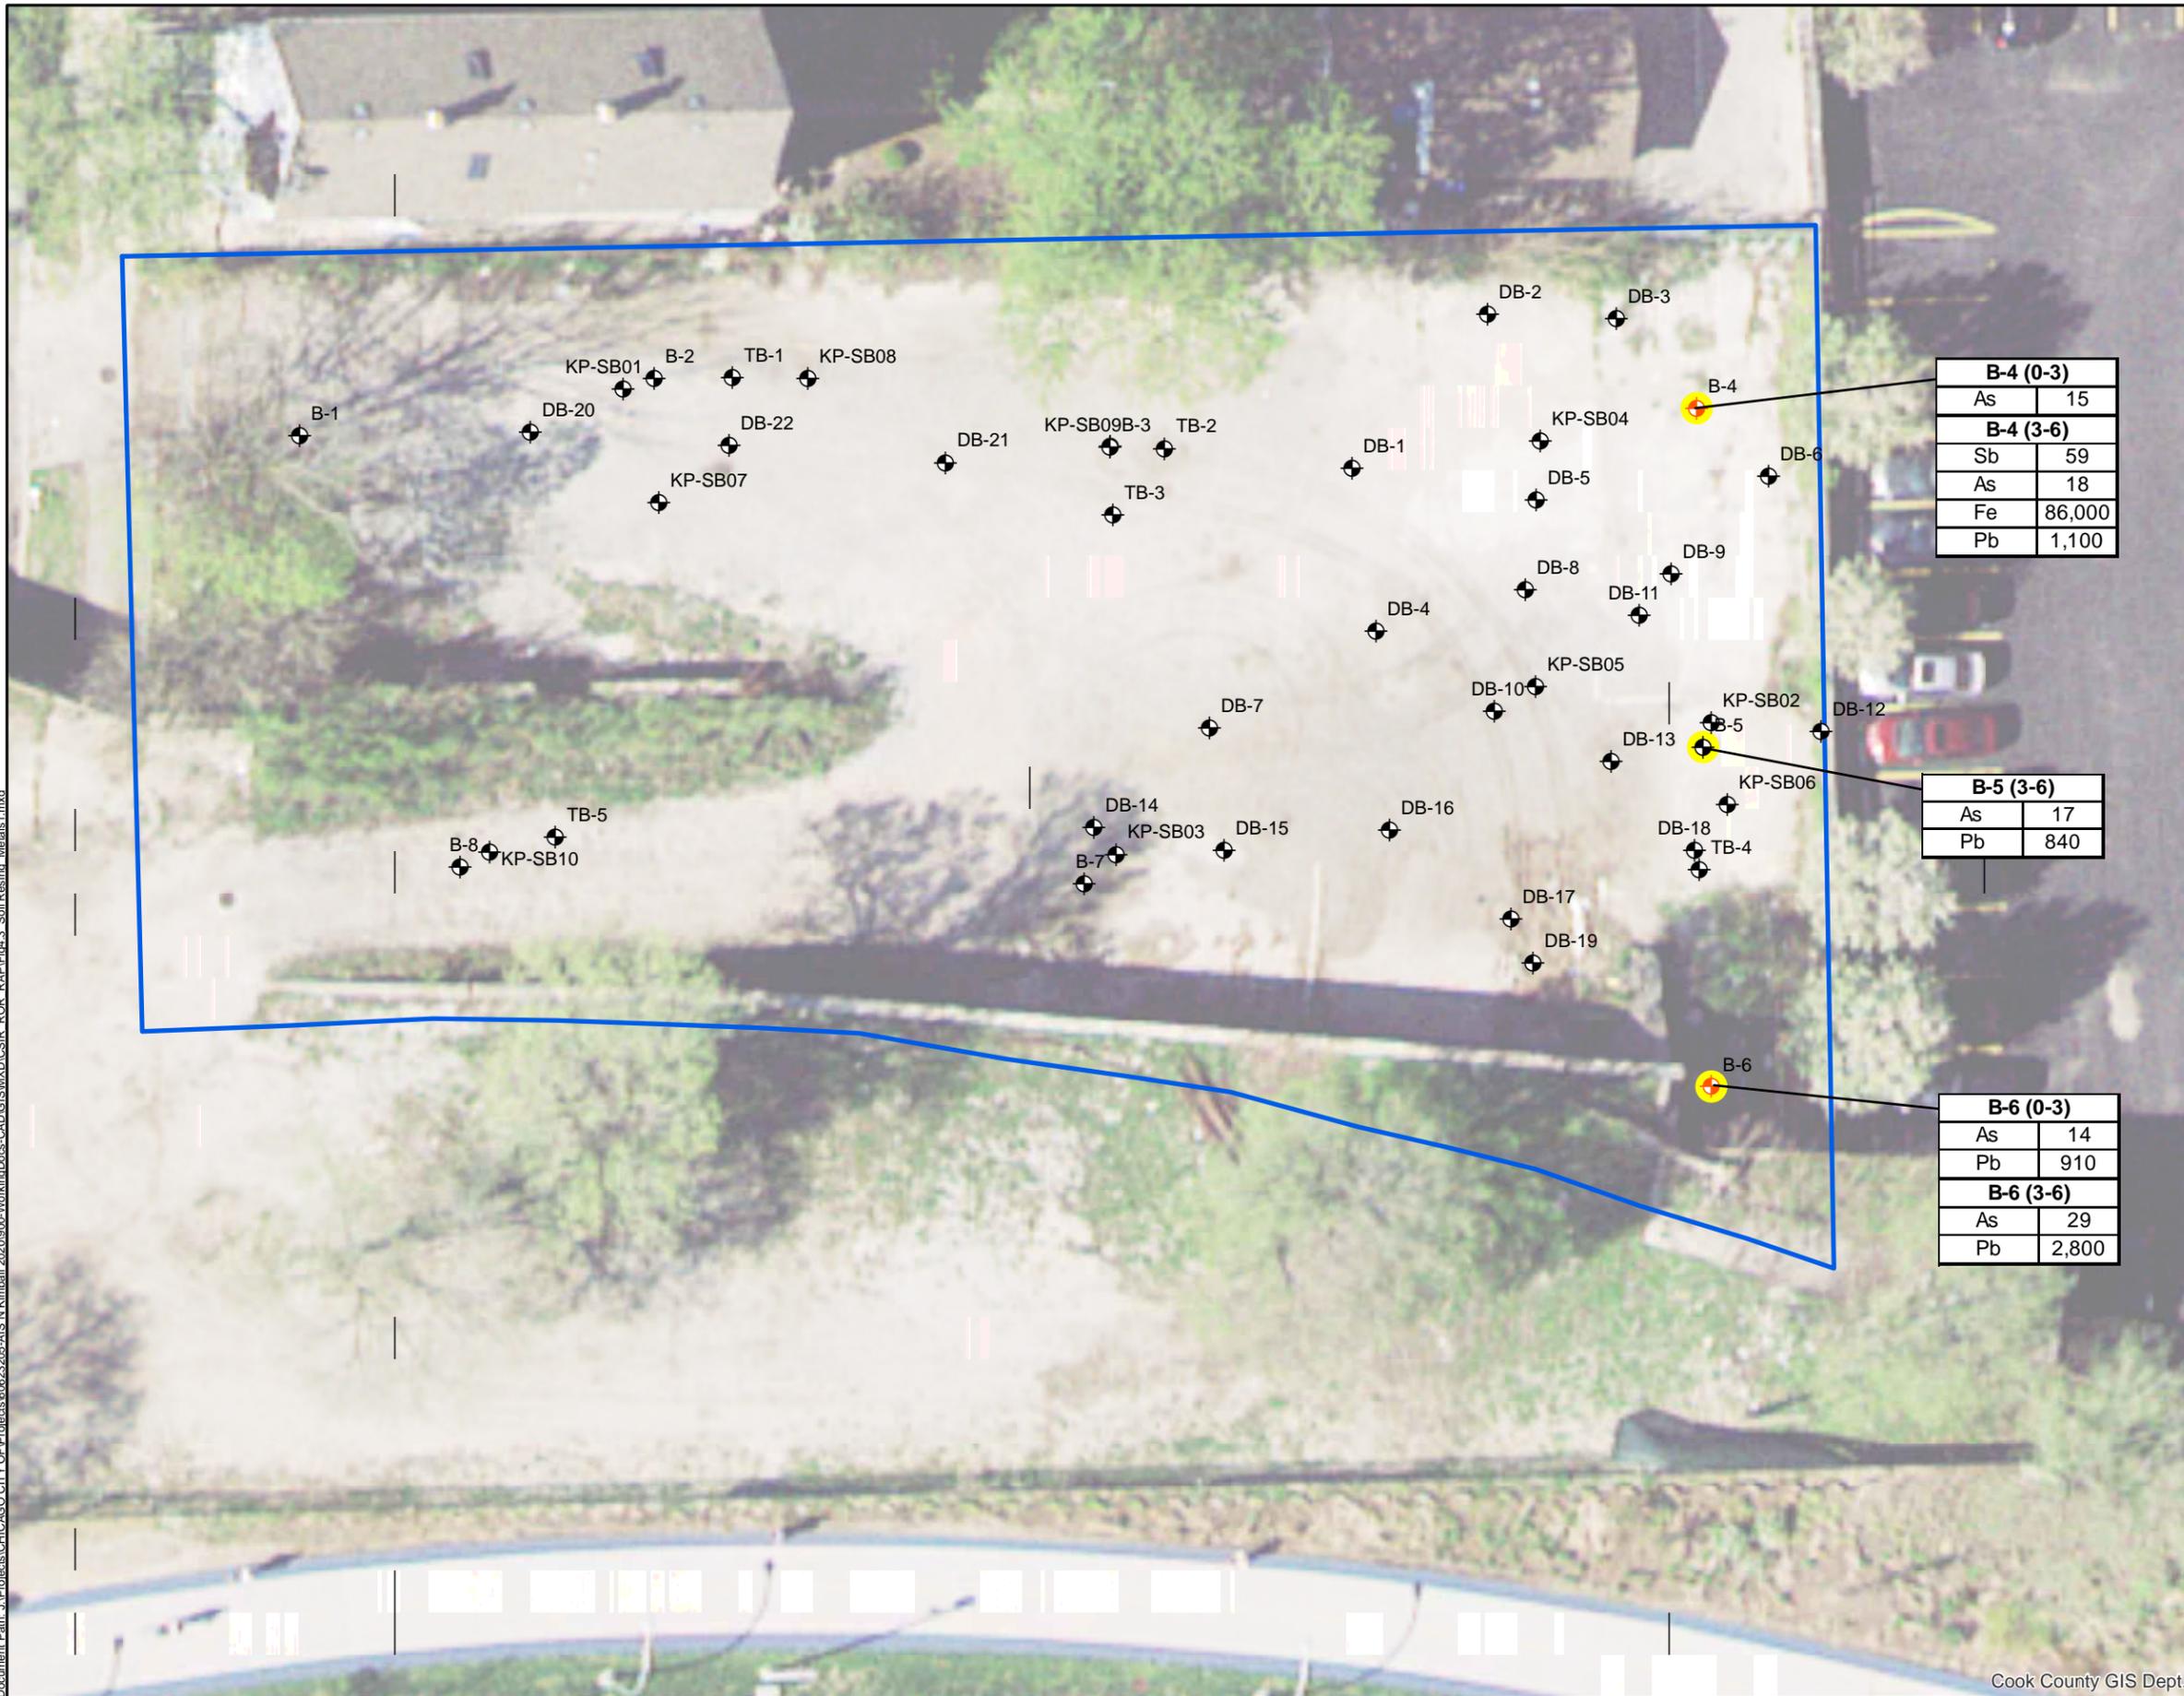
- ◆ Soil Sample Location
- ◆ Shallow (0-3 ft) Tier 1 Residential Ingestion SRO Exceedance: Metals
- ◆ Deep (>3 ft) Tier 1 Residential Ingestion SRO Exceedance: Metals
- ▭ Remediation Site Boundary

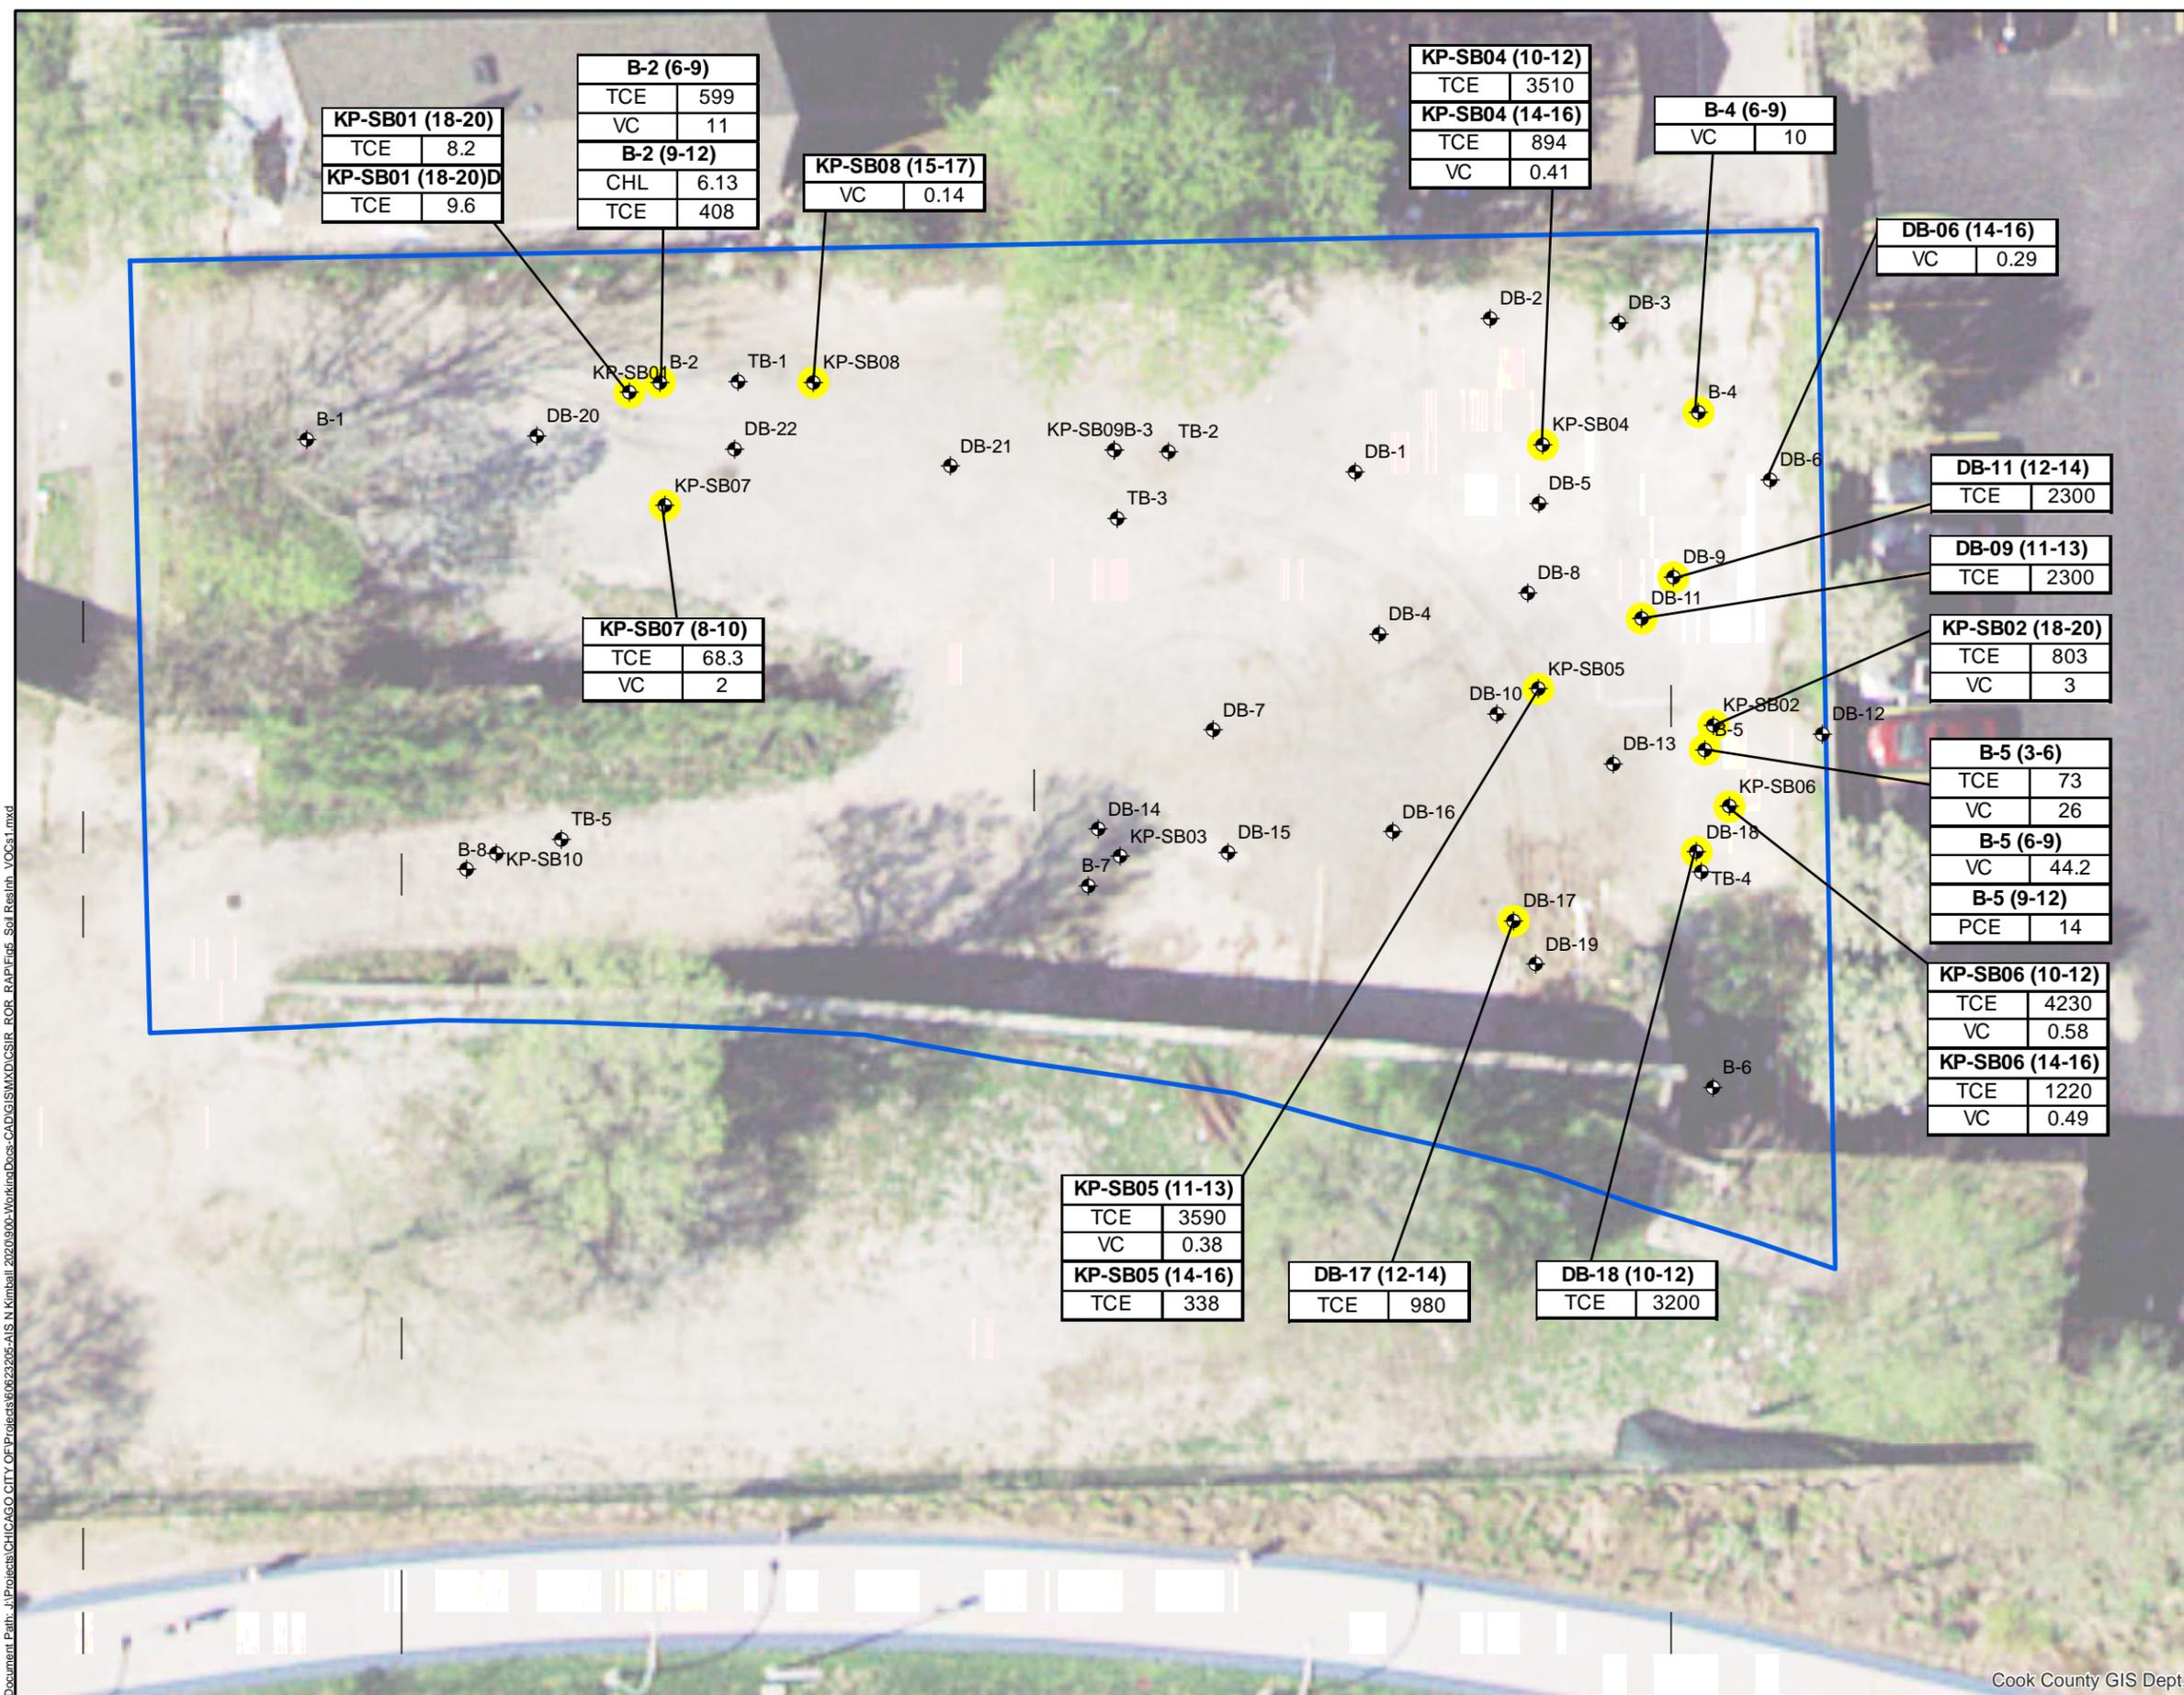
- Legend**
- ◆ Soil Sample Location
 - Deep (> 3 ft) Tier 1 Residential Inhalation SRO Exceedance: VOCs
 - ▭ Remediation Site Boundary

Notes:
 CHL = Chloroform
 PCE = tetrachloroethene
 TCE = trichloroethene
 VC = vinyl chloride
 KP-SB06 (10-12) = Sample Location (depth in feet)
 Concentrations shown in mg/kg

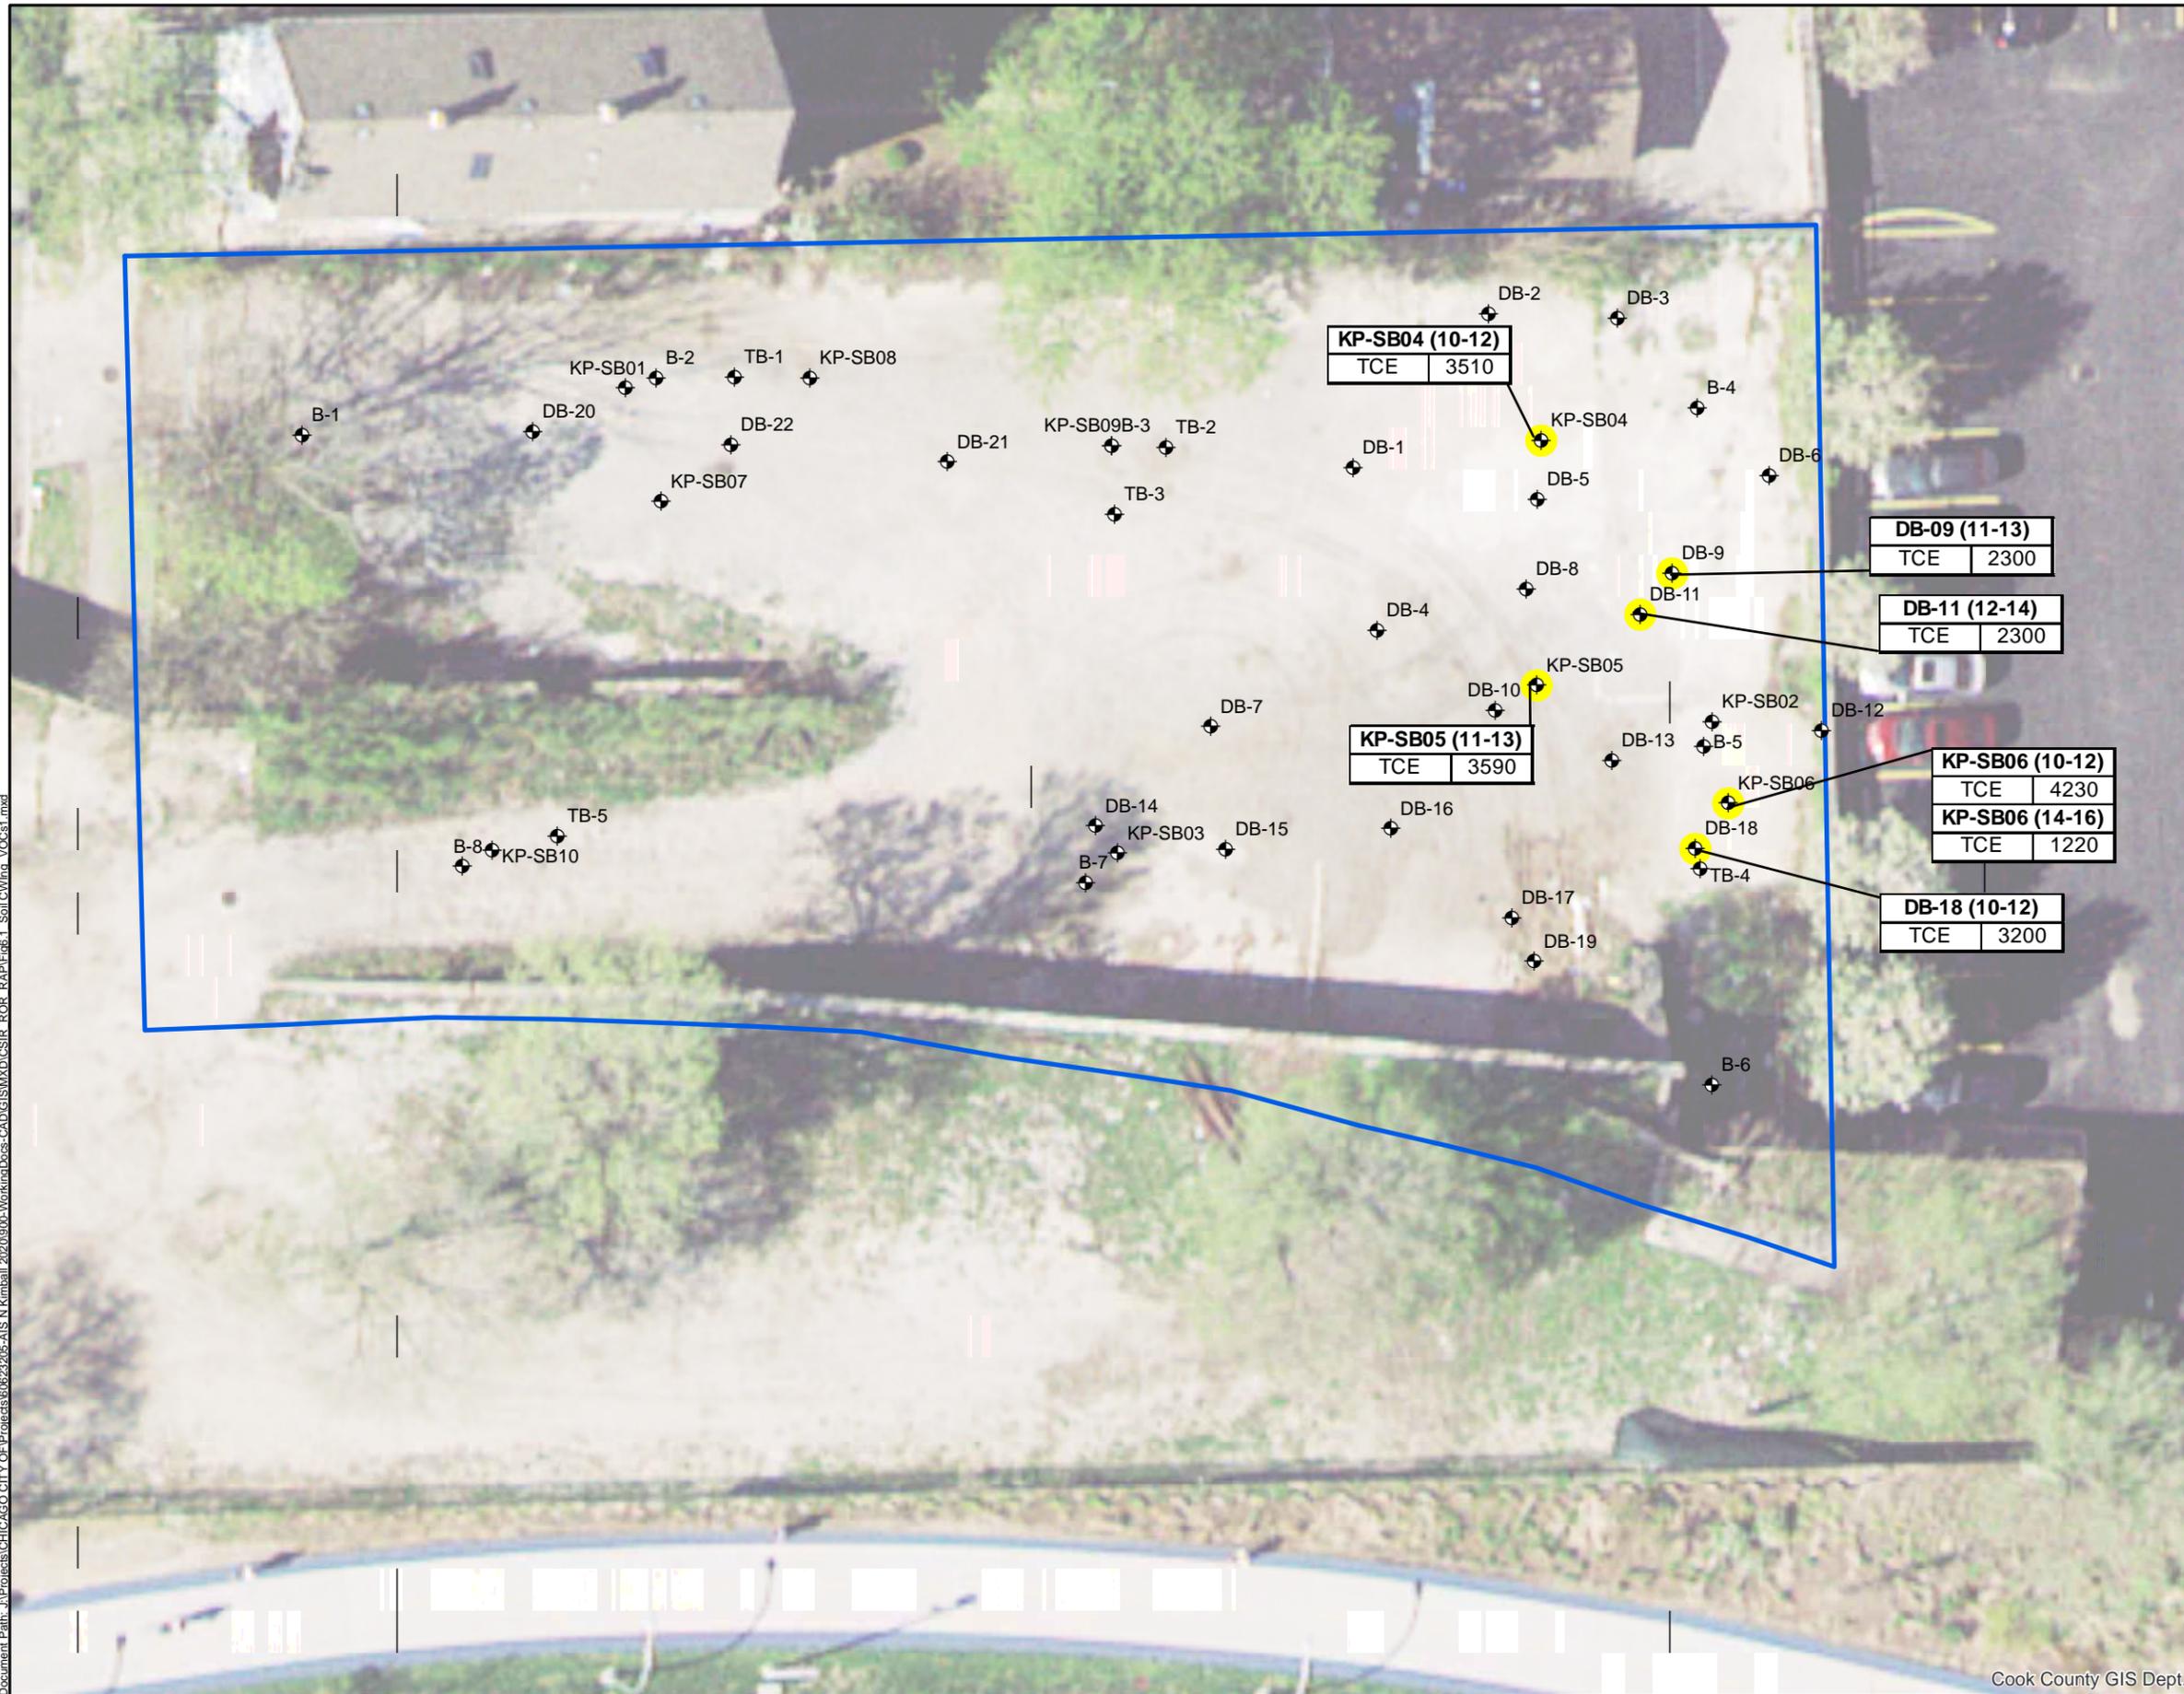
- ◆ Soil Sample Location
- Deep (> 3 ft) Tier 1 CW Ingestion SRO Exceedance: VOCs
- ▭ Remediation Site Boundary

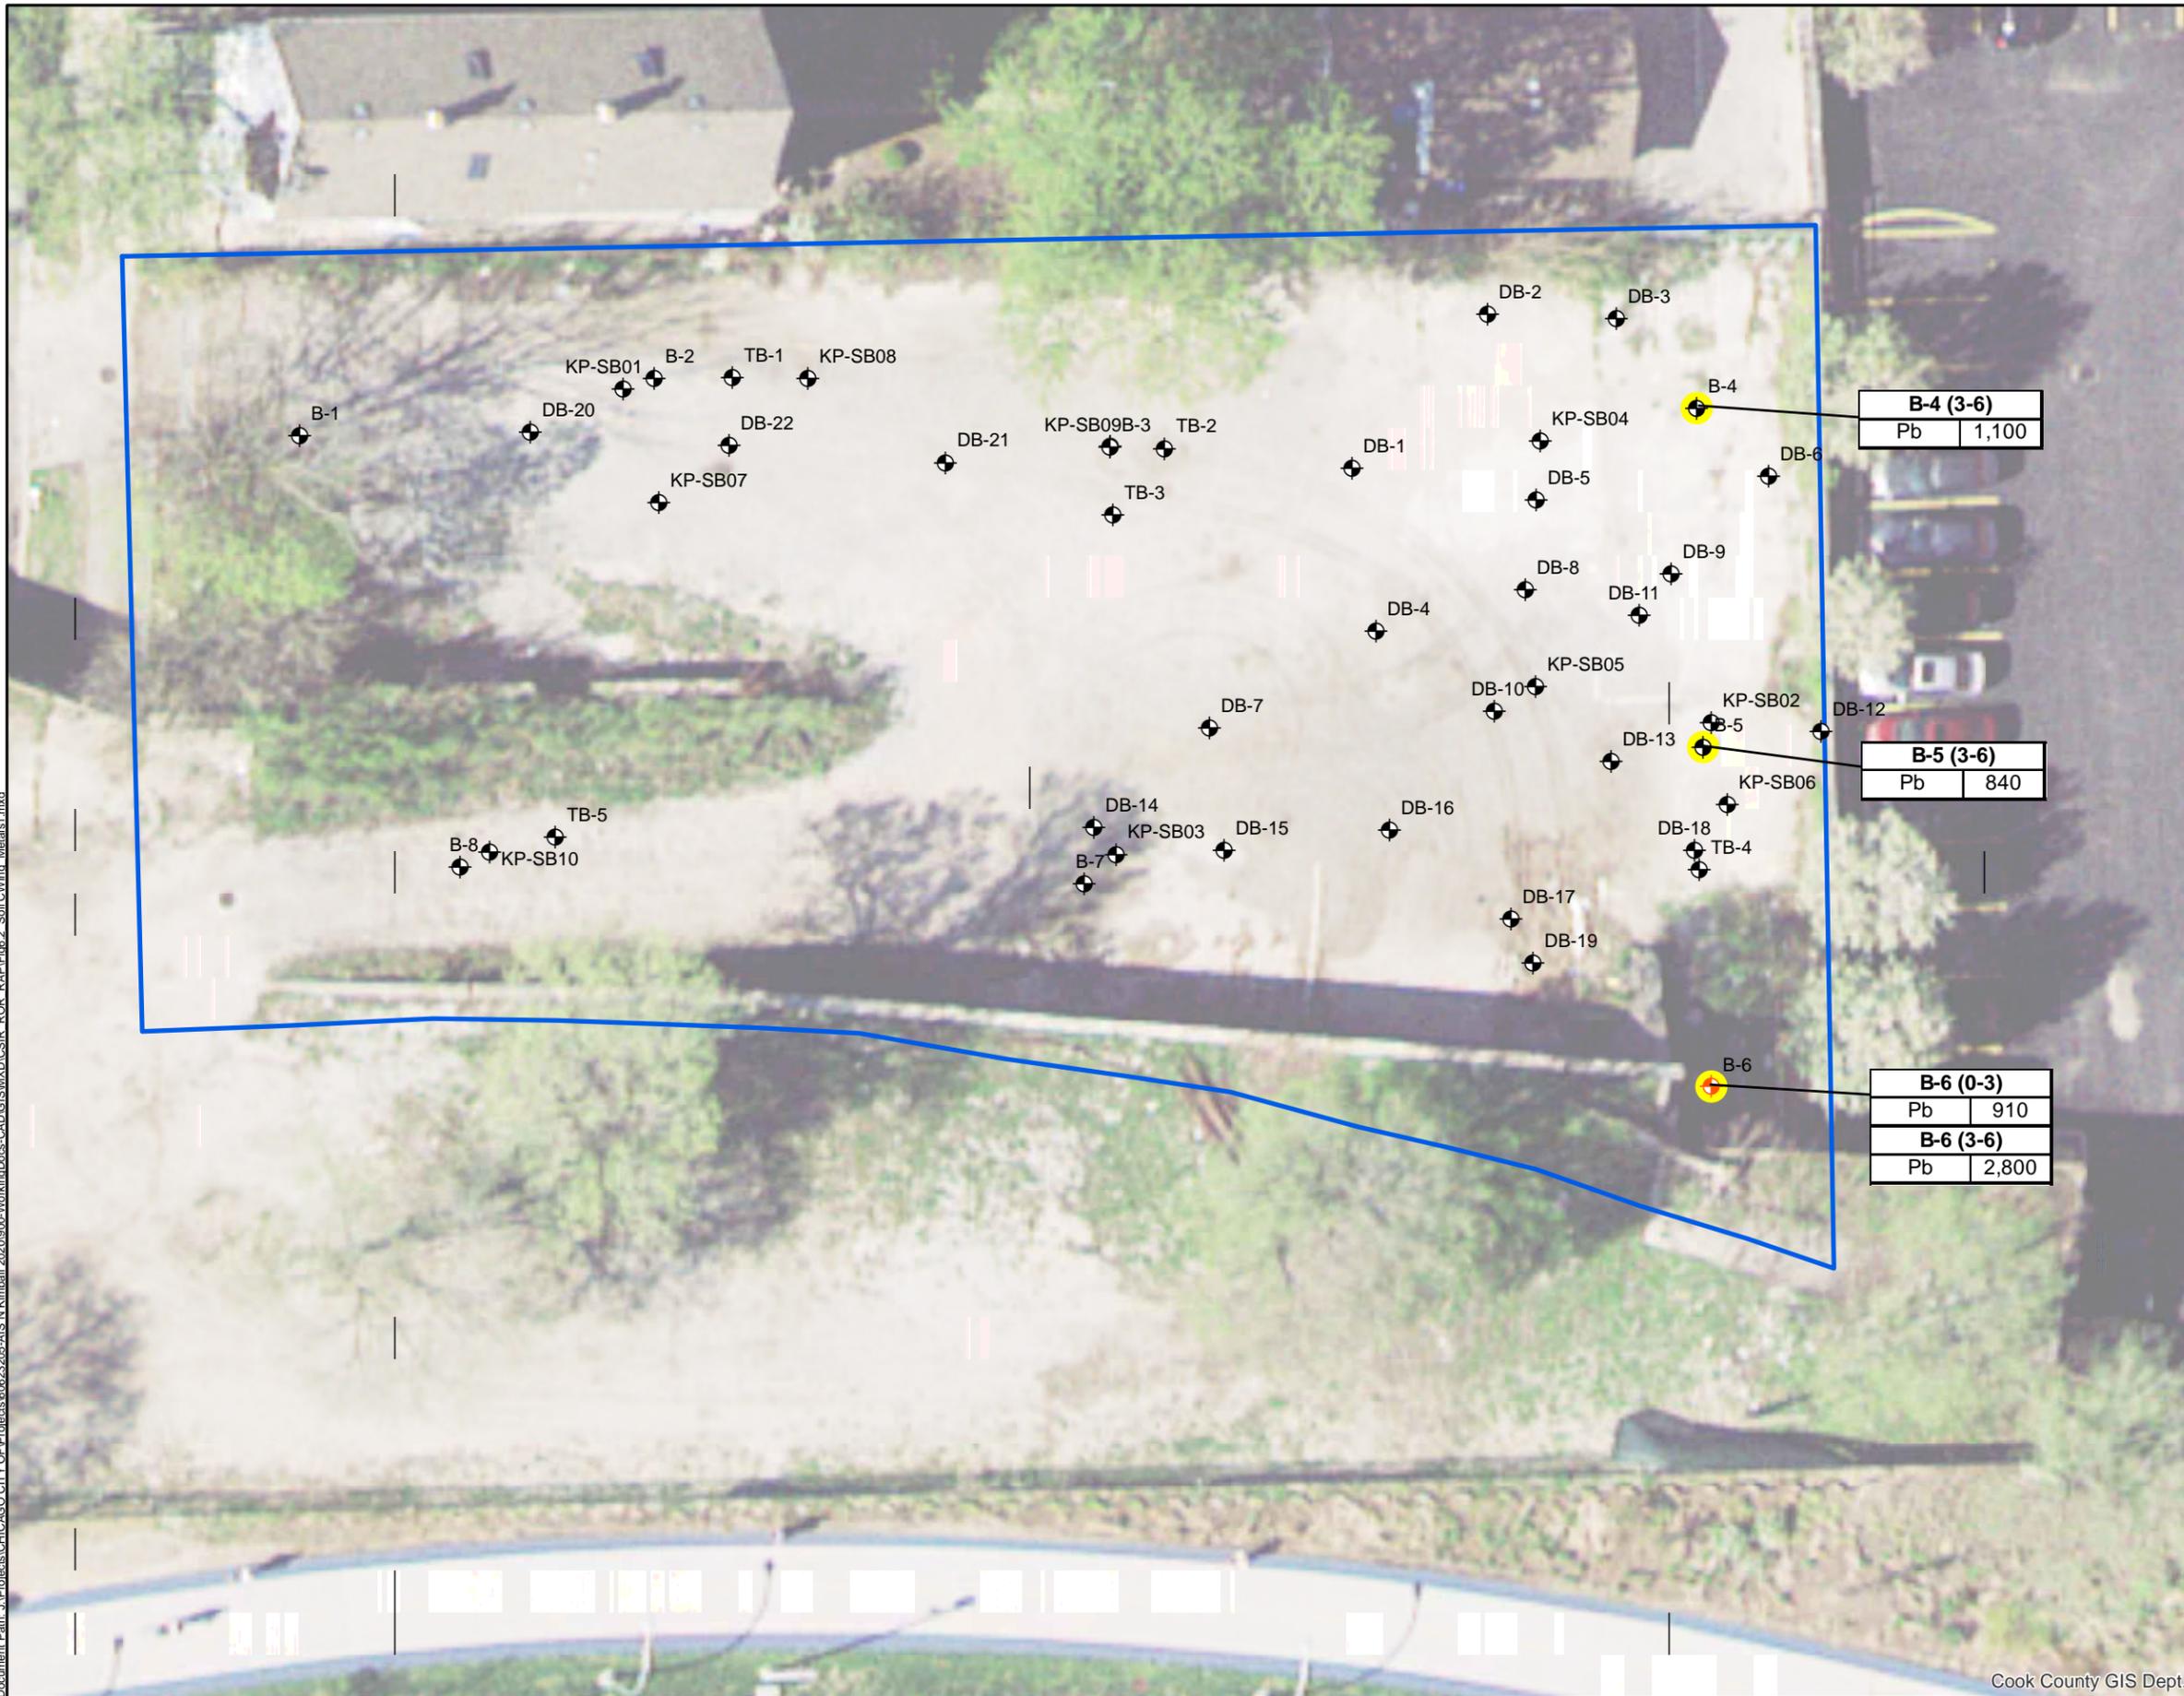
- Legend**
- ◆ Soil Sample Location
 - ◆ Shallow (0-3 ft) Tier 1 CW Ingestion SRO Exceedance: Metals
 - Deep (> 3 ft) Tier 1CW Ingestion SRO Exceedance: Metals
 - ▭ Remediation Site Boundary

Notes:
 Pb = lead
 B-4 (3-6) = Sample Location (depth in feet)
 Concentrations shown in mg/kg
