Comprehensive Site Investigation Report, Remediation Objectives Report, and Remedial Action Plan

North Kimball Brownfield Site
1807-1815 N. Kimball Avenue
Chicago, Illinois

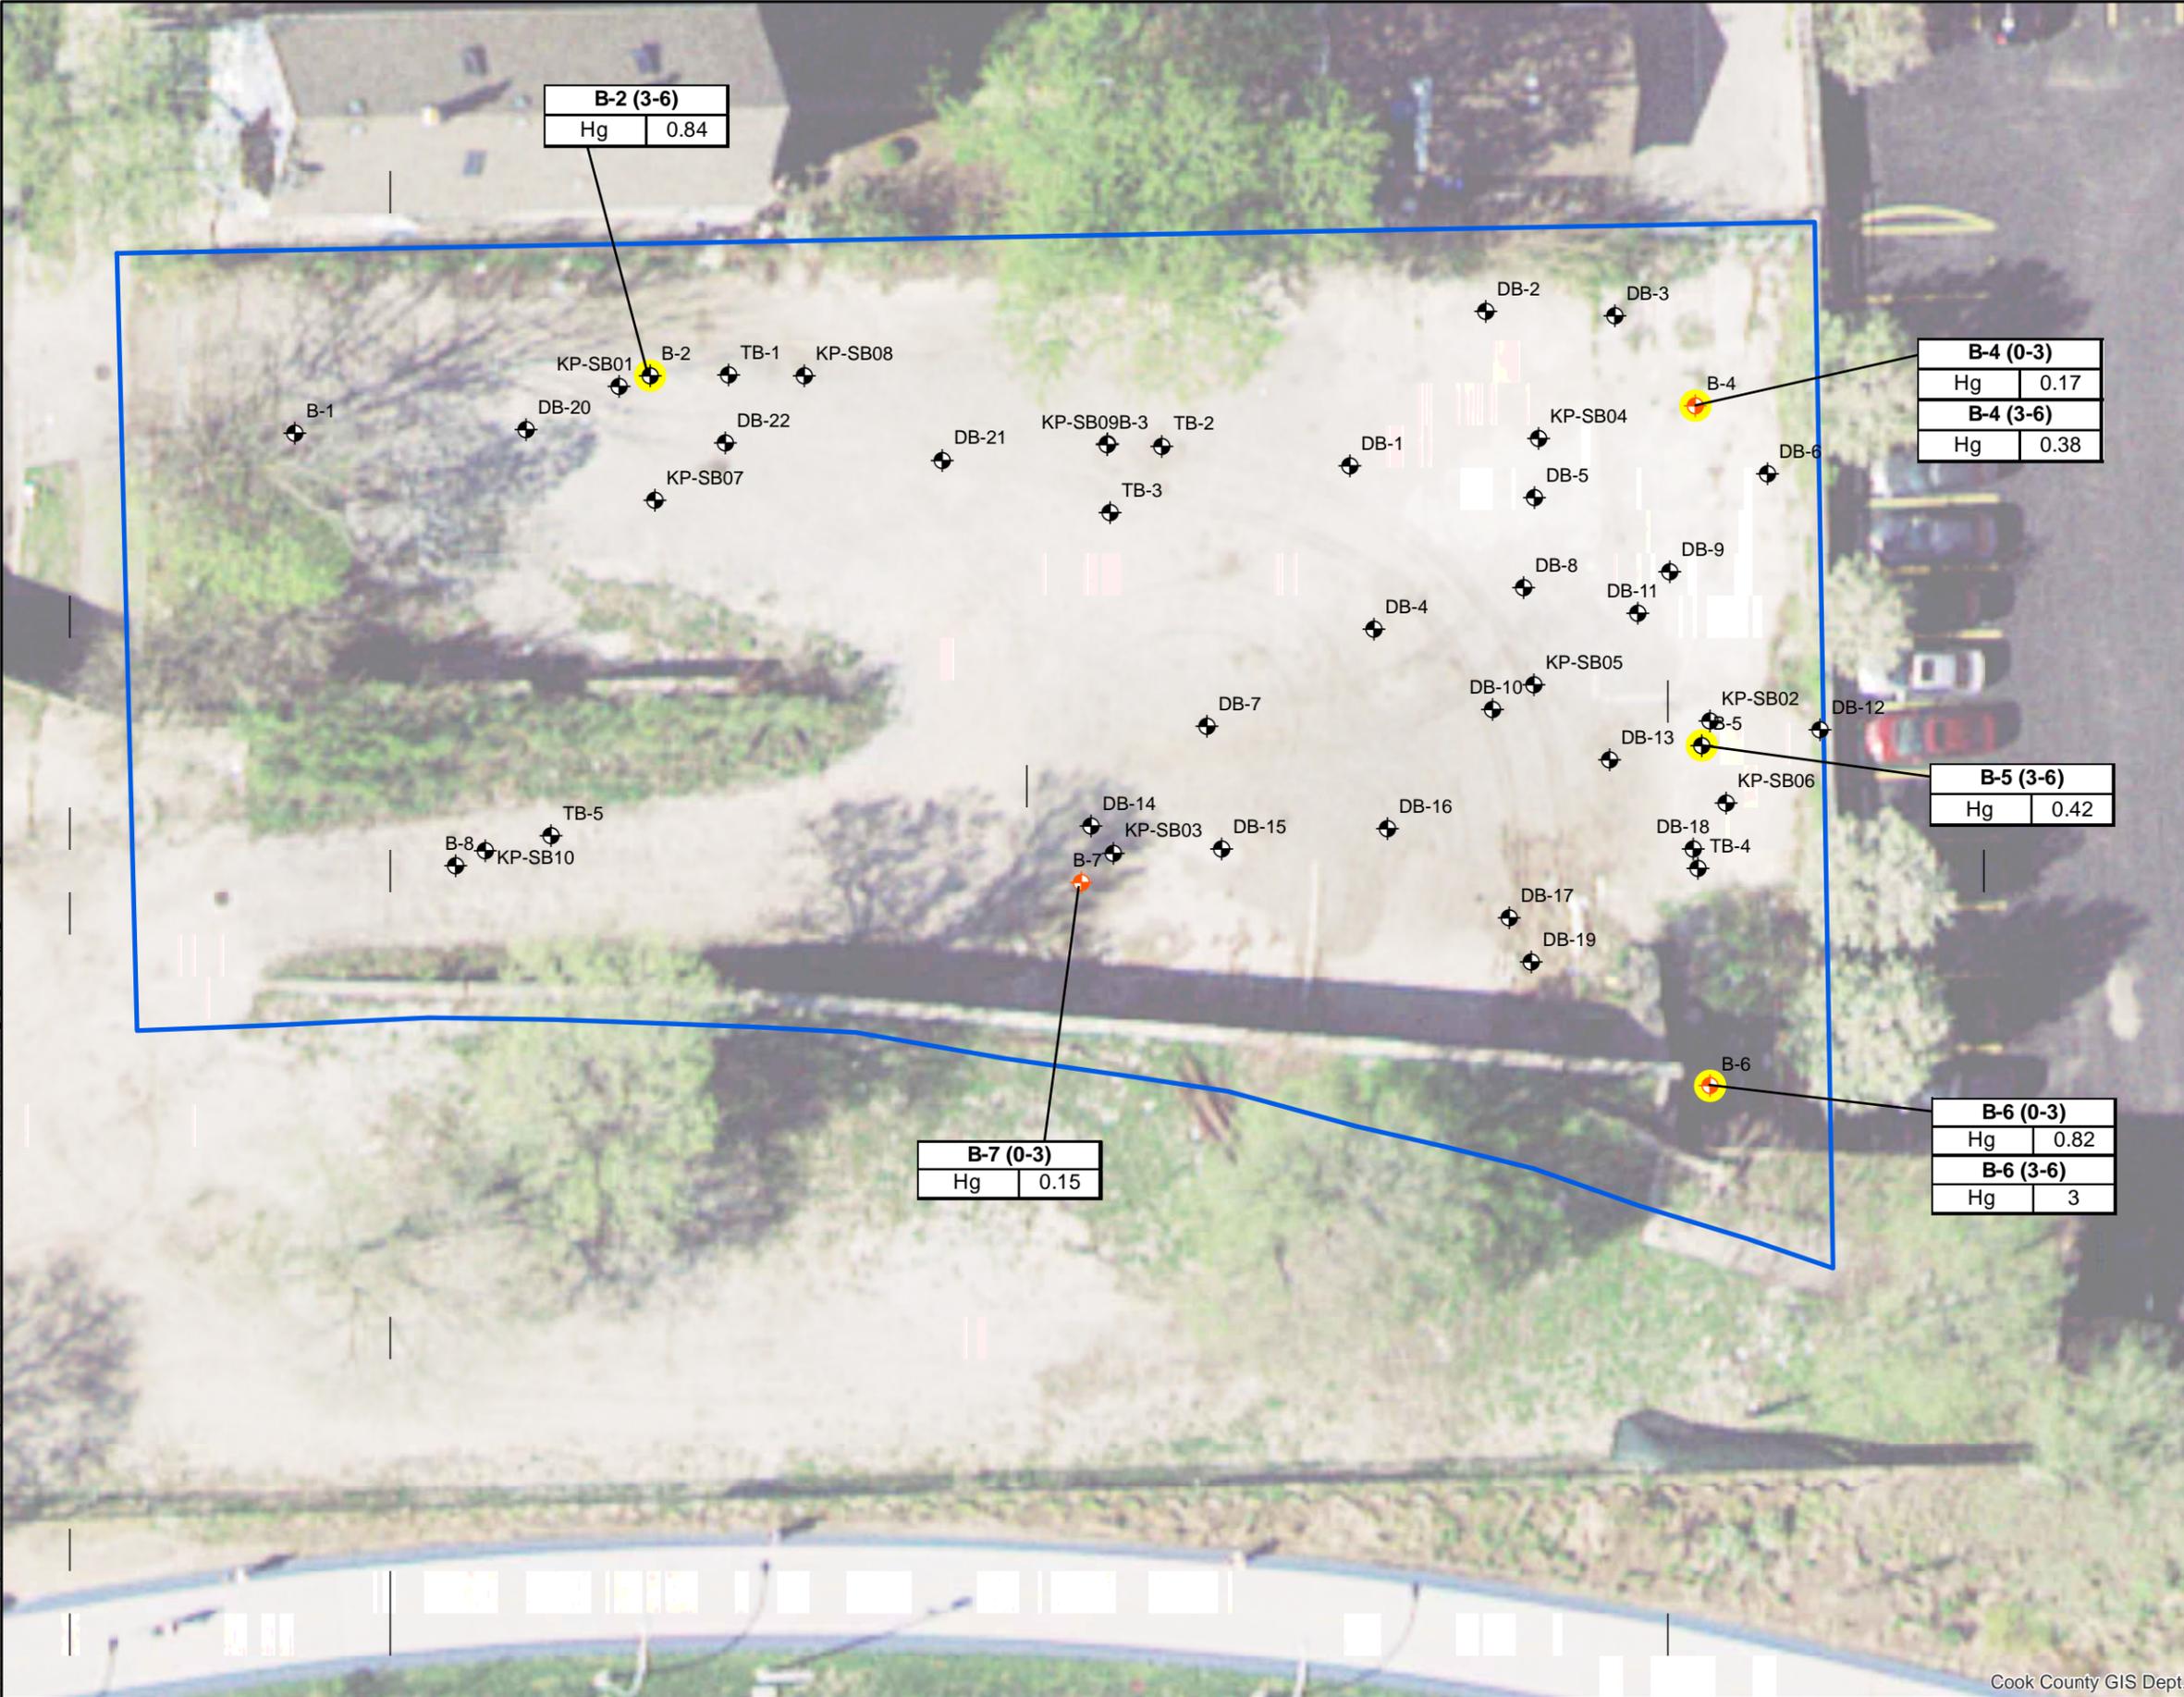
- Legend**
- Soil Sample Location
 - Shallow (0-3 ft) Tier 1 CW Inhalation SRO Exceedance: Metals
 - Deep (> 3 ft) Tier 1 CW Inhalation SRO Exceedance: Metals
 - Remediation Site Boundary

Notes:
 Hg = Mercury
 B-4 (8-9) = Sample Location (depth in feet)
 Concentrations shown in mg/kg

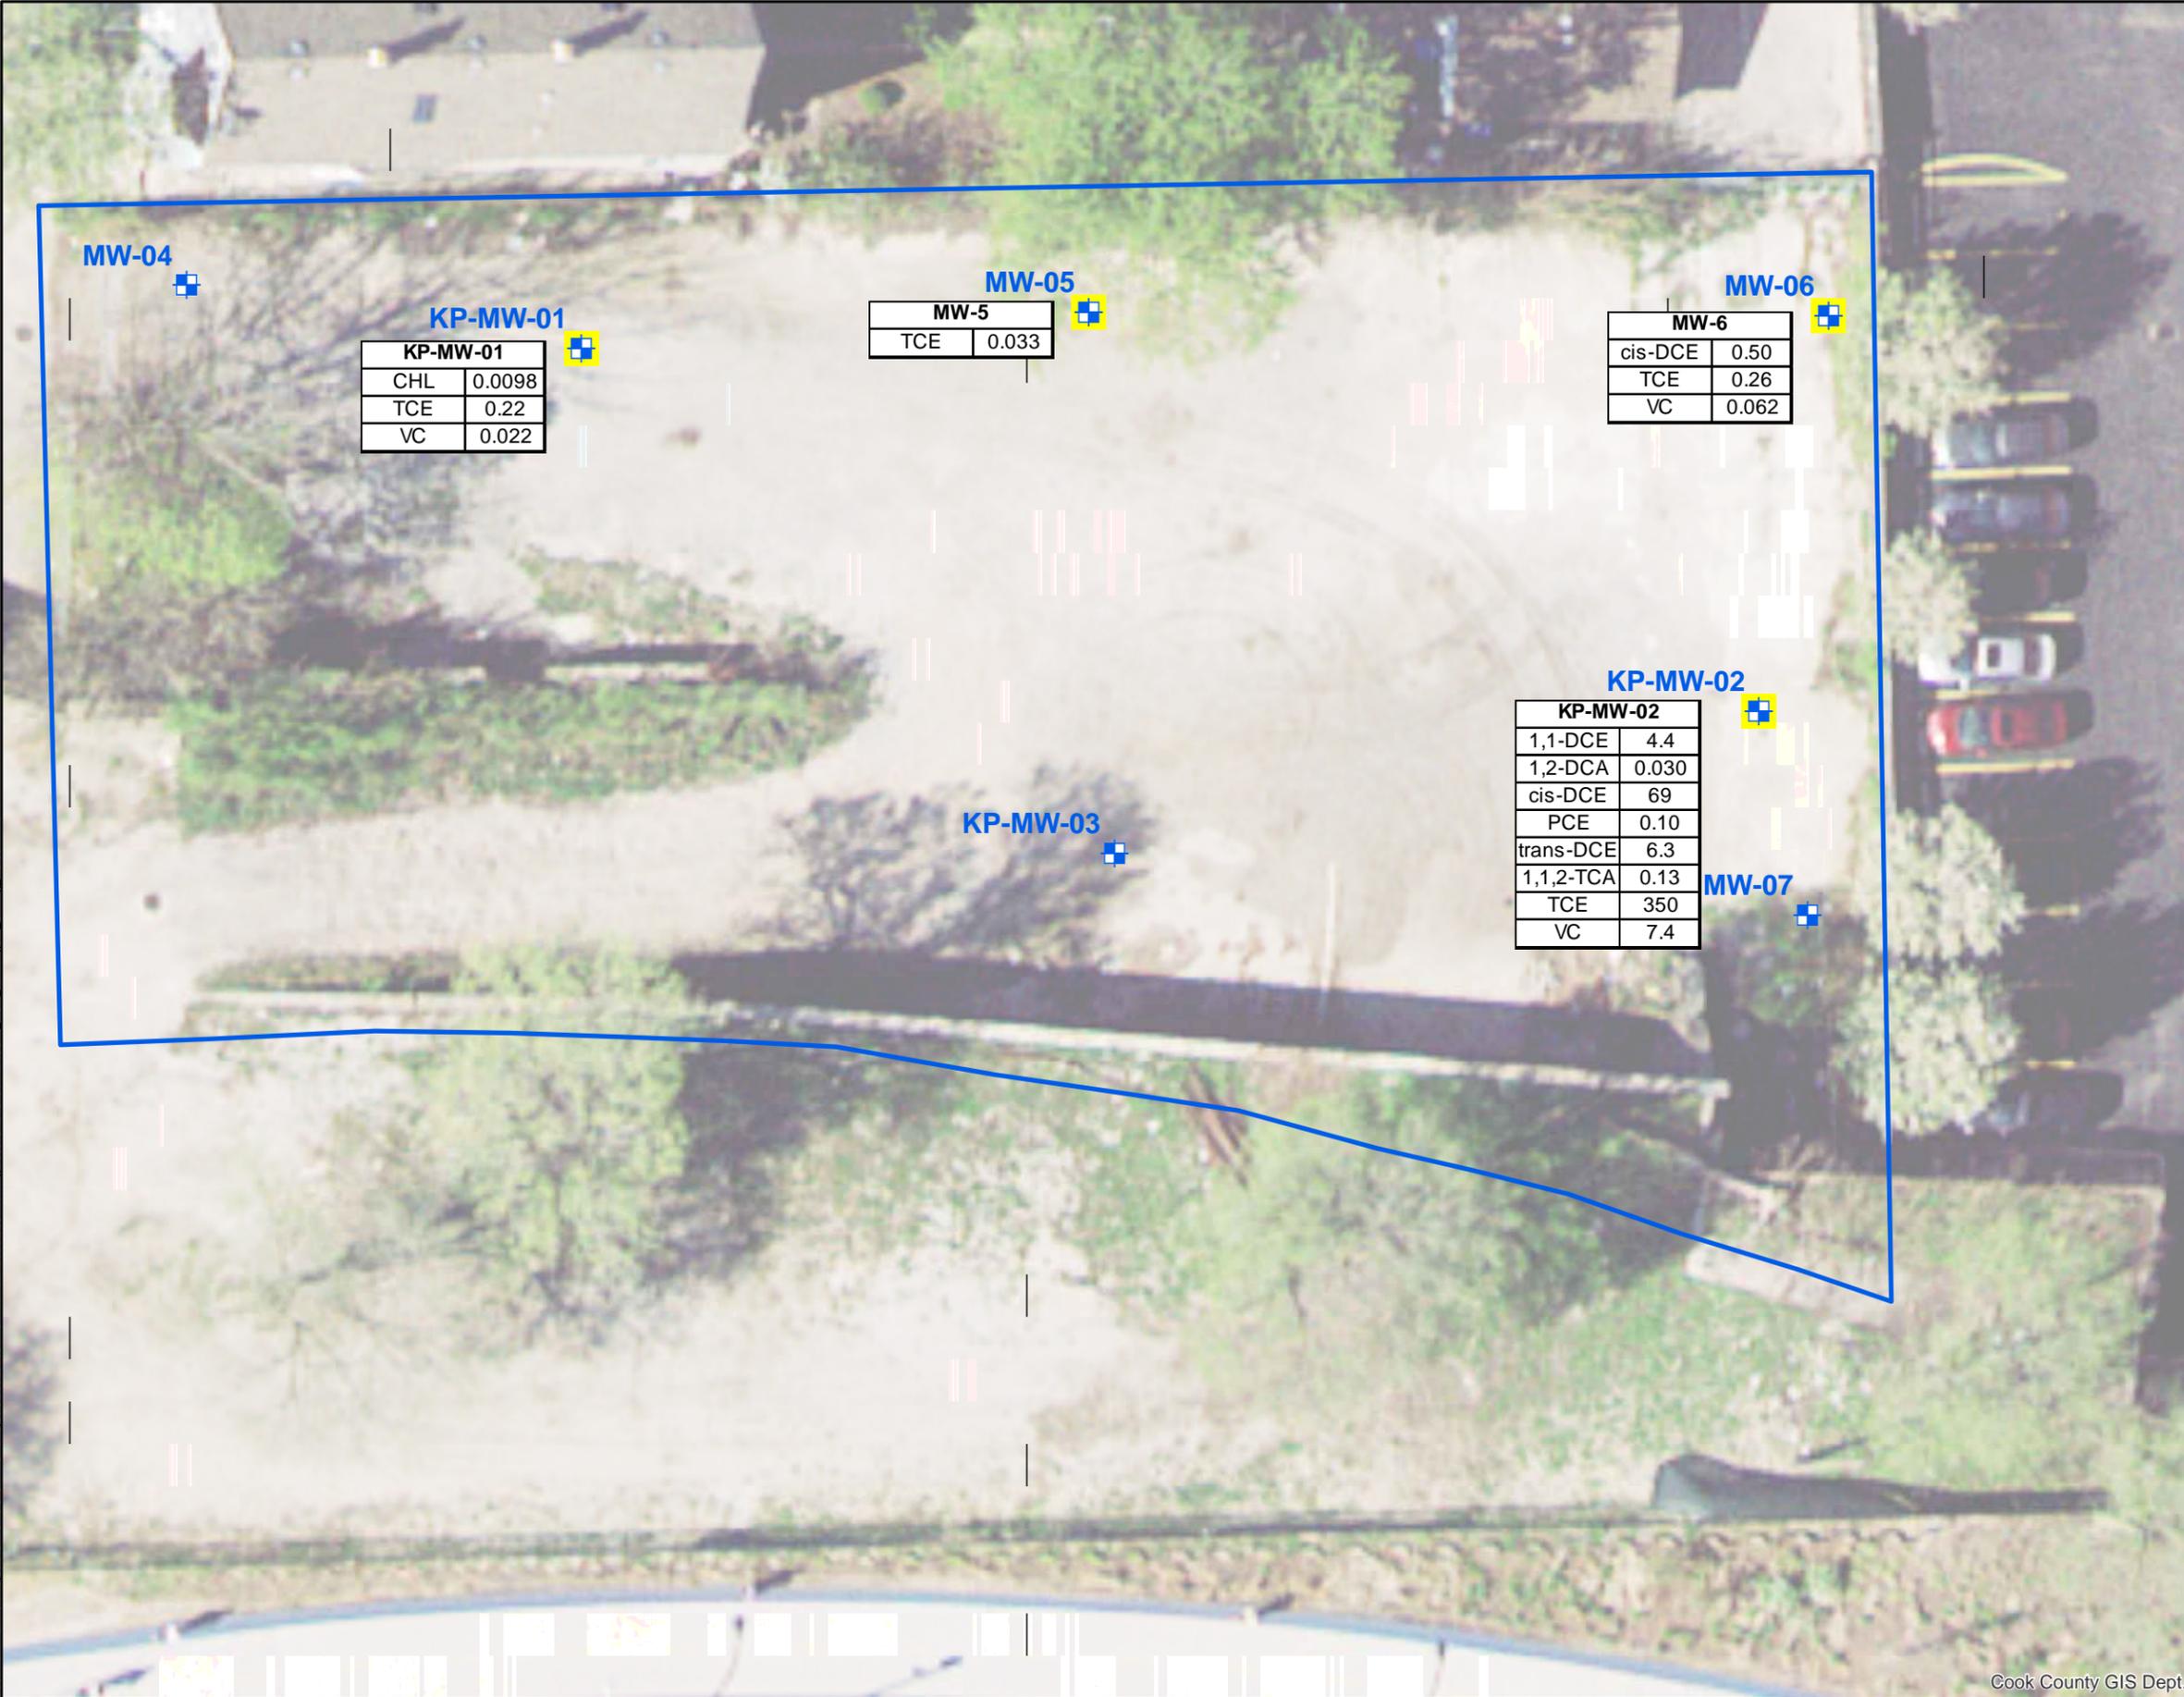
- Groundwater Monitoring Well
- Tier 1 GW Ingestion Exceedance: VOCs
- Remediation Site Boundary

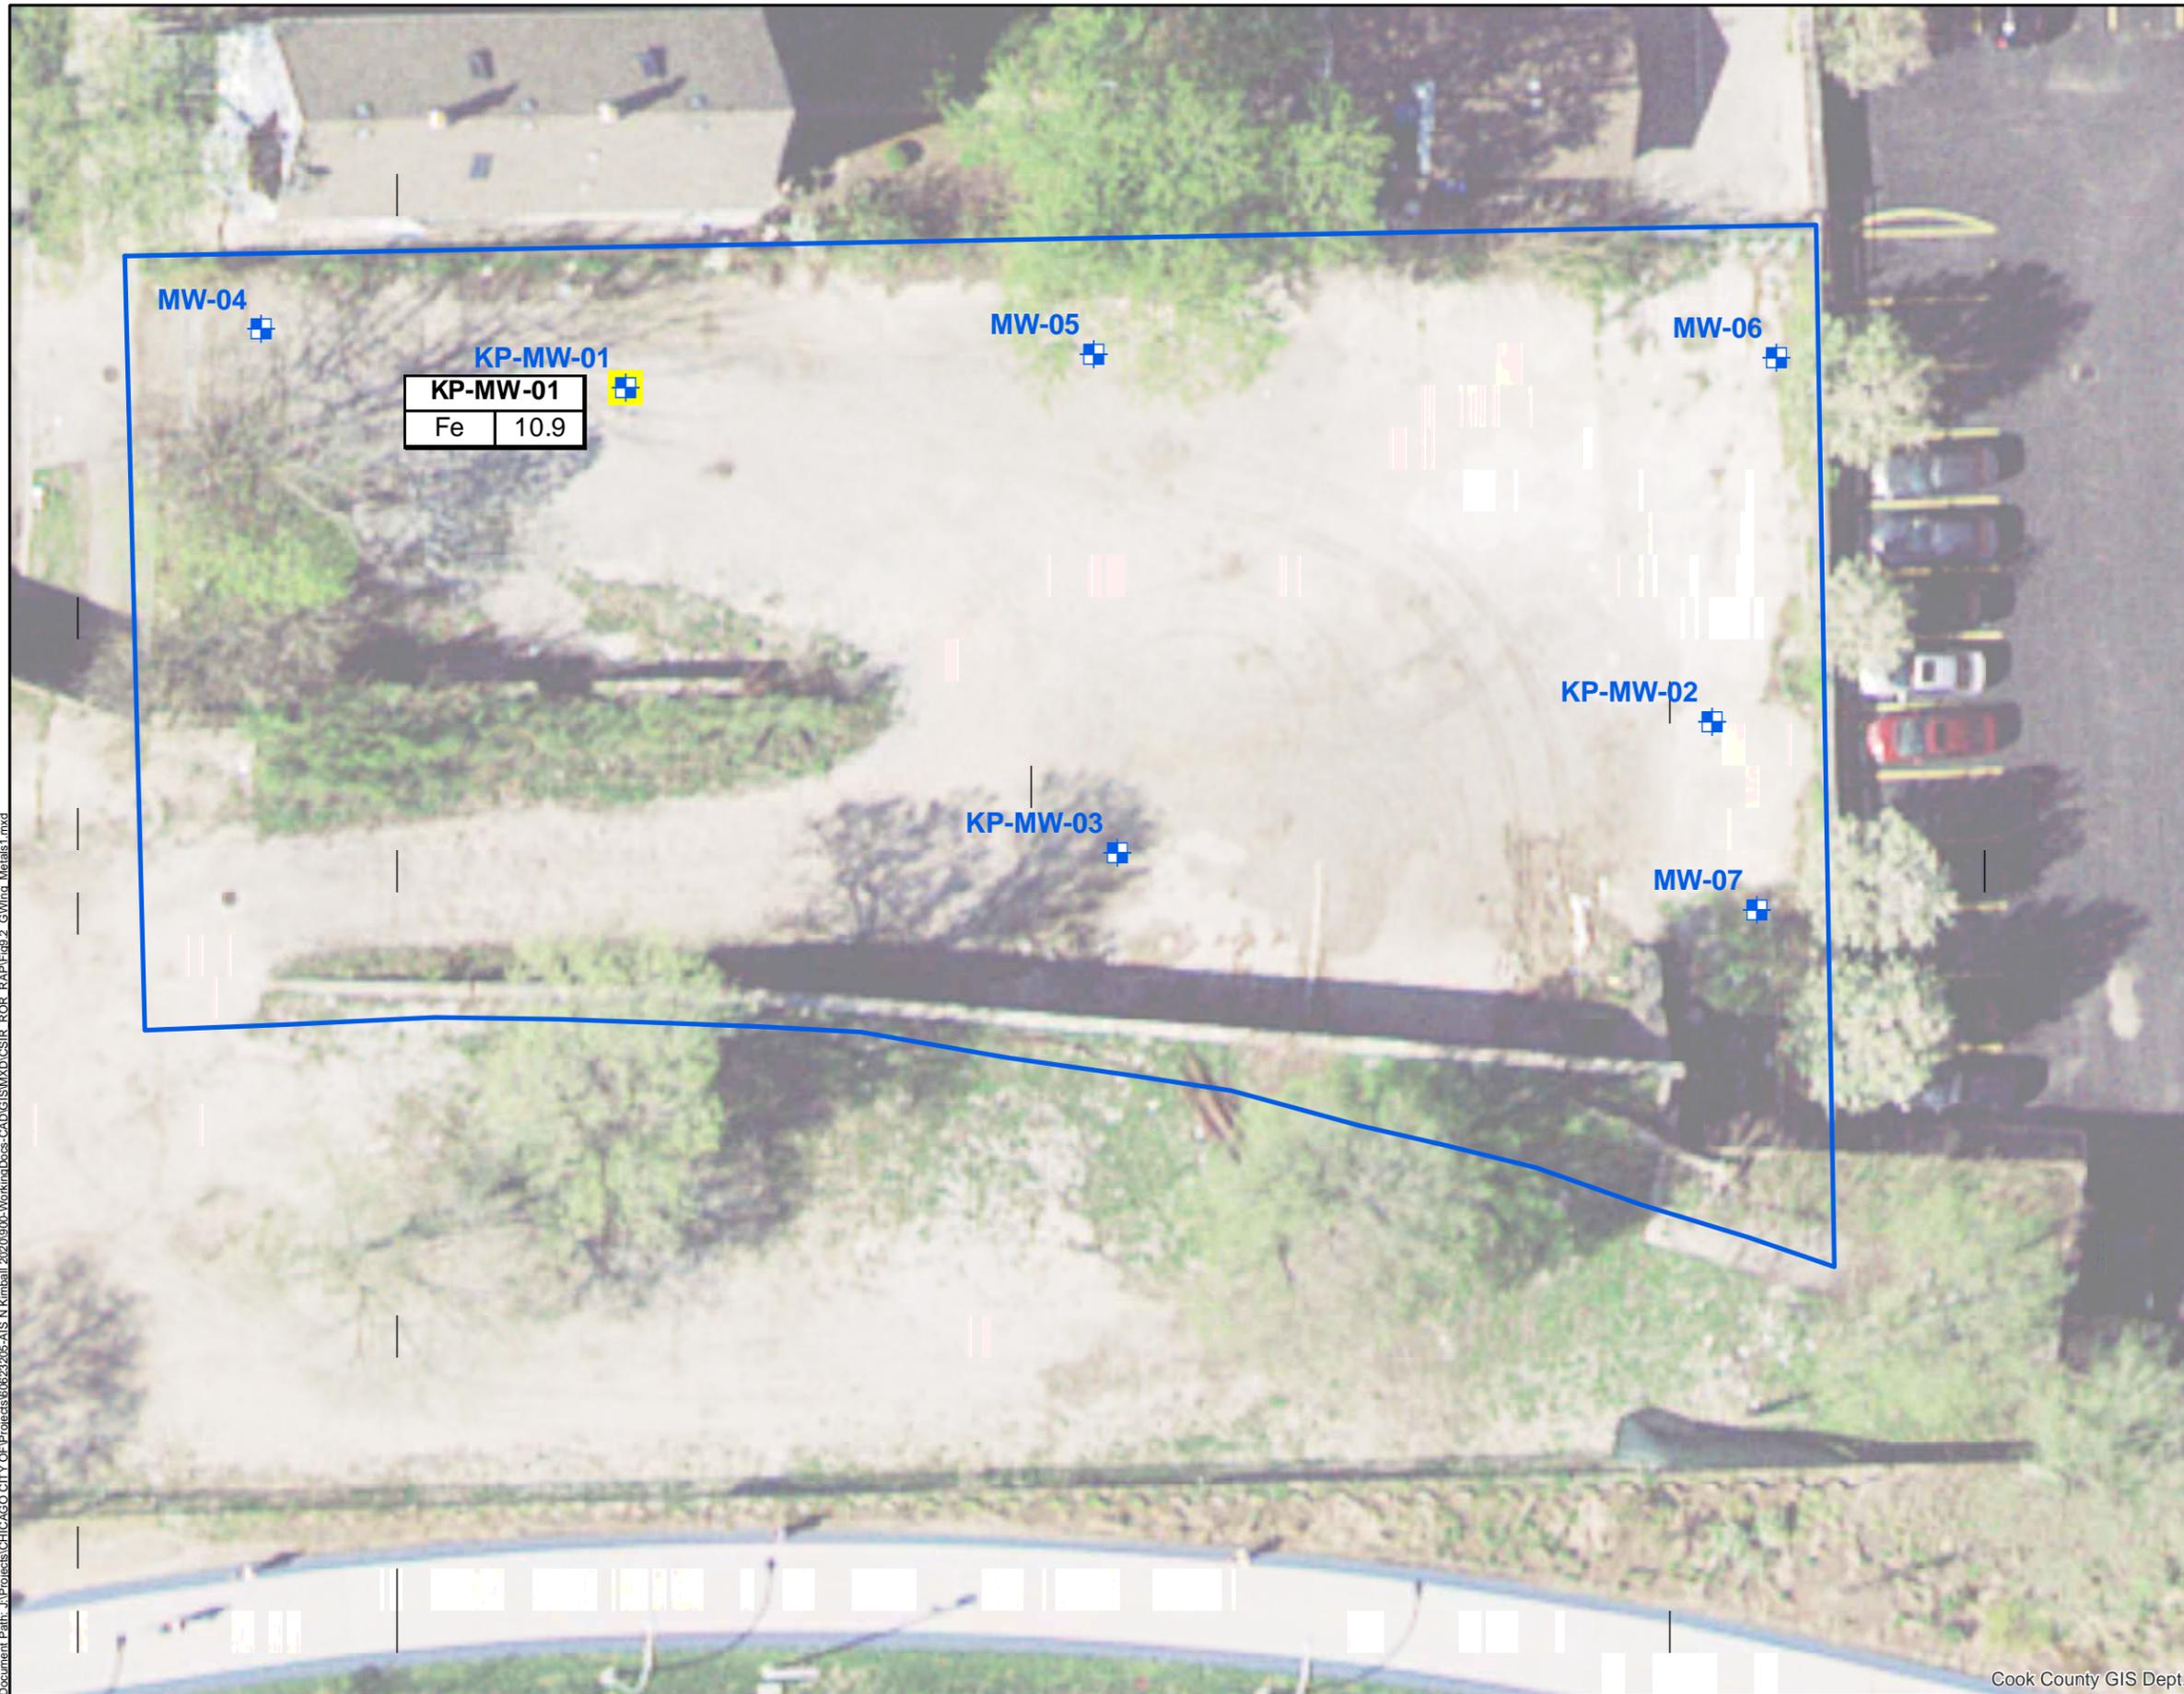
- Groundwater Monitoring
- Tier 1 GW Ingestion Exceedance: Metals
- Remediation Site

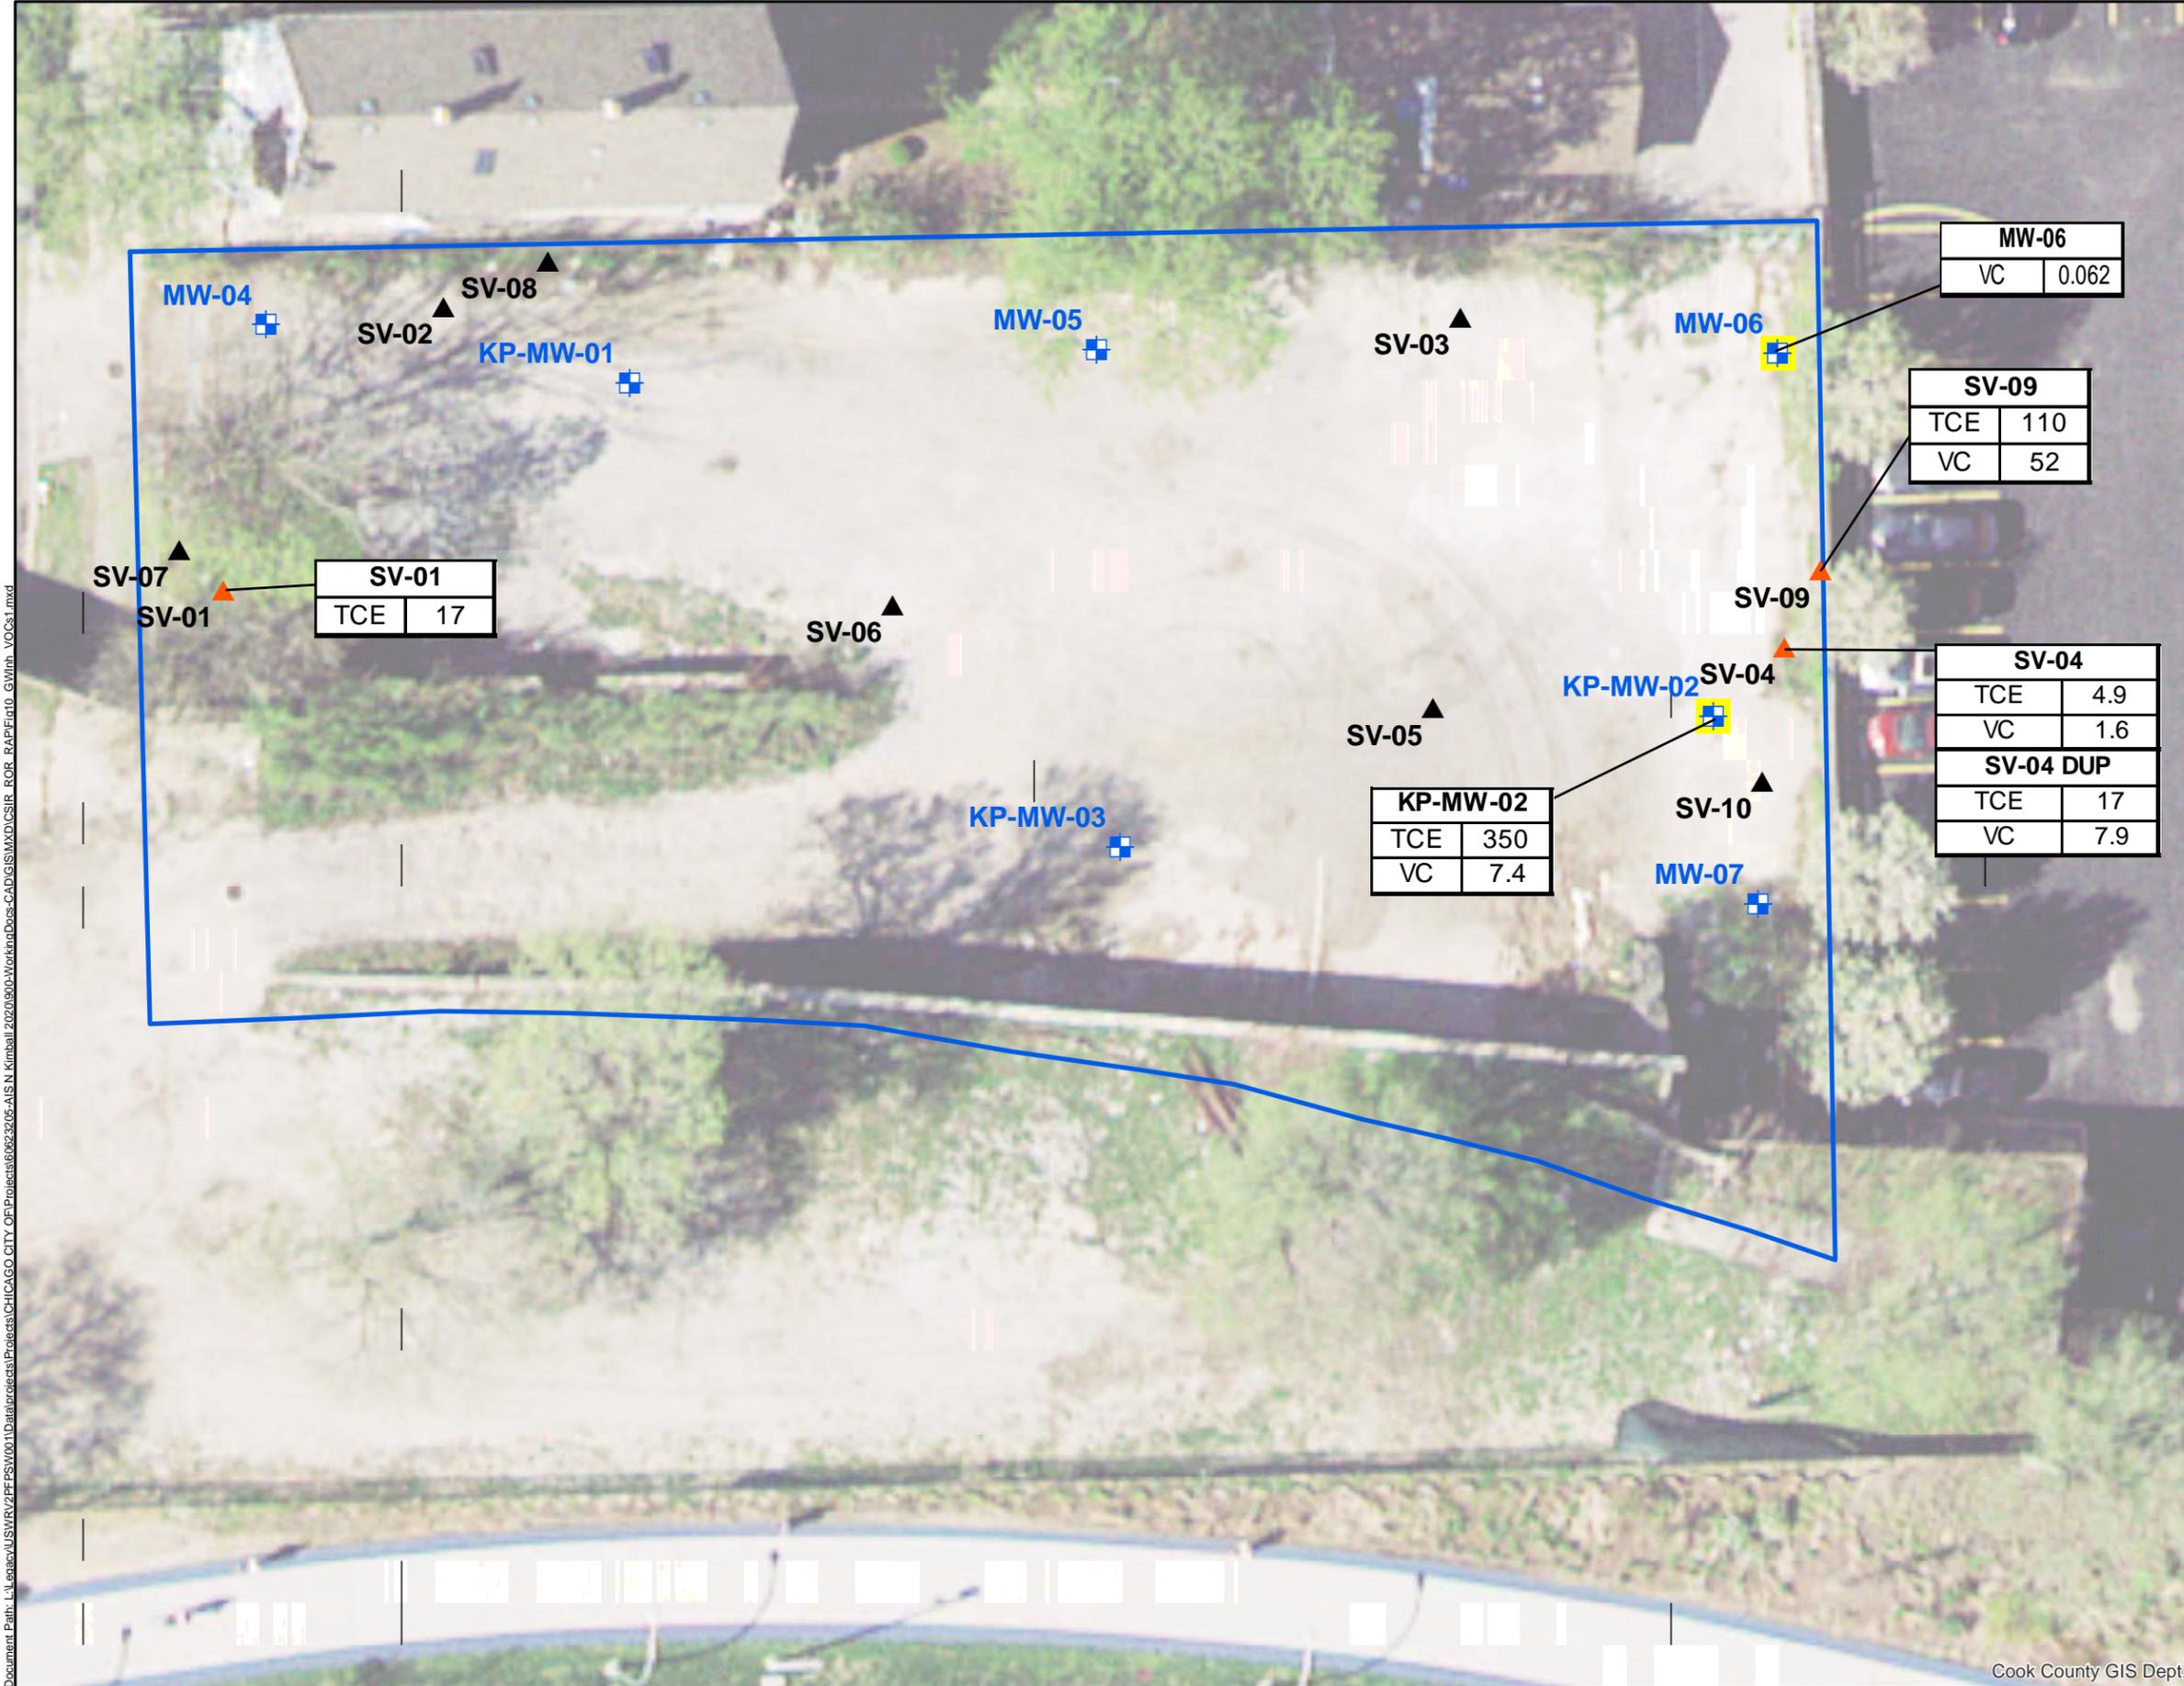
- Legend**
- Groundwater Monitoring Well
 - Tier 1 GW Indoor Inhalation Exceedance: VOCs
 - ▲ Soil Vapor Point
 - ▲ Tier 1 SG Indoor Inhalation Exceedance: VOCs
 - Remediation Site Boundary

Notes:
 TCE = trichloroethene
 VC = vinyl chloride

The soil gas analytical results were compared to the Outdoor Inhalation and Indoor Inhalation Exposure Route ROs for residential properties found in Section 742, Appendix B, Tables G and H (Diffusion and Advection). Trichloroethene and vinyl chloride concentrations detected in SV-09 exceeded Tier 1 ROs for indoor inhalation.

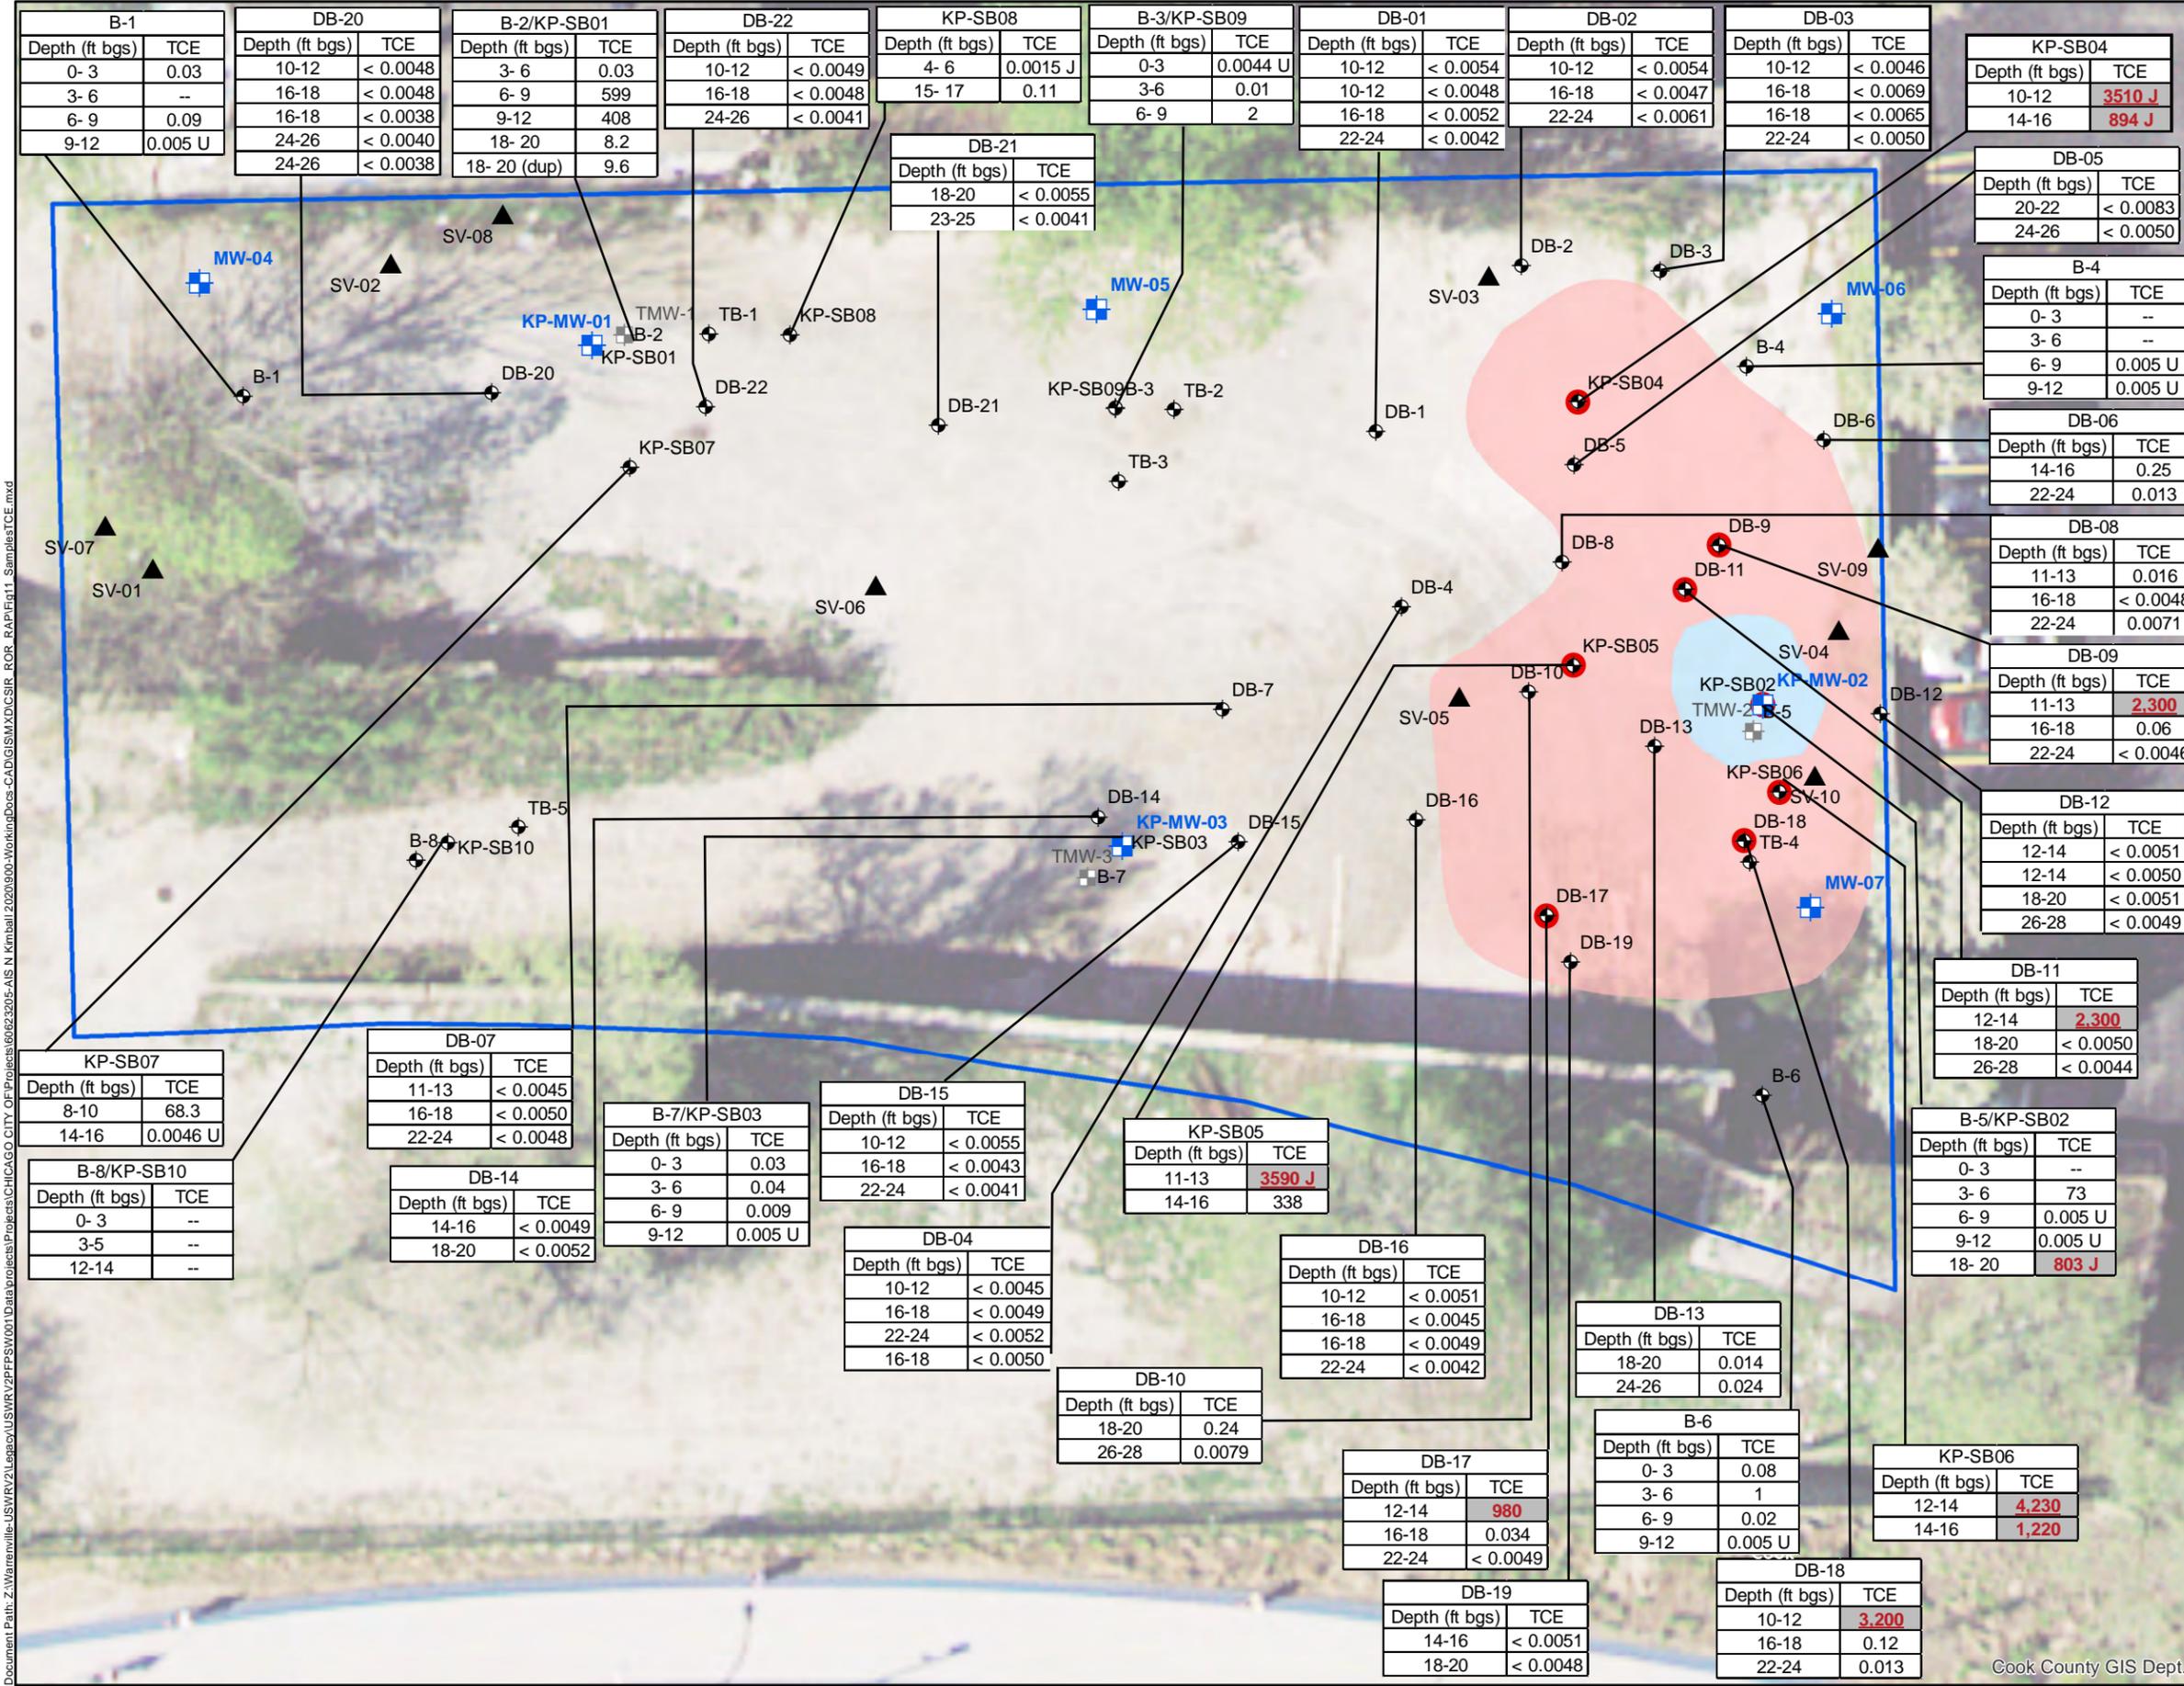
- Temporary Monitoring Well
- Groundwater Monitoring Well
- Soil Vapor Point
- Soil Sample Location
- TCE exceeds C_{sat} limit
- TCE Cs_{at} Remediation Area Limit (8-20 ft bgs)
- TCE Cs_{at} Remediation Area Limit (8-16 ft bgs)
- Remediation Site Boundary

The planned remedial actions presented in this RAP are feasible and achievable based on the Site conditions and AECOM's experience with similar sites. The effectiveness of ISCO to remediate soil exceeding the TCE Csat limit is high. ISCO has been proven to be effective at reducing TCE concentrations to below the Csat limit when reactants are applied at the correct dose and can physically reach the contaminants. AECOM's bench scale pilot testing helped to confirm that this will be an effective treatment for soil from the Site. Soil mixing is the preferable reactant delivery method in low-permeability soils like those found at the Site.

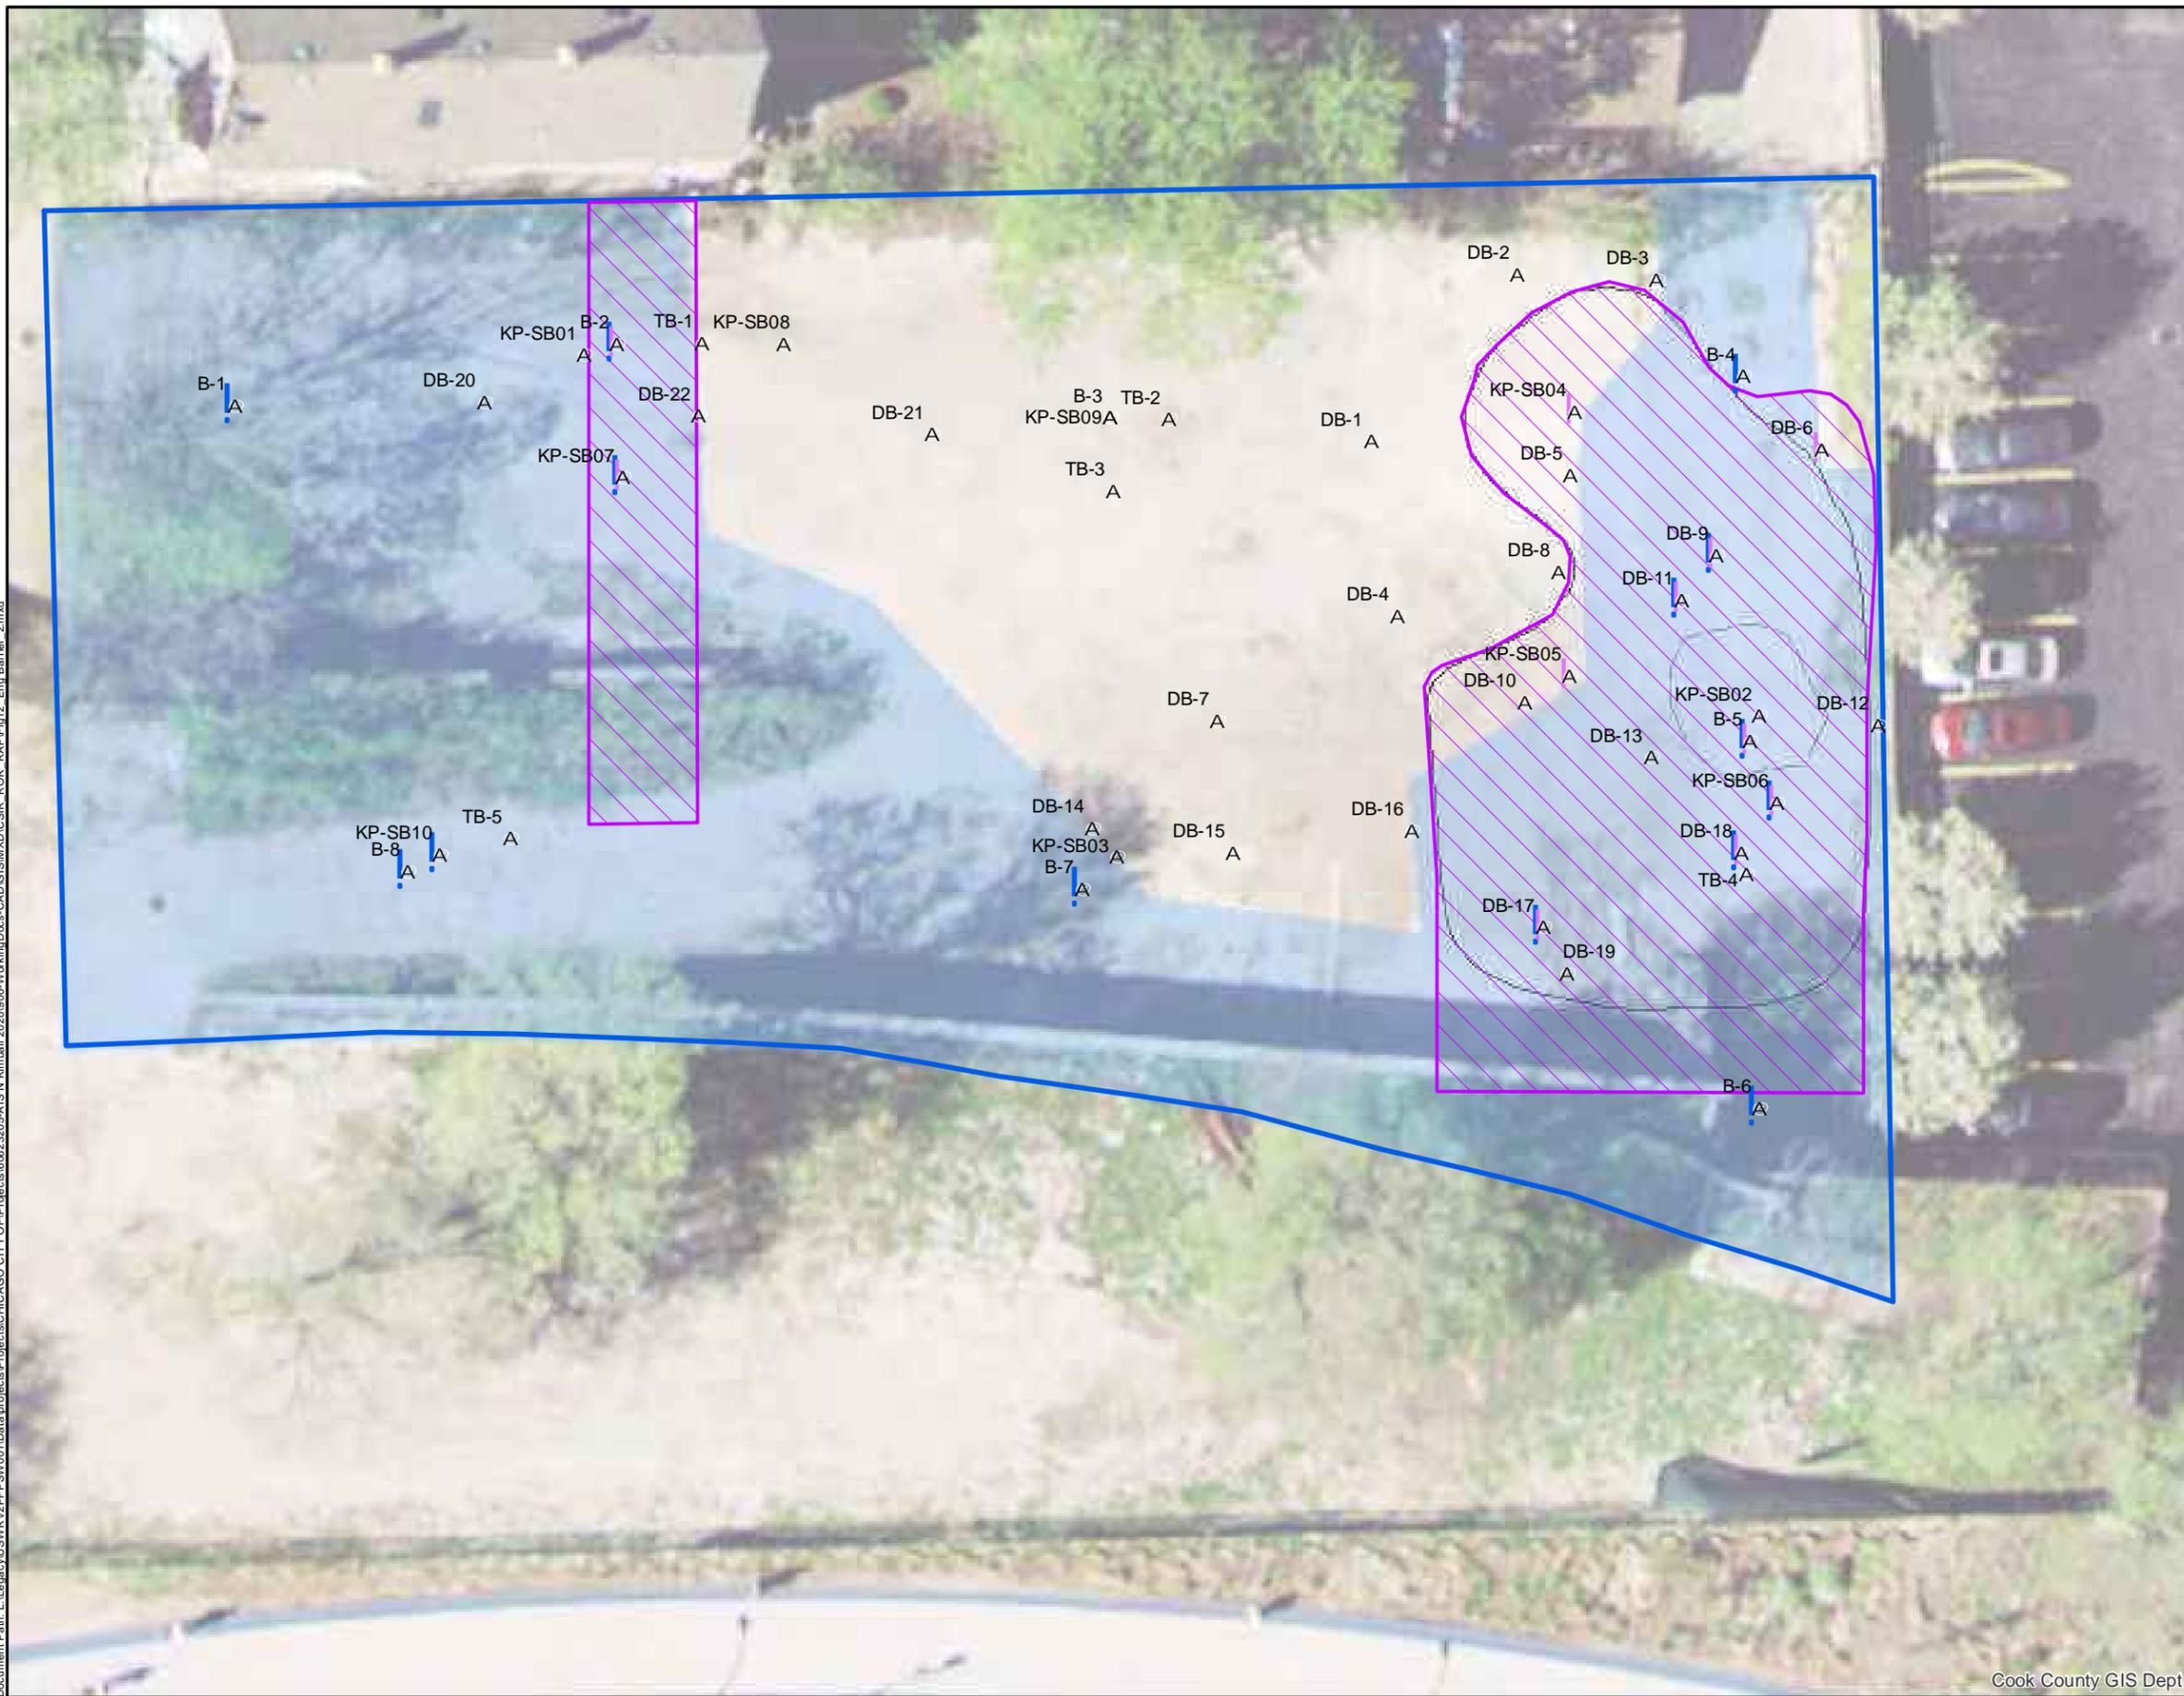
- A Soil Sample Location
- Residential Inhalation RO Exceedance
- Residential Ingestion RO Exceedance
