CITY OF CHICAGO
DEPARTMENT OF PUBLIC HEALTH
PERMITTING AND ENFORCEMENT

NARRATIVE EVALUATION

INSPECTION DATE: 04/11/2020
SITE NAME: Crawford Stack HRP Exchange 55
SITE ADDRESS: 3501 S PULASKI RD, CHICAGO, IL 60623
SITE CODE: Crawford Stack HRP Exchange 55
PERMIT #: ENVGEN1234557

On April 11, 2020, a scheduled implosion demolition of a structure (smokestack) was conducted at the address 3501 S. Pulaski Rd., the former Crawford Power Generating Station. Parties involved in the implosion were:

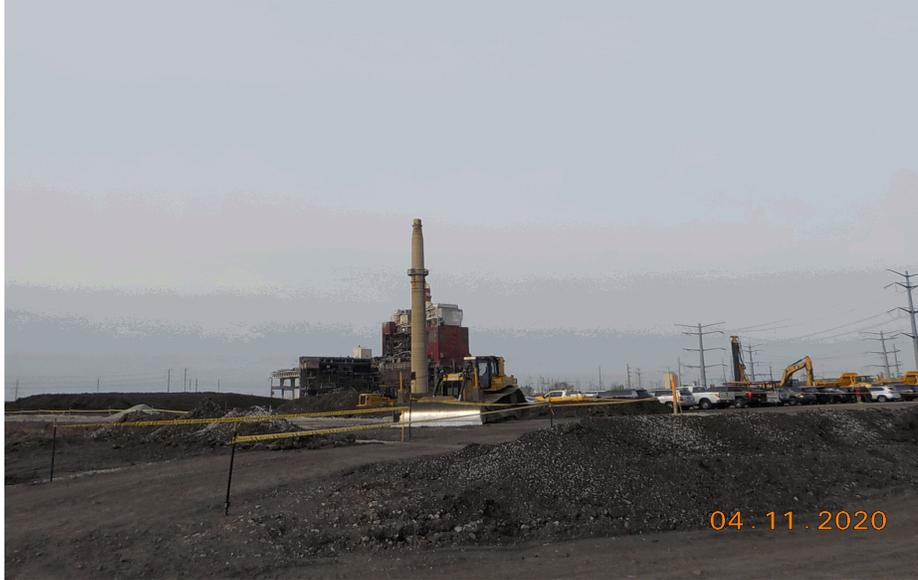
COMMENTS: Photo A- 3501 S. Pulaski Rd., Photo of smokestack before implosion.

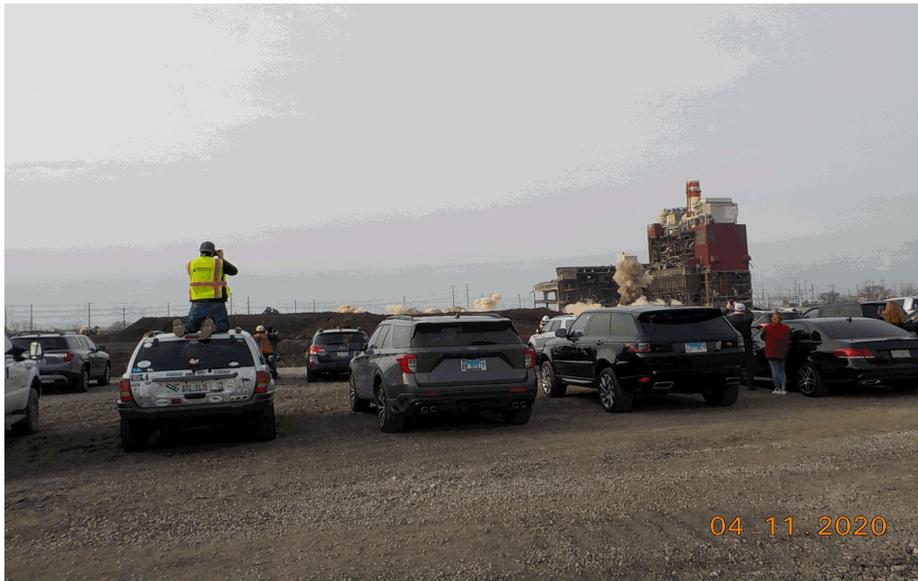
Weather conditions were slightly overcast at 7:38 A.M. The temperature was 45 degrees Fahrenheit. At approximately 7:58 a two-minute-long siren was sounded followed by the explosive detonation at approximately 8:00 A.M. The structure toppled east as planned and generated a plume of dust upon impact with the ground.

COMMENTS: Photo B- 3501 S. Pulaski Rd., Photo of initial impact of smokestack after implosion detonation.

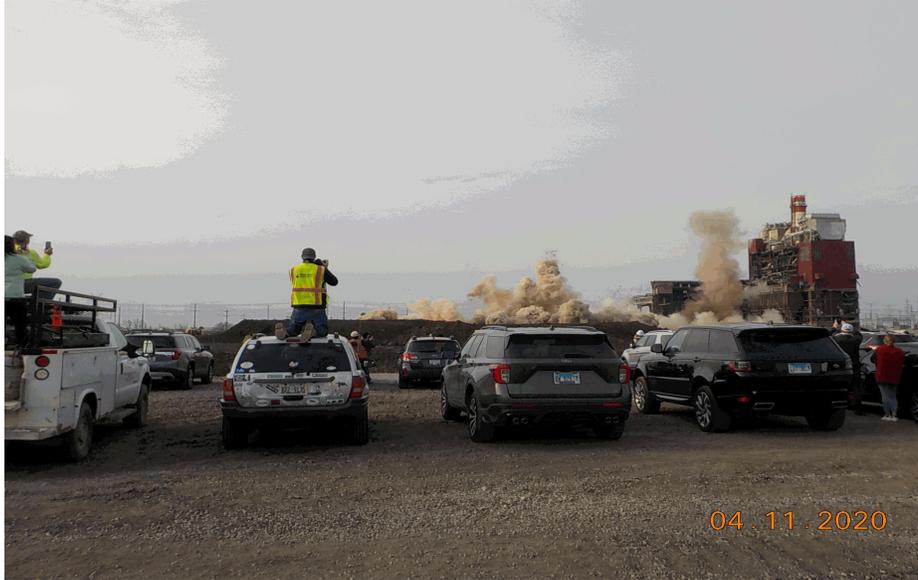
COMMENTS: Photo C- 3501 S. Pulaski Rd., Photo of dust cloud generated by smokestack upon impact with ground.

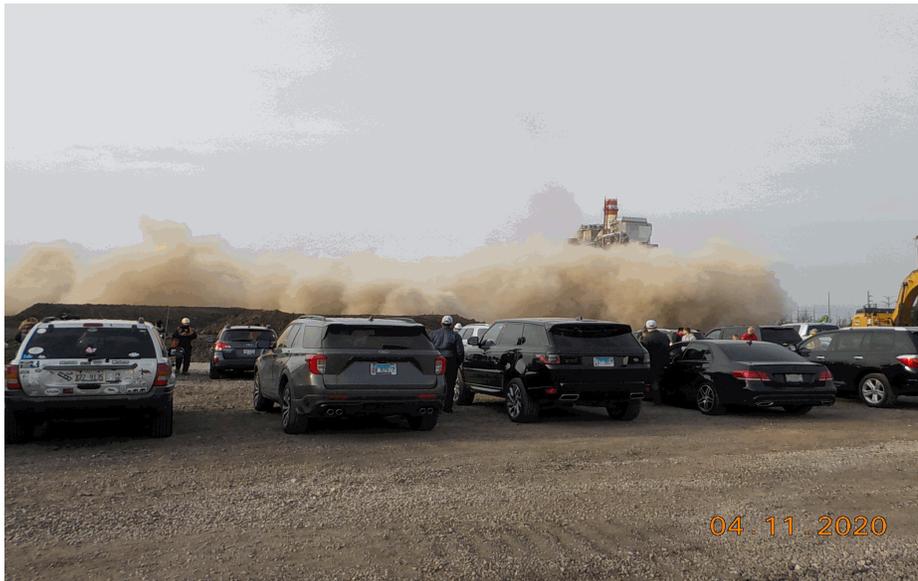
A wind current from the south to north carried the plume of dust through the site due north. The cloud of dust was thick as it traveled through the site. Visibility was limited due to the dust. Two rented water trucks stationed at the northern perimeter of the site were hosing the area to prevent the dust cloud from exiting the site. The reporting inspector's line of sight was positioned westward as the dust cloud traveled northbound. The reporting inspector did not observe what CFD was doing at the time due to the inspector's line of sight. The dust was not suppressed adequately and continued to travel off-site towards the residential area north of the site.

COMMENTS: Photo D- 3501 S. Pulaski Rd., Photo of dust cloud moving north from impact drop area.

HRP Exchange 55 LLC failed to take reasonable precautions to minimize wind borne particulates from the demolition of the smoke stack. HRP Exchange 55 LLC failed to adequately wet the smoke stack demolition area to prevent the emission or dispersion of dust. HRP Exchange 55 LLC failed to adequately wet the site in order to prevent the off site dispersion of the dust and therefore also caused a nuisance. HRP Exchange 55 LLC did not have adequate dust control measures in place which allowed the demolition of the smoke stack to generate and disperse dust to the adjacent residential area. By allowing the dust to migrate off site, HRP Exchange 55 LLC generated conditions detrimental to the health of the nearby residents, and therefore also created a nuisance.

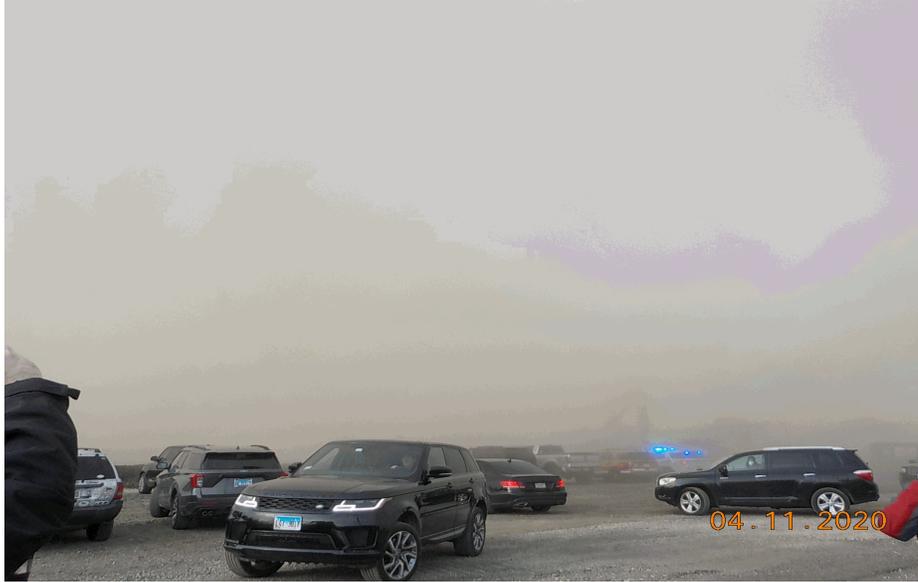
COMMENTS: Photo E- 3501 S. Pulaski Rd., Photo of dust cloud continuing to move north from impact drop area. Thick cloud of particulates can be seen.

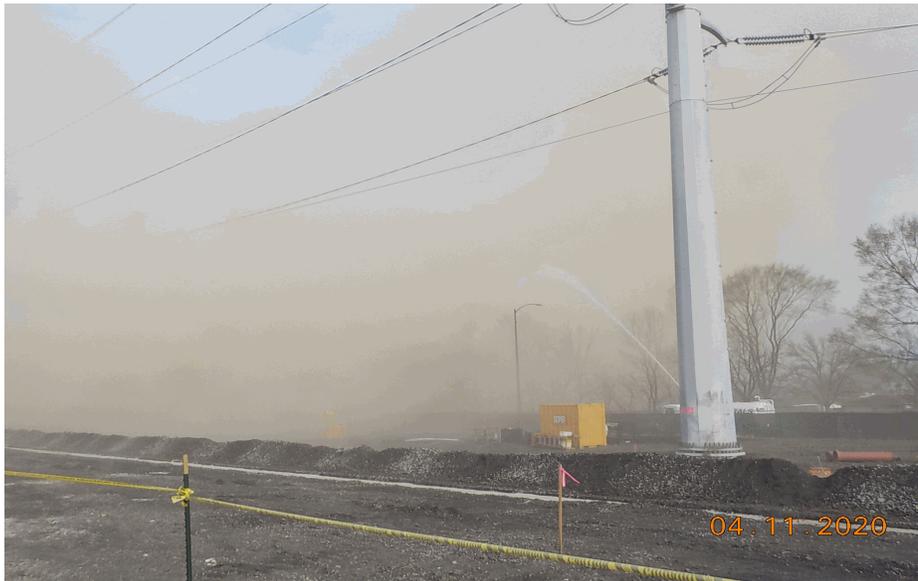
COMMENTS: Photo F- 3501 S. Pulaski Rd., Photo of dust cloud can be seen moving north onto residential area. Water truck can be seen hosing water.

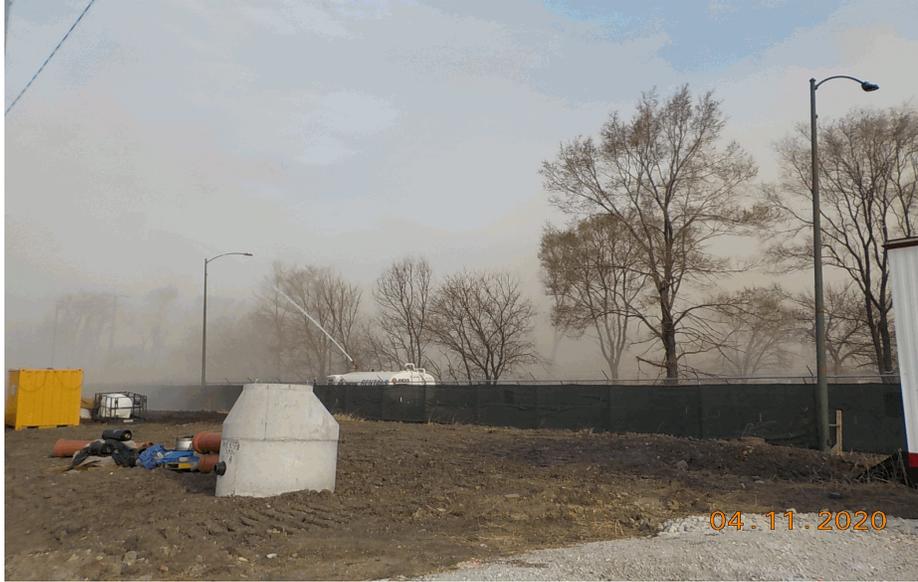
COMMENTS: Photo G- 3501 S. Pulaski Rd., Photo of dust cloud continuing to migrate north.

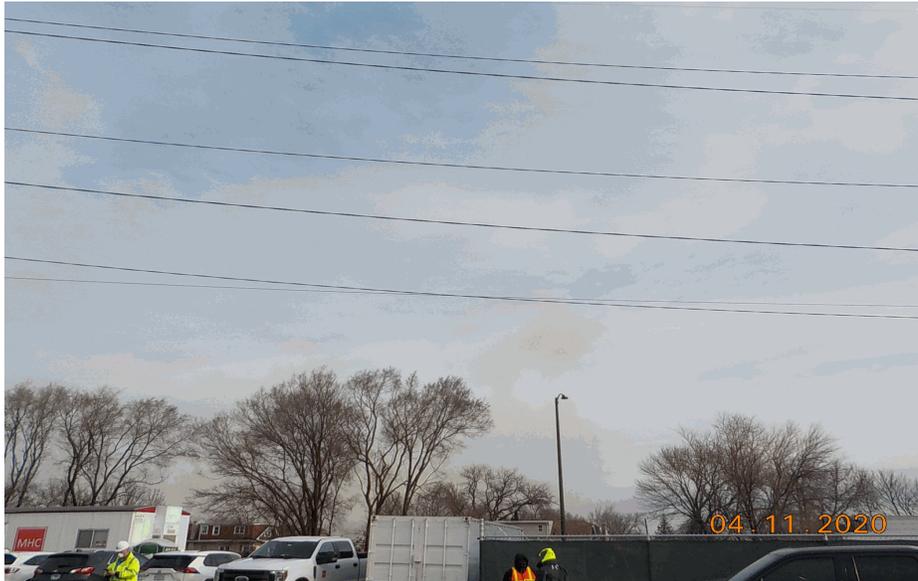
COMMENTS: Photo H- 3501 S. Pulaski Rd., Photo of dust cloud continuing to move north.

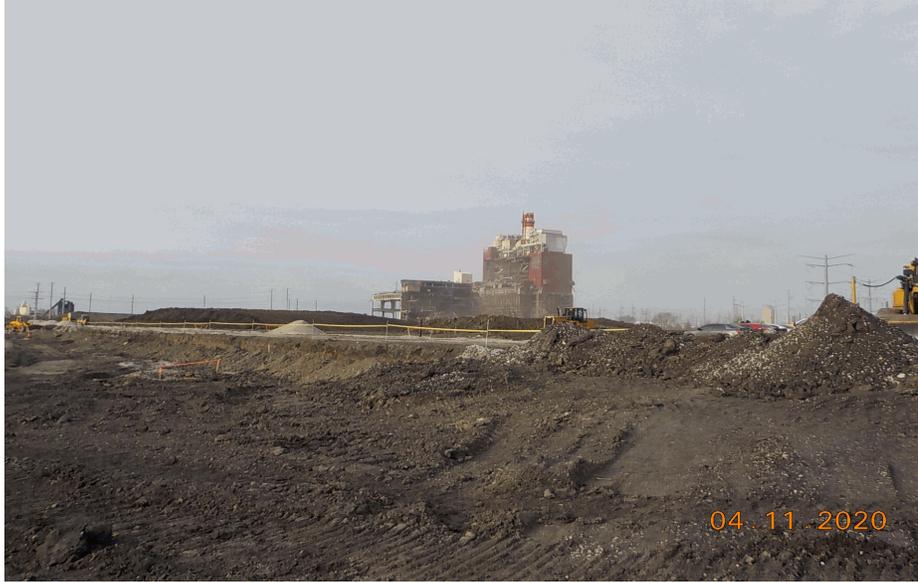
COMMENTS: Photo I- 3501 S. Pulaski Rd., Photo of area where smokestack was dropped. Dust can still be seen.

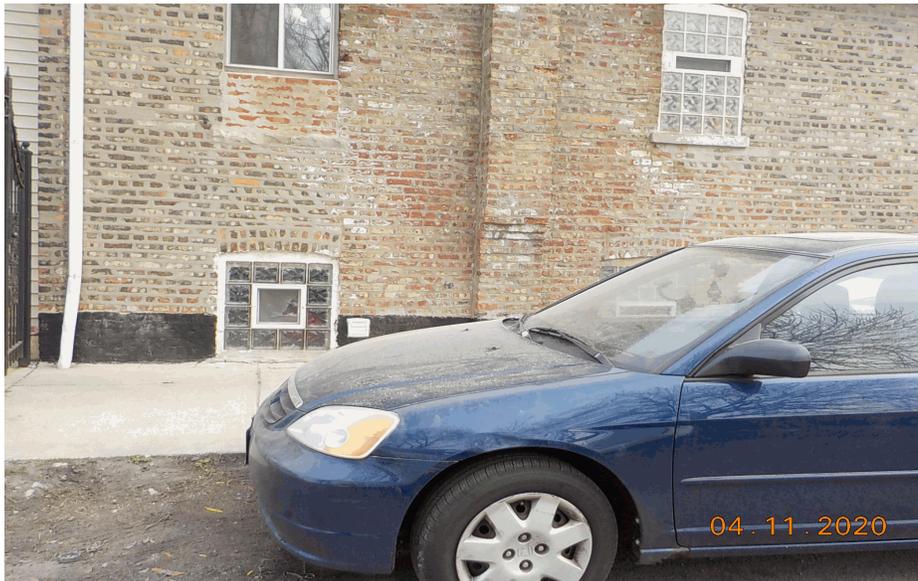
The cloud of dust slowly dispersed and became less thick as it continued to travel northbound. The reporting inspector then drove around the residential area directly north of the site to view if any residual dust from the cloud had settled. The reporting inspector observed dust on multiple cars and on trees.

COMMENTS: Photo J- 3501 S. Pulaski Rd., Photo of car located in residential area north of site. Dust can be seen on car.

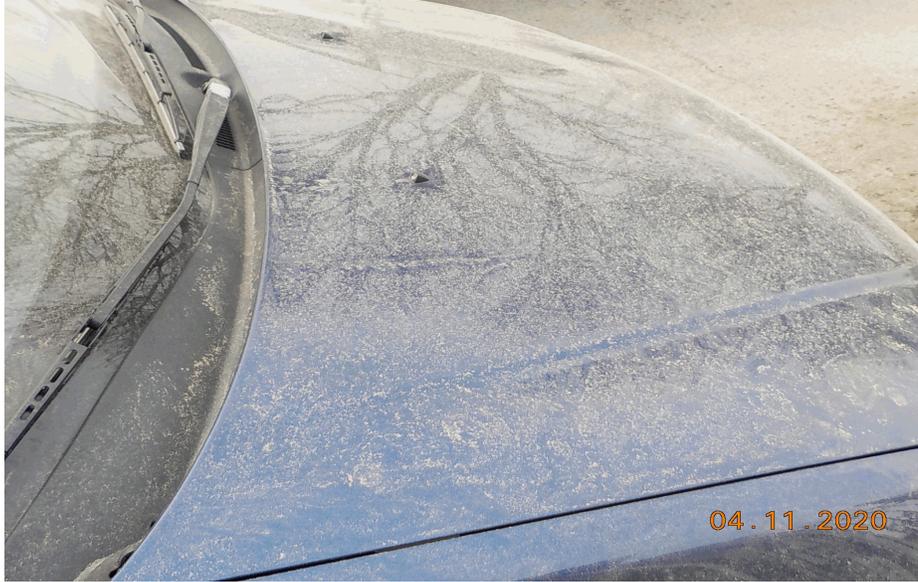
COMMENTS: Photo K-3501 S. Pulaski Rd., Photo of car located in residential area north of site. Settled dust can be seen on car.

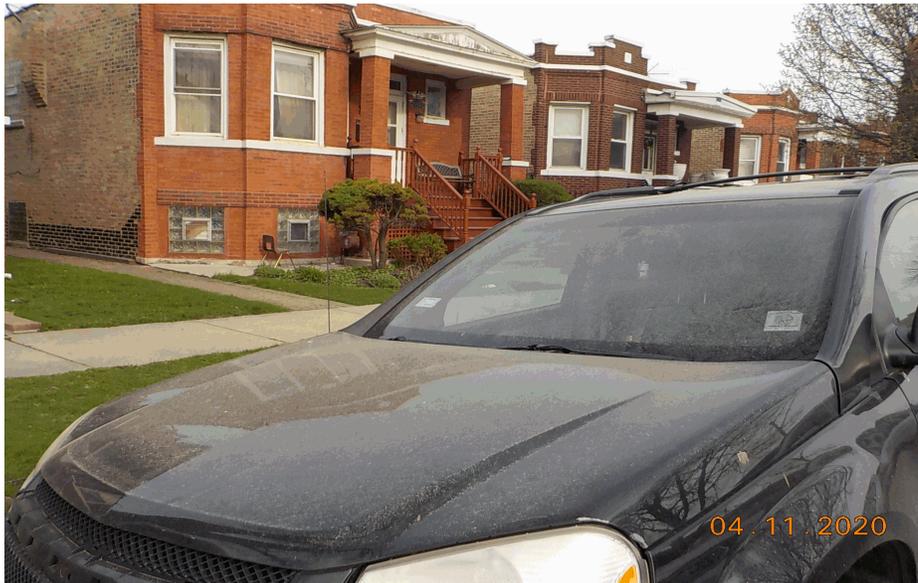
COMMENTS: Photo L-3501 S. Pulaski Rd., Photo of car located in residential area north of site. Settled dust can be seen on car.

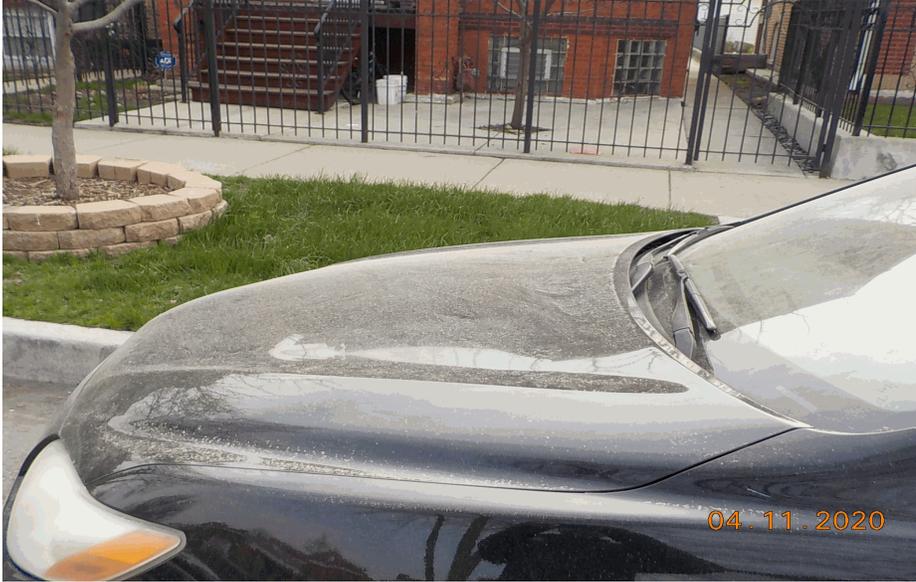
COMMENTS: Photo M-3501 S. Pulaski Rd. Photo of settled dust on car located in residential area north of site.

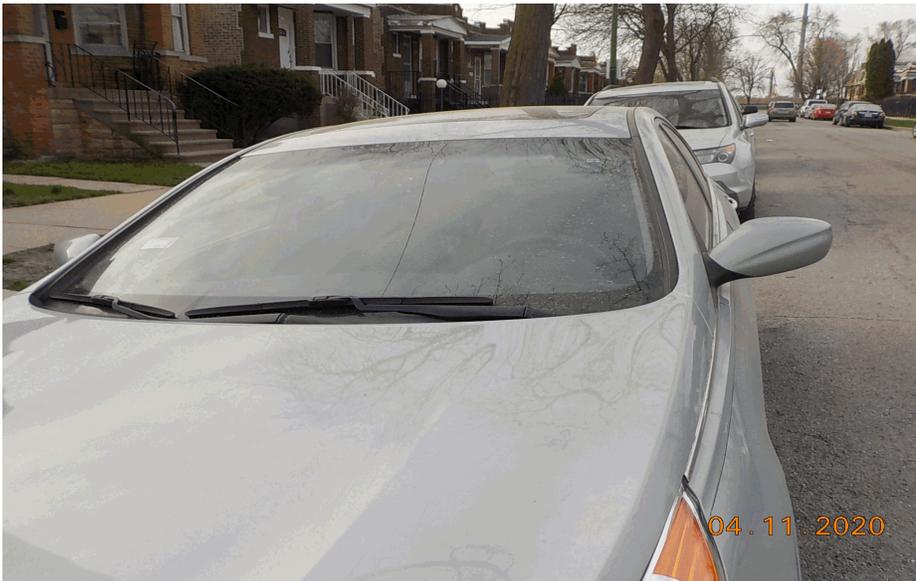
COMMENTS: Photo N-3501 S. Pulaski Rd. Photo of car with settled dust located in residential area north of site. Car is facing north. Site where implosion took place can be seen in the rear.

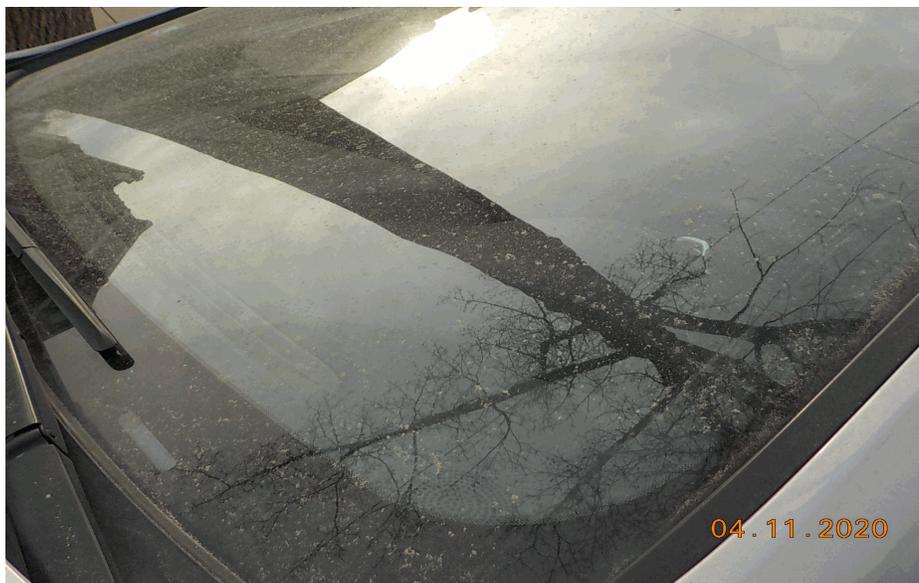
COMMENTS: Photo O-3501 S. Pulaski Rd. Closer view of car facing north. Settled dust can be seen.
