**CHICAGO PARK DISTRICT
&
CHICAGO DEPARTMENT OF TRANSPORTATION**

**LAKE MICHIGAN HIGH WATER LEVEL
SHORELINE ASSESSMENT**

FINAL REPORT

SMITHGROUP
35 E. Wacker Drive #900
Chicago, IL
Project Number: 12153

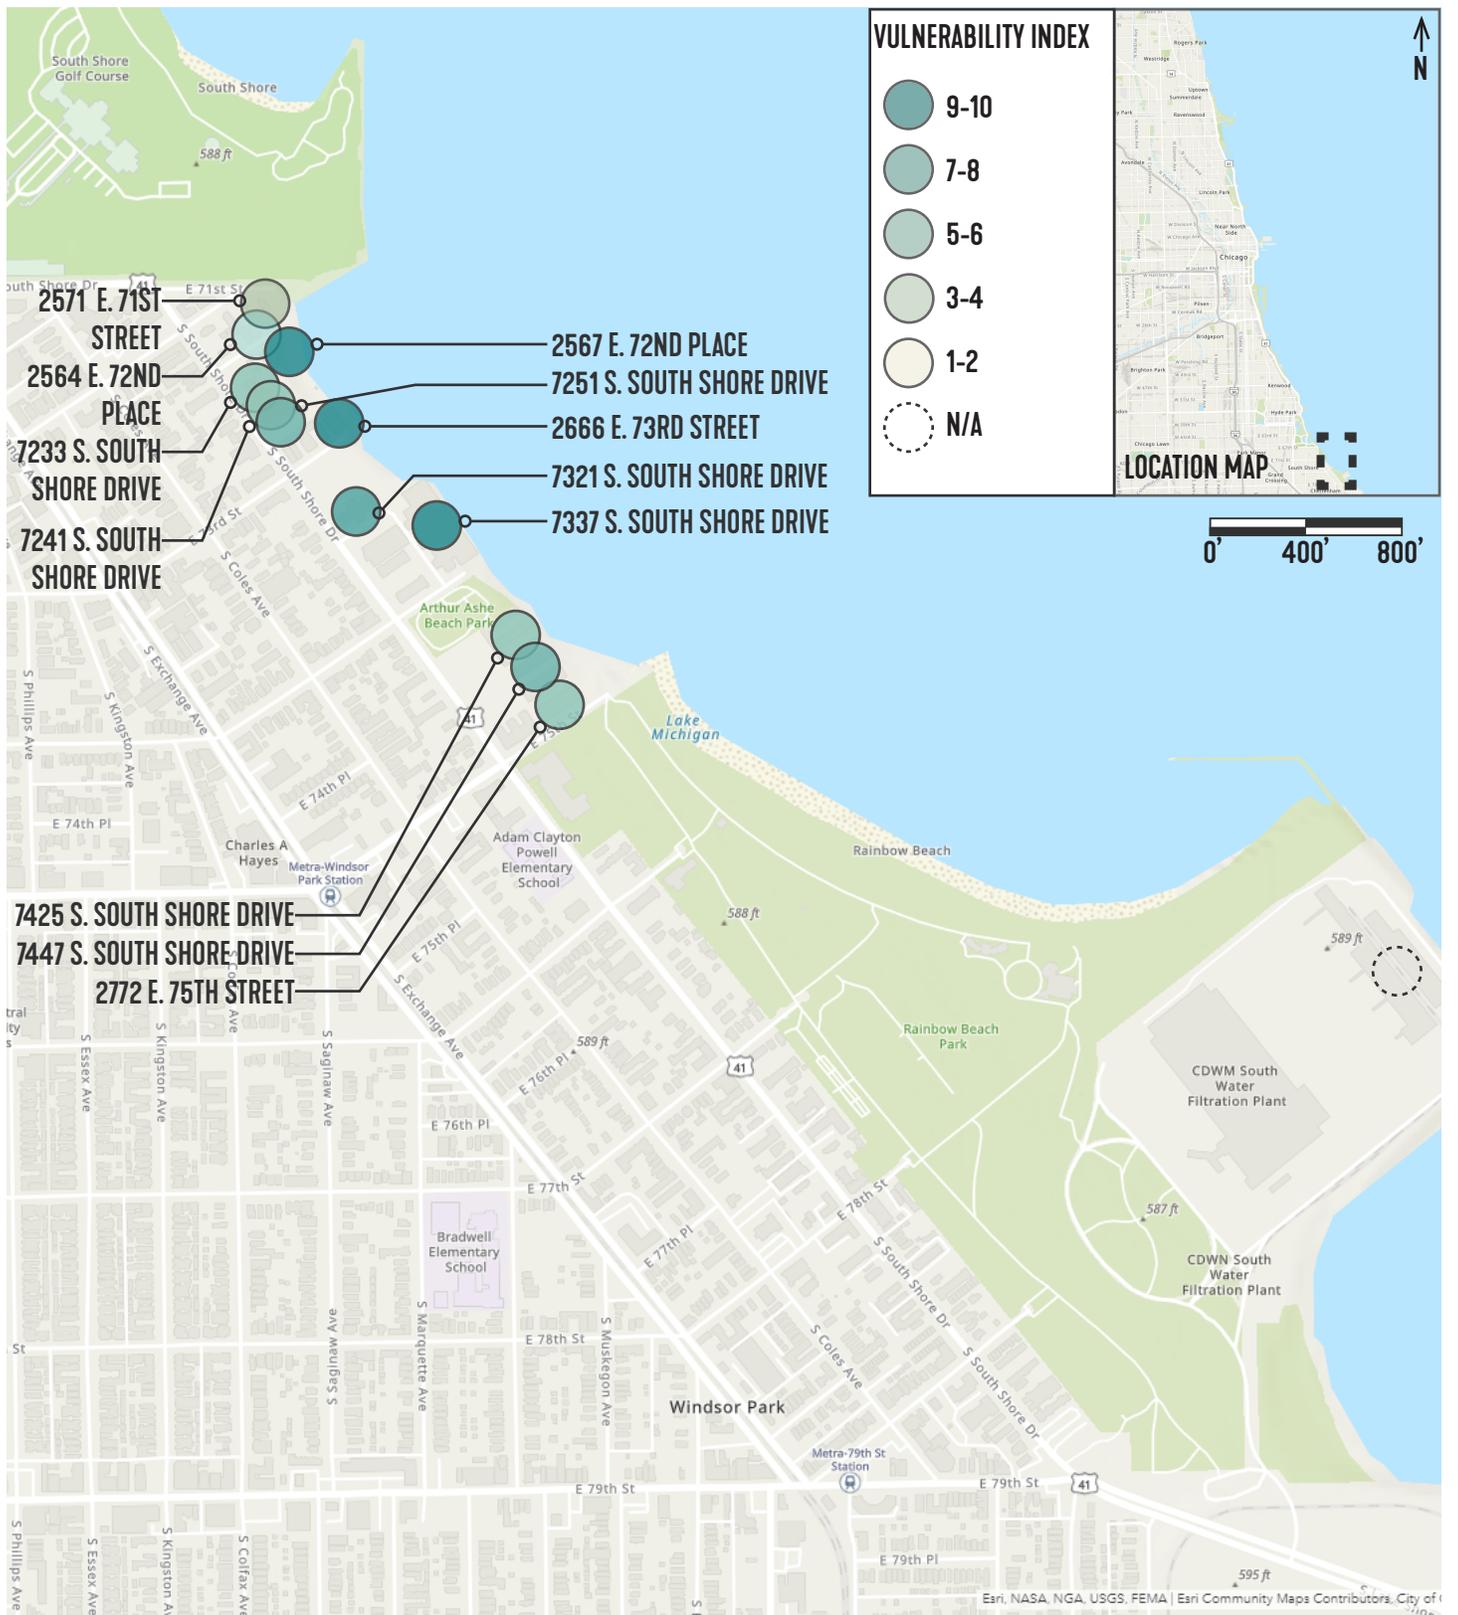
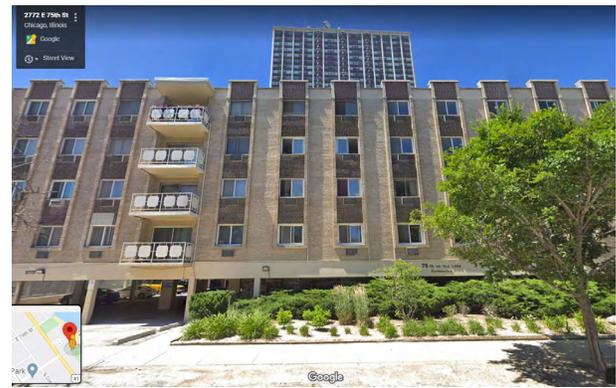
Ownership	Private
Number of Units	Unknown
Vulnerability Index	3
01/11/20 Flooding	Yes
Construction Date	1960s
Floors Above Grade	5
Floors Below Grade	0
Flood Insurance	Unable to answer

Structural Vulnerability	1	Structure Type	Cast in place concrete
Building Evac. Plan	No	Cladding Type	Masonry
Flood Access Impact	Yes	# of Egress Impacted	2
Min. 50% Assistance	Yes	Elevator Termination	At grade
Occupancy Notes	None		
Building Construction	None		
Flooding Impact History	No previous flooding. 1/11/20 flooding noted.

Coastal Vulnerability	3	O&M Shore Protection	No
Wave Overtopping	Yes	Foundation Type	Concrete Wall
Shore Protection	Concrete seawall	Crest Over Shore Protection	2 - 4 feet above grade
Shore Protection Notes	100' of beach 2' concrete seawall. Concrete seawall varies in height. No weep holes in seawall. 2 CB 30' west of seawall, drainage for overtop. Rubblemound adjacent to beach. DWM placed jersey barriers south of property. Indicates ROW was obstructed.

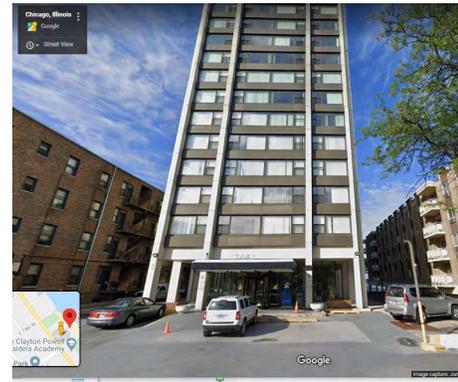
Ownership	Private
Number of Units	N/A
Vulnerability Index	6
01/11/20 Flooding	Yes
Construction Date	1968
Floors Above Grade	34
Floors Below Grade	1
Flood Insurance	Unable to answer

Structural Vulnerability	2	Structure Type	Cast in place concrete
Building Evac. Plan	No	Cladding Type	Glass curtain wall
Flood Access Impact	Yes	# of Egress Impacted	2
Min. 50% Assistance	No	Elevator Termination	Below grade (basement)
Occupancy Notes	None		
Building Construction	None		
Flooding Impact History	Previous flooding, typically one per year. 1/11/20 Ground water issues in boiler room during. Water entered through basement door. Door has been taped shut.

Coastal Vulnerability	3	O&M Shore Protection	Unknown
Wave Overtopping	Unknown	Foundation Type	Concrete Wall
Shore Protection	Rubble mound with sheet pile wall	Crest Over Shore Protection	Unknown
Shore Protection Notes	50' of beach 2' high rubblemound in front of sheet pile 3' wide concrete wall in front of 5' high concrete wall.

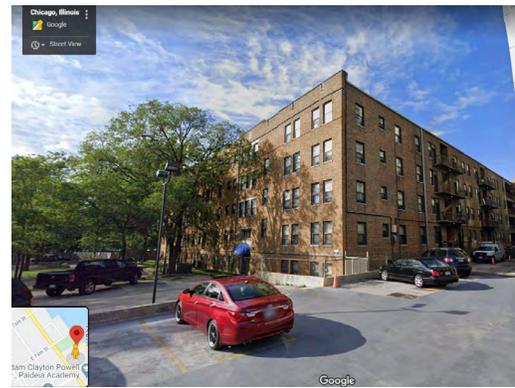
Ownership	Private
Number of Units	104 Units
Vulnerability Index	4
01/11/20 Flooding	Yes
Construction Date	1926
Floors Above Grade	4.5
Floors Below Grade	Unknown
Flood Insurance	Unable to answer

Structural Vulnerability	2	Structure Type	Cast in place concrete
Building Evac. Plan	Yes	Cladding Type	Masonry
Flood Access Impact	No	# of Egress Impacted	Unknown
Min. 50% Assistance	No	Elevator Termination	Unknown
Occupancy Notes	Mostly older folks but mobile		
Building Construction	Courtyard building, opening to lake. Access to courtyards is through 2 building pass-throughs from parking lot fronting the street. Combo cast-in-place and bearing wall construction		
Flooding Impact History	Lake level has eliminated private beach. Water gets into the basement through exterior stairs at north elevation.

Coastal Vulnerability	3	O&M Shore Protection	No
Wave Overtopping	Yes	Foundation Type	Not discernable
Shore Protection	Concrete seawall	Crest Over Shore Protection	2 - 4 feet above grade
Shore Protection Notes	There are some large concrete blocks out from the seawall. Assuming concrete wall may be attached to structure at northeast corner of structure based on proximity of structure to sea wall. Ice buildup on land behind the sea wall suggests overtopping. It was indicated that water surged up over the sea wall up to a height of around 18" against the building. Pieces of the concrete sea wall broke off, but cannot verify as all is covered in ice. Pavement and patio behind the sea wall were damaged and undermined. Pavement damage was visible. There was also a beach but it is now underwater.

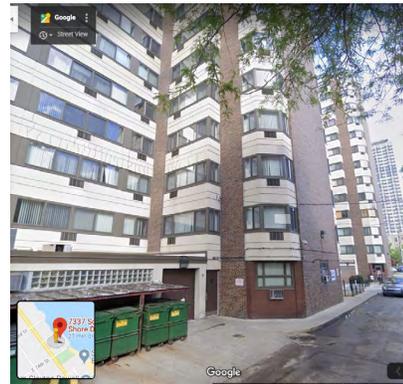
Ownership	Private
Number of Units	360 Units
Vulnerability Index	9
01/11/20 Flooding	Yes
Construction Date	1958
Floors Above Grade	13
Floors Below Grade	1
Flood Insurance	Unable to answer

Structural Vulnerability	4	Structure Type	Cast in place concrete
Building Evac. Plan	Yes	Cladding Type	Glass window walls / Concrete panels
Flood Access Impact	No	# of Egress Impacted	Unknown
Min. 50% Assistance	No	Elevator Termination	At grade
Occupancy Notes	About 30% seniors, 5% mobility-impaired		
Building Construction	First floor is storage, retail and parking. Second floor is amenity space. Units start on 3rd floor.		
Flooding Impact History	Flooding of basement parking area on 12/19/19; 10 inches of water in basement parking area. Has also flooded in the past, including in 1987. Basement did not flood on 1/11/20; the waves overtopped but the water froze before it could reach the basement. Standing water in sub grade level parking lot. Water enters at northeast corner of exterior parking lot where waves crash over corrugated wall and backflows into parking lot. Water rises to 9" and can backup and effect MEP in sub-basement mech room.

Coastal Vulnerability	5	O&M Shore Protection	No
Wave Overtopping	Yes	Foundation Type	Not discernable
Shore Protection	Unknown	Crest Over Shore Protection	> 6 feet above grade
Shore Protection Notes	N to S: Approx. 30 LF of concrete wall with sheetpile backing. The rest is sheetpile w/ poured concrete basement wall directly behind it. Enclosed parking garage with surface deck borders the lake. Crest elev >6 ft relative to top of parking deck. Assuming sheetpile may be attached to structure based on proximity. Ice buildup on top of railing at sea wall. Ice buildup on deck immediately behind sea wall.

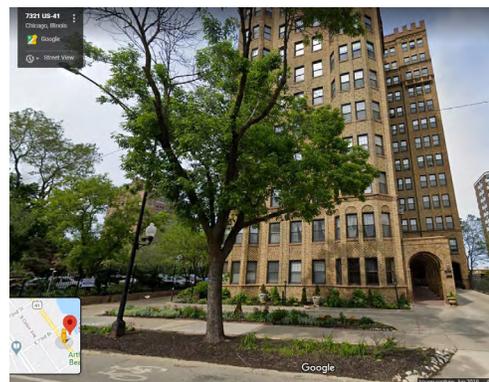
Ownership	Private
Number of Units	Over 10 Units
Vulnerability Index	7
01/11/20 Flooding	Unknown
Construction Date	Unknown
Floors Above Grade	Unknown
Floors Below Grade	Unknown
Flood Insurance	Unknown

Structural Vulnerability	2	Structure Type	Unknown
Building Evac. Plan	Unknown	Cladding Type	Unknown
Flood Access Impact	Unknown	# of Egress Impacted	Unknown
Min. 50% Assistance	Unknown	Elevator Termination	Unknown
Occupancy Notes	None		
Building Construction	None		
Flooding Impact History	Exterior erosion on lake front property and some water seepage in basement. Basement shows signs of water seepage but no active water penetration at time of inspection. Water has seeped into the basement at East side of building.

Coastal Vulnerability	5	O&M Shore Protection	No
Wave Overtopping	Yes	Foundation Type	Unknown
Shore Protection	Steel Sheet bulkhead	Crest Over Shore Protection	4 - 6 feet above grade
Shore Protection Notes	Major erosion at East and Northeast portion of property. Water from lake overflow has damaged the break wall at rear of property causing erosion. Engineer is currently working on a temporary repair to get them through this winter and hopefully next winter where then they can plan a more permanent solution to the lake flooding. Temporary repairs using crushed stone with fabric membrane and stacked stone to keep membrane in place and allow water to flow into lake.

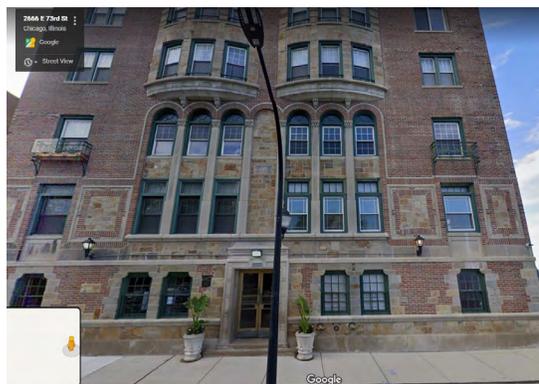
Ownership	Private
Number of Units	50-60 Units
Vulnerability Index	9
01/11/20 Flooding	Yes
Construction Date	1928
Floors Above Grade	13
Floors Below Grade	1
Flood Insurance	Yes

Structural Vulnerability	4	Structure Type	Cast in place concrete
Building Evac. Plan	Yes	Cladding Type	Masonry
Flood Access Impact	Yes	# of Egress Impacted	2
Min. 50% Assistance	Yes	Elevator Termination	Unknown
Occupancy Notes	Multi-unit Co-op. Over 90% elderly		
Building Construction	None		
Flooding Impact History	1986 water went into window well on west side of building and into the basement. Emergency pump in basement for boiler, laundry, storage. Revetment added. Late 80's, parking lot flooded and froze and cars were stuck. 1-2" standing water in basement laundry storage. Multiple events in past year. On 1/11/20 waves broke windows, ground floor flooded.

Coastal Vulnerability	5	O&M Shore Protection	Unknown
Wave Overtopping	Unknown	Foundation Type	Unknown
Shore Protection	Unknown	Crest Over Shore Protection	Unknown
Shore Protection Notes	None

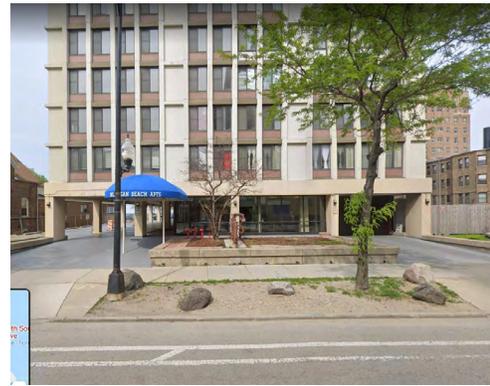
Ownership	Private
Number of Units	239 Units
Vulnerability Index	6
01/11/20 Flooding	Yes
Construction Date	Unknown
Floors Above Grade	21
Floors Below Grade	1
Flood Insurance	Yes

Structural Vulnerability	4	Structure Type	Cast in place concrete
Building Evac. Plan	Yes	Cladding Type	Precast concrete
Flood Access Impact	No	# of Egress Impacted	Unknown
Min. 50% Assistance	Unknown	Elevator Termination	Below grade (basement)
Occupancy Notes	None		
Building Construction	None		
Flooding Impact History	No previous flooding. 1/11/20 fully flooded the lowest garage level 8", and partially flooded the upper garage level. Water entry was through the southeast most stairwell, this stairwell is right behind the seawall. The lowest basement level was below lake level and the upper basement was partially below lake level.

Coastal Vulnerability	4	O&M Shore Protection	No
Wave Overtopping	Yes	Foundation Type	Not discernable
Shore Protection	Other or combination	Crest Over Shore Protection	> 6 feet above grade
Shore Protection Notes	Crest as relative to top of parking deck. Covered in ice. Building contact said there is sheet pile wall at the perimeter. Assuming attachment of shore protection to structure based on proximity.

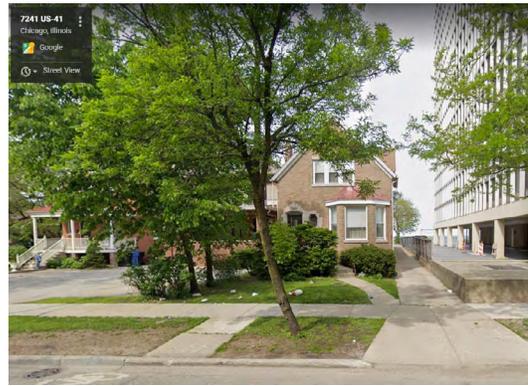
Ownership	Private
Number of Units	Single Family Home
Vulnerability Index	3
01/11/20 Flooding	Unknown
Construction Date	Unknown
Floors Above Grade	2
Floors Below Grade	Unknown
Flood Insurance	Unknown

Structural Vulnerability	N/A	Structure Type	Unknown
Building Evac. Plan	Unknown	Cladding Type	Masonry
Flood Access Impact	Unknown	# of Egress Impacted	Unknown
Min. 50% Assistance	Unknown	Elevator Termination	Unknown
Occupancy Notes	Single Family Residence		
Building Construction	None		
Flooding Impact History	Unknown

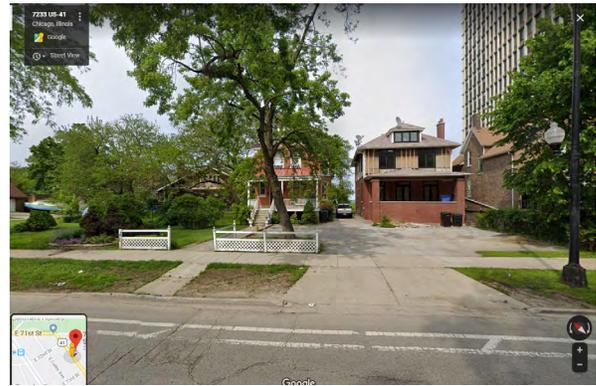
Structural Vulnerability	2	Structure Type	Bearing wall / Light framing
Building Evac. Plan	No	Cladding Type	Masonry
Flood Access Impact	Yes	# of Egress Impacted	2
Min. 50% Assistance	Unable to answer	Elevator Termination	Unknown
Occupancy Notes	Property consists of single-family house with rental cottage to the east.		
Building Construction	None		
Flooding Impact History	Experienced significant flooding in late 1980s. No flooding noted on 1/11/20.

Systems Vulnerability	5
Building System Notes	Access to property limited to exterior only. Sever damage to patio very near electrical pole/service and near gas meter service (protected by dike/wall).

Coastal Vulnerability	4	O&M Shore Protection	Unknown
Wave Overtopping	Unknown	Foundation Type	Unknown
Shore Protection	Unknown	Crest Over Shore Protection	Unknown
Shore Protection Notes	Rear back yard retaining wall and back yard concrete collapsed.

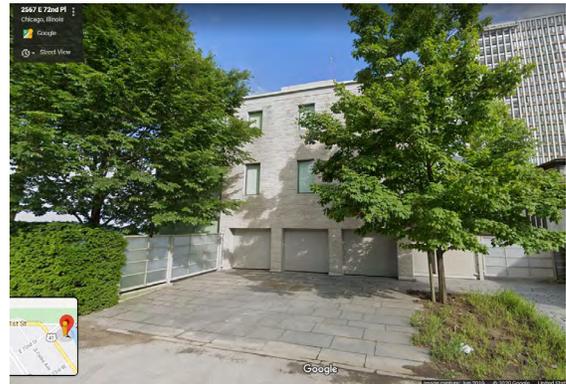
Structural Vulnerability	5	Structure Type	Structural steel
Building Evac. Plan	No	Cladding Type	Glass curtain wall/ Masonry
Flood Access Impact	Yes	# of Egress Impacted	Unknown
Min. 50% Assistance	Unknown	Elevator Termination	Unknown
Occupancy Notes	None		
Building Construction	Steel frame and concrete slabs.		
Flooding Impact History	The structure on the water experienced flooded 1st floor which receded after 30 hours. Sliding glass door was blown off hinges; 2 glass panels blown out and 2 broken. Since first floor glass panels boarded up. Waves coming over 2nd floor balcony, water damage to the 1st floor ceiling. Street was flooded, could only access in SUV.

Systems Vulnerability	5
Building System Notes	All MEP equipment is on the ground level. Recent flood damage to MEPPF equipment. Underfloor ducts were flooded. Electrical service and/or electrical panels are on ground level. Emergency Generator is on ground level, inside detached garage.

Coastal Vulnerability	5	O&M Shore Protection	No
Wave Overtopping	Yes	Foundation Type	Not discernable
Shore Protection	Unknown	Crest Over Shore Protection	3-4 Ft / 4-6 ft
Shore Protection Notes	Crest varies. 3-4 feet to the north at yard area. 4-6 feet to the south adjacent to the home. Ice buildup on shore. Damaged exterior metal gates. Damaged pavers and pavements. Land erosion and sinkholes. Scattered debris; chunks of broken pavement larger than 1 foot found >50 ft from shoreline. Per homeowner, patio pavers were found inside the home kitchen area. Exposed plastic utility pipes. Dirt and sand on property and public street adjacent to home.

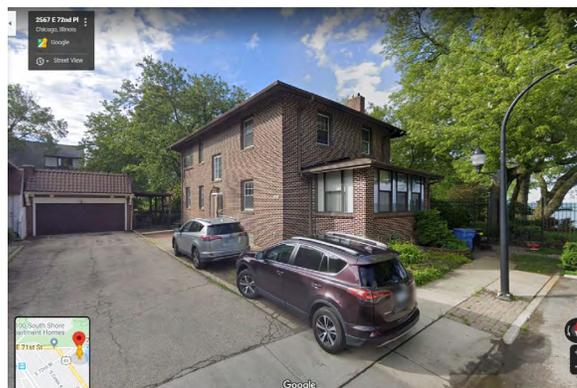
Structural Vulnerability	N/A	Structure Type	Unknown
Building Evac. Plan	No	Cladding Type	Unknown
Flood Access Impact	Yes	# of Egress Impacted	Unknown
Min. 50% Assistance	No	Elevator Termination	Unknown
Occupancy Notes	Not full time resident.		
Building Construction	None		
Flooding Impact History	No previous flooding.

Coastal Vulnerability	4	O&M Shore Protection	No
Wave Overtopping	Yes	Foundation Type	Not discernable
Shore Protection	Unknown	Crest Over Shore Protection	3-4 Ft / 4-6 ft
Shore Protection Notes	Crest varies. 3-4 feet to the north at yard area. 4-6 feet to the south adjacent to the home. Along lake frontage of the home: there are concrete blocks with a concrete seawall behind the blocks. To the north of the home there is a concrete seawall with stone rubble in front of the seawall. Ice buildup on shore. Damaged exterior metal gates. Damaged pavers and pavements. Land erosion and sinkholes. Scattered debris; chunks of broken pavement larger than 1 foot found >50 ft from shoreline. Per homeowner, patio pavers were found inside the home kitchen area. Exposed plastic utility pipes. Dirt and sand on property and public street adjacent to home.

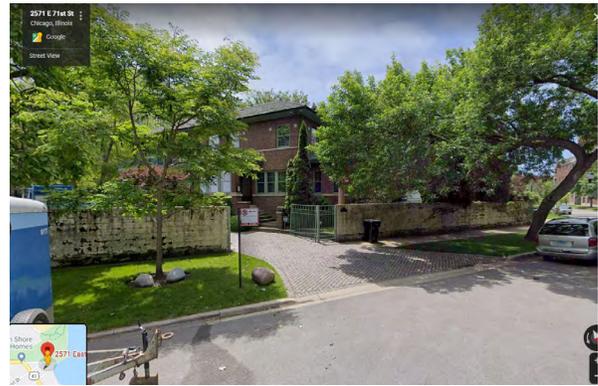
Structural Vulnerability	N/A	Structure Type	Unknown
Building Evac. Plan	Unknown	Cladding Type	Unknown
Flood Access Impact	Unknown	# of Egress Impacted	Unknown
Min. 50% Assistance	Unknown	Elevator Termination	Unknown
Occupancy Notes	None		
Building Construction	None		
Flooding Impact History	Unknown

Systems Vulnerability	3
Building System Notes	No access to property, however due to the property's location and presence of a basement along with a recent report of flooding, indicates MEPFP equipment is likely at risk of flood damage

Coastal Vulnerability	5	O&M Shore Protection	Unknown
Wave Overtopping	Unknown	Foundation Type	Unknown
Shore Protection	Unknown	Crest Over Shore Protection	Unknown
Shore Protection Notes	None

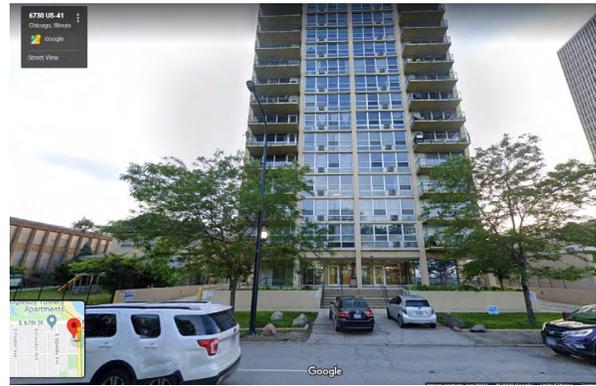
Structural Vulnerability	2	Structure Type	Unknown
Building Evac. Plan	Unknown	Cladding Type	Unknown
Flood Access Impact	Unknown	# of Egress Impacted	Unknown
Min. 50% Assistance	Unable to answer	Elevator Termination	Below grade (basement)
Occupancy Notes	None		
Building Construction	None		
Flooding Impact History	Top of parking garage asphalt top coat deteriorating throughout. Concrete beams and slab show signs of water penetration. Buildings main basement area near storage lockers show no sign of water seepage. Rear concrete columns at back of building show cracking and spalling masonry at bottoms. No flooding information provided.

Coastal Vulnerability	3	O&M Shore Protection	Unknown
Wave Overtopping	Unknown	Foundation Type	Concrete Wall
Shore Protection	None - Building setback from lakefront	Crest Over Shore Protection	Unknown
Shore Protection Notes	Property not located directly on lakefront. The lake is across the 4 lane road (South Shore Drive) and the north edge of the South Shore Golf Course. Building management indicated South Shore Drive floods in front of their building during major storms.

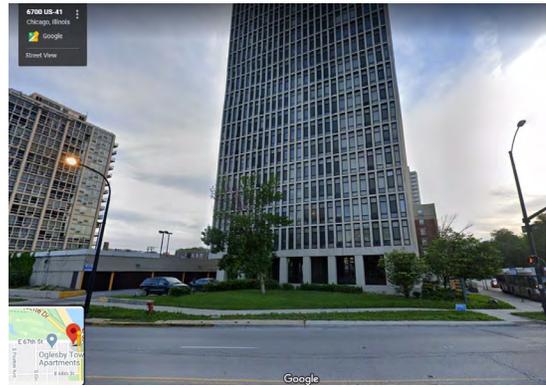
Structural Vulnerability	1	Structure Type	Cast in place concrete
Building Evac. Plan	Yes	Cladding Type	Precast concrete
Flood Access Impact	No	# of Egress Impacted	0
Min. 50% Assistance	Yes	Elevator Termination	Below grade (basement)
Occupancy Notes	Condo building. First floor built above grade. Structure built in high podium. Less prone to flooding.		
Building Construction	First floor is above grade.		
Flooding Impact History	No flooding. Northwest basement area shows signs of water seepage at some point in time. South garage has deteriorated concrete slabs / beam below grade. Top membrane is deteriorates with water damage throughout. Water seepage at east and west exterior walls at lower levels. Tarps are hanging above vehicles to prevent water and debris from hit tenants cars. Channels have been drenched at lower slab to divert water penetrating to drains in the floor.

Coastal Vulnerability	3	O&M Shore Protection	Unknown
Wave Overtopping	Unknown	Foundation Type	Concrete Wall
Shore Protection	None - Building setback from lakefront	Crest Over Shore Protection	Unknown
Shore Protection Notes	Property not located directly on lakefront. The lake is across the 4 lane road (South Shore Drive) and the north edge of the South Shore Golf Course. Building management indicated South Shore Drive floods in front of their building during major storms.

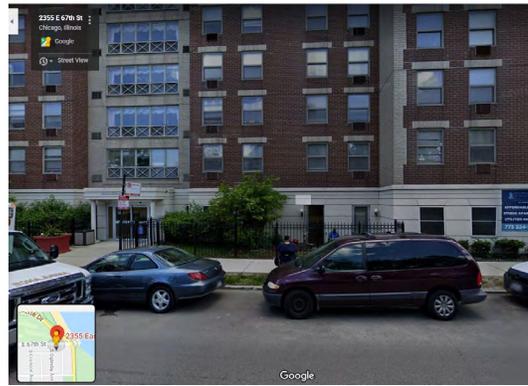
Structural Vulnerability	2	Structure Type	Cast in place concrete
Building Evac. Plan	Yes	Cladding Type	Masonry
Flood Access Impact	No	# of Egress Impacted	0
Min. 50% Assistance	Yes	Elevator Termination	At grade
Occupancy Notes	Senior living.		
Building Construction	Minor break down of building materials due to age and exposure. Future storm events may cause further breakdown of materials.		
Flooding Impact History	Minor leaks in garage and basement during bad weather. Basement mechanical room experienced about 1" of standing water.

Coastal Vulnerability	3	O&M Shore Protection	Unknown
Wave Overtopping	Unknown	Foundation Type	Slab on Grade / Masonry Block
Shore Protection	None - Building setback	Crest Over Shore Protection	Unknown
Shore Protection Notes	South Shore Drive and E 67th street experience flooding.

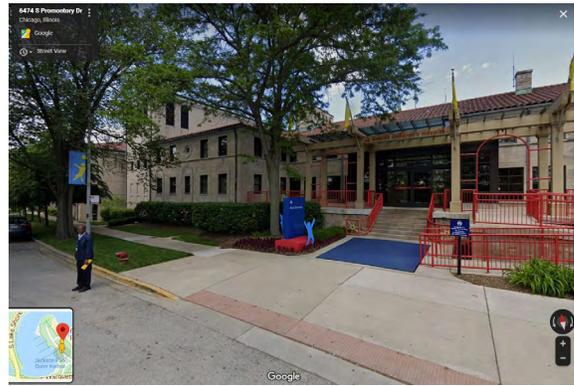
Structural Vulnerability	1	Structure Type	Additions precast concrete / New wing is steel
Building Evac. Plan	Unknown	Cladding Type	Historic masonry / Glass addition
Flood Access Impact	No	# of Egress Impacted	Unknown
Min. 50% Assistance	Yes	Elevator Termination	At grade
Occupancy Notes	La Rabida, very sick children		
Building Construction	None		
Flooding Impact History	No flooding. On 1/11/20 there was some flooding at the surface parking area north of the Yacht Club; this lot is used by the hospital. At inspection there is approx. 1.5 - 2 feet of freeboard at this lot area. This lot has previously experienced extended periods of standing water due to lake levels.

Systems Vulnerability	4
Building System Notes	Mechanical equipment (Boilers, Chillers, Med Gases) is 3 feet below grade. Mechanical room is exposed to the Lake. The Emergency generator Louvers, Mechanical Room Louvers are low on the wall facing the lake. All/most MEPFP equipment below grade potentially at risk of flood damage. Electrical services are inside at grade .DWHs are inside below grade. Flood protection limited to sump pump(s) at lowest level. Fire Pump is below grade. Fire Alarm Panel is above grade.

Coastal Vulnerability	3	O&M Shore Protection	Varies
Wave Overtopping	Yes	Foundation Type	Not discernable
Shore Protection	Unknown	Crest Over Shore Protection	Unknown
Shore Protection Notes	Crest elevation varies. Public path obstructed by debris from 1/11/20 overtopping. Debris areas on path and to north of large revetment. Debris north of large revetment includes sand, stone, woody debris, stones as large as around 10 inches. There is a catch basin behind the new revetment area adjacent to the hospital building; possible susceptibility to surcharge.

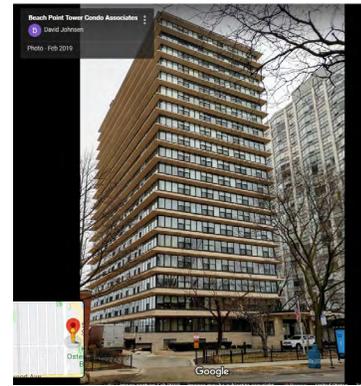
Structural Vulnerability	1	Structure Type	Cast in place concrete
Building Evac. Plan	No	Cladding Type	Precast concrete / Glass curtain wall
Flood Access Impact	No	# of Egress Impacted	0
Min. 50% Assistance	Unknown	Elevator Termination	Below grade (basement)
Occupancy Notes	None		
Building Construction	None		
Flooding Impact History	No lake flooding. Flooding due to excessive amount of rain. Stormsewer floor drain flooding during large rain events

Systems Vulnerability	3
Building System Notes	All major MEPFP equipment (electrical service/panels, boilers/water heaters, pumps, chiller, gas meter) below grade at risk of flood damage with flood protection limited to duplex sump pump(s). Flooding poses risk of electrocution from Cabinet Unit Heater mounted low at egress. Has below grade parking garage with electrical panels, exhaust fan and steam unit heaters. Louvers low above grade exposed to the lake.

Coastal Vulnerability	2	O&M Shore Protection	No
Wave Overtopping	No	Foundation Type	Concrete Wall
Shore Protection	Steel Sheet bulkhead	Crest Over Shore Protection	4 - 6 feet above grade
Shore Protection Notes	Water has reached the steel bulkhead. Water has not overtopped steel bulkhead

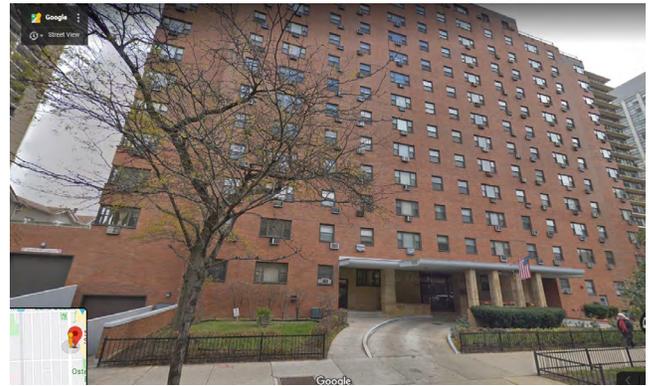
Structural Vulnerability	1	Structure Type	Unknown
Building Evac. Plan	Unknown	Cladding Type	Unknown
Flood Access Impact	Unknown	# of Egress Impacted	Unknown
Min. 50% Assistance	No	Elevator Termination	At grade
Occupancy Notes	None		
Building Construction	Built as condos, recently bought and converted to apartments; undergoing renovations		
Flooding Impact History	No building impact from lake. Concern about standing water/flooding in adjacent bird sanctuary at Osterman Beach. Some seepage observed during 1/11/20 event.

Coastal Vulnerability	2	O&M Shore Protection	No
Wave Overtopping	No	Foundation Type	Unknown
Shore Protection	Sheetpile wall	Crest Over Shore Protection	4 - 6 feet above grade
Shore Protection Notes	Sheetpile wall at perimeter of deck area, with extended sandy land frontage beyond. Building manager indicated that during wave events, the water surges all the way up to the steps on their deck, but does not overtop onto the deck. The wave action and surging leaves behind a significant amount of standing water.

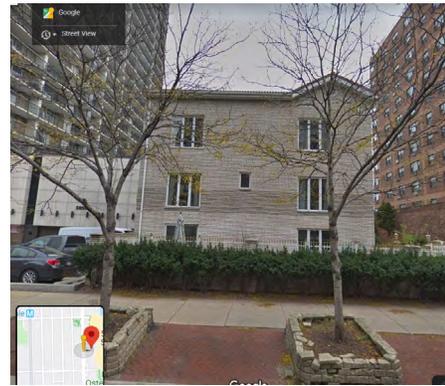
Structural Vulnerability	2	Structure Type	Light framing structure
Building Evac. Plan	No	Cladding Type	Masonry
Flood Access Impact	No	# of Egress Impacted	Unknown
Min. 50% Assistance	Unable to answer	Elevator Termination	Unknown
Occupancy Notes	None		
Building Construction	Complex is a series of individually-owned row houses.		
Flooding Impact History	Flooding due to excessive amount of rain. Stormsewer floor drain flooding during large rain events. No lake flooding.

Coastal Vulnerability	2	O&M Shore Protection	No
Wave Overtopping	No	Foundation Type	Concrete Wall
Shore Protection	Concrete seawall	Crest Over Shore Protection	4 - 6 feet above grade
Shore Protection Notes	200' to coast from concrete seawall. Steel sheeting on adjacent property. Dual layered seawall of east side of building 2' high 12' gap to a 2' high seawall.

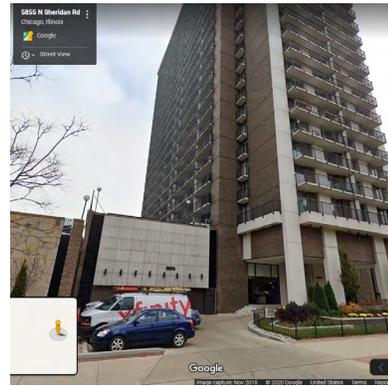
Structural Vulnerability	1	Structure Type	Cast in place concrete
Building Evac. Plan	Yes	Cladding Type	Masonry
Flood Access Impact	No	# of Egress Impacted	Unknown
Min. 50% Assistance	Yes	Elevator Termination	At grade
Occupancy Notes	Mostly more mature residents who have lived here since it opened, starting to see more younger residents moving in but generally no families		
Building Construction	3 stories of parking above ground, amenities and units start on 4		
Flooding Impact History	In 80's water flooded garage. After installed ledges at exterior beach level doors to prevent water getting into garage. 1/11/20 water rising on property. No water from October/November storms. Installed sandbags and fabric barrier on back fencing to prevent wave action. Water ponding inside of sand bag line, not reaching the building. At site concrete has erosion below, had an engineer look at it, will evaluate more in spring. Concerned that erosion will reach building foundation.

Coastal Vulnerability	3	O&M Shore Protection	No
Wave Overtopping	Yes	Foundation Type	Not discernable
Shore Protection	Concrete wall on top of metal sheetpile wall.	Crest Over Shore Protection	4 - 6 feet above grade
Shore Protection Notes	The shore protection is a 1' x 4' tall concrete wall, on top of metal sheetpile wall. There is rubble mound majority of the length. The rubble mound was installed by the Corps in the 1980s. At the area where there is no rubble mound, building engineer indicated the water forms eddies and is causing erosion of lakebed causing some spalling of the concrete seawall. Ice buildup on pavement. Sand buildup on pavement. Sand beach no longer visible.

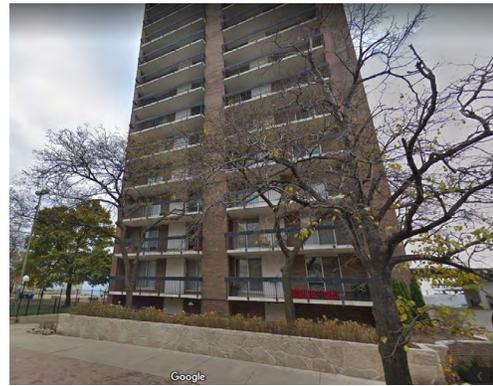
Structural Vulnerability	1	Structure Type	Cast in place concrete
Building Evac. Plan	Yes	Cladding Type	Glass curtain wall
Flood Access Impact	No	# of Egress Impacted	Unknown
Min. 50% Assistance	Yes	Elevator Termination	At grade
Occupancy Notes	None		
Building Construction	None		
Flooding Impact History	No flooding.

Coastal Vulnerability	1	O&M Shore Protection	Yes
Wave Overtopping	No	Foundation Type	Concrete Wall
Shore Protection	Concrete seawall	Crest Over Shore Protection	> 6 feet above grade
Shore Protection Notes	20' wide rubblemound stone in front of 5' - 6' high concrete seawall. No damage visible to shore protection

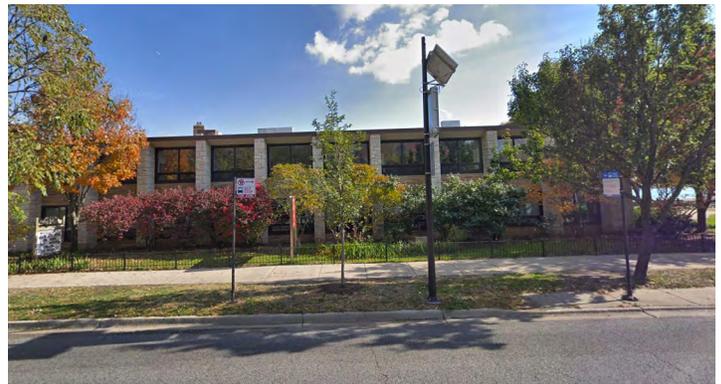
Structural Vulnerability	1	Structure Type	Cast in place concrete
Building Evac. Plan	Yes	Cladding Type	Masonry
Flood Access Impact	Yes	# of Egress Impacted	Unknown
Min. 50% Assistance	No	Elevator Termination	Unknown
Occupancy Notes	Place of worship.		
Building Construction	None		
Flooding Impact History	Experienced significant flooding in late 1980s. USACE did remediation after 1987 flood of adjacent beach. Current flooding is from floor drain sewer backup.

Systems Vulnerability	2
Building System Notes	All major MEPFP equipment (electrical service/panels, boilers, pumps, gas meter, fire alarm panel) below grade potentially at risk of flood damage.

Coastal Vulnerability	4	O&M Shore Protection	Unknown
Wave Overtopping	Unknown	Foundation Type	Not discernable
Shore Protection	Concrete seawall	Crest Over Shore Protection	Unknown
Shore Protection Notes	Concrete seawall has several cracks that go through the wall. Sections of significant damage. Parking lot between building and seawall at 5% min slope. No flooding issues in building.

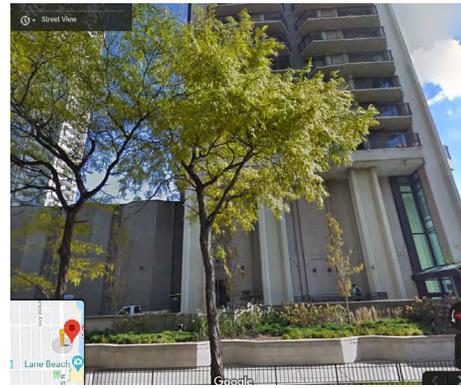
Ownership	Private
Number of Units	347 Units
Vulnerability Index	2
01/11/20 Flooding	No
Construction Date	1969
Floors Above Grade	39
Floors Below Grade	1
Flood Insurance	Yes

Structural Vulnerability	1	Structure Type	Cast in place concrete
Building Evac. Plan	Yes	Cladding Type	Masonry
Flood Access Impact	No	# of Egress Impacted	Unknown
Min. 50% Assistance	No	Elevator Termination	At grade
Occupancy Notes	None		
Building Construction	347 condo units		
Flooding Impact History	Unknown

Coastal Vulnerability	4	O&M Shore Protection	Unknown
Wave Overtopping	Unknown	Foundation Type	Pile Foundation
Shore Protection	Steel Sheet bulkhead	Crest Over Shore Protection	Unknown
Shore Protection Notes	Will share report from scuba team inspection of sea wall.

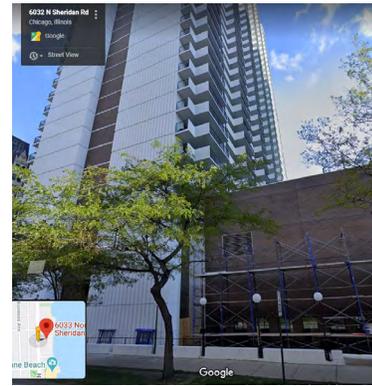
Ownership	Private
Number of Units	498 Units
Vulnerability Index	2
01/11/20 Flooding	No
Construction Date	Unknown
Floors Above Grade	46
Floors Below Grade	0
Flood Insurance	Yes

Structural Vulnerability	1	Structure Type	Unknown
Building Evac. Plan	Yes	Cladding Type	Unknown
Flood Access Impact	No	# of Egress Impacted	Unknown
Min. 50% Assistance	No	Elevator Termination	At grade
Occupancy Notes	30-40 people in need of assistance in an emergency		
Building Construction	45 residential floors, garden level first floor of retail concourse and building amenities. Lowest level is MEP rooms, 4' below grade. Had scuba investigation of sea wall 2 years ago, then hired consultant to do engineering to attach sea wall to building; waiting for permit.		
Flooding Impact History	Experienced significant flooding in late 1980s. Concrete wall at end of Glenlake was constructed since late 80s. At that time lake water came over the street and into areaway to building corridor. Water flooded down stairs in building. Abated with sandbags from the city. No flooding noted on 1/11/20.

Coastal Vulnerability	4	O&M Shore Protection	Unknown
Wave Overtopping	No	Foundation Type	Pile Foundation
Shore Protection	Steel Sheet bulkhead	Crest Over Shore Protection	> 6 feet above grade
Shore Protection Notes	No visible signs of overtopping. Building manager indicated only spray occurs above top of wall. Concerned wall is tilting and no longer 90 degrees, that the wave action is putting pressure on the bottom of wall. Building manager indicated the building plans to hire consultant to renovate and attach seawall to building.

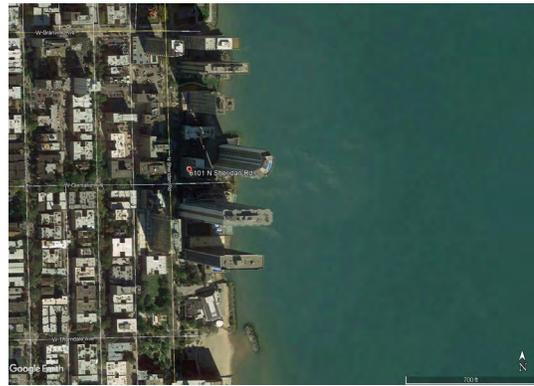
Ownership	Private
Number of Units	160 Units
Vulnerability Index	6
01/11/20 Flooding	Yes
Construction Date	1969
Floors Above Grade	Unknown
Floors Below Grade	Unknown
Flood Insurance	Yes

Structural Vulnerability	3	Structure Type	Cast in place concrete
Building Evac. Plan	Yes	Cladding Type	Masonry
Flood Access Impact	Yes	# of Egress Impacted	Unknown
Min. 50% Assistance	No	Elevator Termination	Below grade (basement)
Occupancy Notes	Population skews older but is a mix. Has diversified in age more in recent years.		
Building Construction	Units all condos. Slab is a mix of waffle, smooth/tensioned, and cast beams (more linear than a waffle). Direction of linear beams changes.		
Flooding Impact History	No previous flooding. On 1/11/20 noted flooding.

Coastal Vulnerability	5	O&M Shore Protection	No
Wave Overtopping	Yes	Foundation Type	Pile Foundation
Shore Protection	Steel sheetpile / Concrete wall	Crest Over Shore Protection	> 6 feet above grade
Shore Protection Notes	Concrete wall 6 feet above grade appears to be connected to building structure. Approximately 8 feet wide of rubblemound in front of concrete wall visible. Shore protection bounds both east side and north side corner of building. No gaps in shore protection observed.

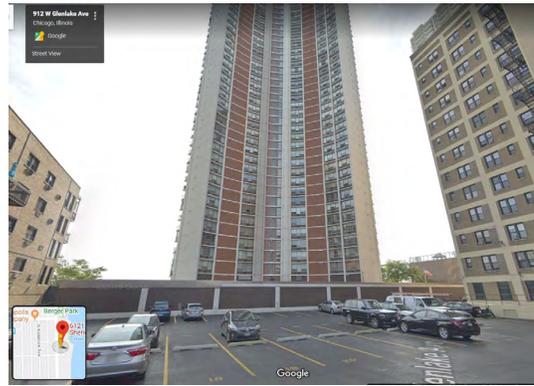
Ownership	Private
Number of Units	31 Units
Vulnerability Index	3
01/11/20 Flooding	Yes
Construction Date	1960s
Floors Above Grade	5
Floors Below Grade	Unknown
Flood Insurance	Unable to answer

Structural Vulnerability	1	Structure Type	Cast in place concrete
Building Evac. Plan	No	Cladding Type	Masonry
Flood Access Impact	No	# of Egress Impacted	Unknown
Min. 50% Assistance	No	Elevator Termination	Unknown
Occupancy Notes	Mix of middle aged, some elderly, some young families		
Building Construction	Ground floor parking is approx. 2' below grade with 5 floors of units above.		
Flooding Impact History	No previous flooding. On 1/11/20 noted flooding.

Coastal Vulnerability	3	O&M Shore Protection	Unknown
Wave Overtopping	Yes	Foundation Type	Slab on Grade
Shore Protection	Rubble mound / Concrete wall	Crest Over Shore Protection	Unknown
Shore Protection Notes	Lakeside of property has rubble mound with concrete wall with 3 foot cinder block wall. Northeast corner of property has concrete block and concrete wall only. Broken and displaced revetment stone. 10" ice on pavement along east building face. Ice on east fence. Staining and ice on east building wall. Northeast corner of property has damage to stairs and concrete wall.

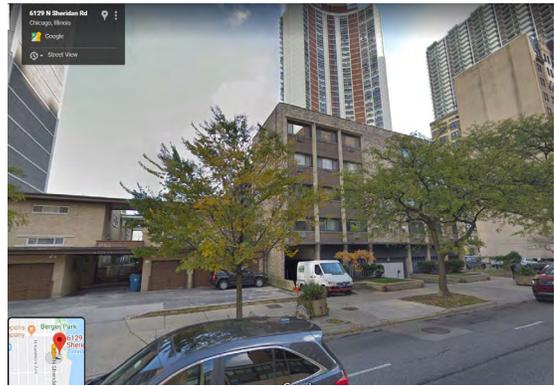
Ownership	Private
Number of Units	Over 10 Units
Vulnerability Index	2
01/11/20 Flooding	No
Construction Date	1957
Floors Above Grade	2
Floors Below Grade	0
Flood Insurance	Unable to answer

Structural Vulnerability	1	Structure Type	Bearing wall
Building Evac. Plan	Unknown	Cladding Type	Masonry
Flood Access Impact	No	# of Egress Impacted	Unknown
Min. 50% Assistance	Unable to answer	Elevator Termination	Unknown
Occupancy Notes	Mix of ages		
Building Construction	Garden style duplexes		
Flooding Impact History	No flooding.

Coastal Vulnerability	3	O&M Shore Protection	No
Wave Overtopping	Yes	Foundation Type	Not discernable
Shore Protection	Concrete	Crest Over Shore Protection	4 - 6 feet above grade
Shore Protection Notes	Building manager described the shoreline as a concrete slab, with accumulated sand and stone over the top of the slab. Slab is not visible due to the accumulations. The accumulations have occurred over time. Behind the slab/ accumulated sand and stone, and set back around feet from the waters edge is a concrete knee wall. Crest from water to top of kneewall. Some ice buildup on land side of kneewall. Sand behind kneewall per building manager. Building manager said there was no flooding of buildings during the 1/11/20 event.

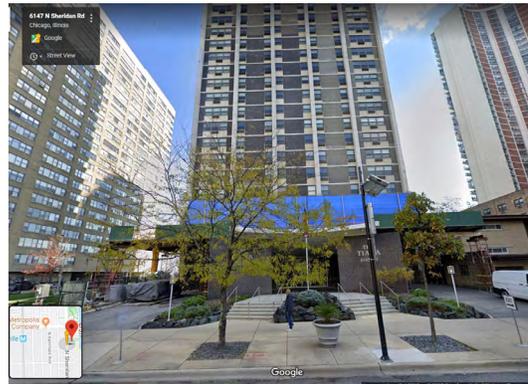
Ownership	Private
Number of Units	100 Units
Vulnerability Index	2
01/11/20 Flooding	Yes
Construction Date	1965
Floors Above Grade	30
Floors Below Grade	0
Flood Insurance	Yes

Structural Vulnerability	2	Structure Type	Structural steel
Building Evac. Plan	Yes	Cladding Type	Masonry
Flood Access Impact	No	# of Egress Impacted	1
Min. 50% Assistance	No	Elevator Termination	At grade
Occupancy Notes	25% - 33% of tenants would need assistance in an emergency		
Building Construction	3 floors of parking above ground. Amenity spaces on 4th floor. Units start on 5th floor.		
Flooding Impact History	Waves run up and enter the garage through louvers on east face on the second level. There is also a doorway on the east face on the first level where water from waves enters. The building engineer removed approx. 160 gallons of water from behind the doorway as a result of the 1/11/20 event.

Systems Vulnerability	4
Building System Notes	Individual condo FC/AC unit are present. Louvers low above grade exposed to the lake. Previously minor leakage through garage vent louver. Electrical service and/or electrical panels is below grade. There is no sump pump. DWH is inside below grade. Domestic Booster Pump is below grade. Fire Pump is below grade. Fire Alarm Panel is above grade.

Coastal Vulnerability	3	O&M Shore Protection	No
Wave Overtopping	Yes	Foundation Type	Not discernable
Shore Protection	Rubblemound with likely sheetpile wall	Crest Over Shore Protection	2 - 4 feet above grade
Shore Protection Notes	Could not see the sheetpiling due to ice and snow cover. Per building engineer, during the 1/11/20 event, a few of the revetment stones broke into multiple pieces from the wave action. Significant ice cover limited visibility. There is around 10 inches of ice on the concrete pavement along the east face of the building. There is ice on the fence along the east face of the building. There is ice and staining on the east building wall.

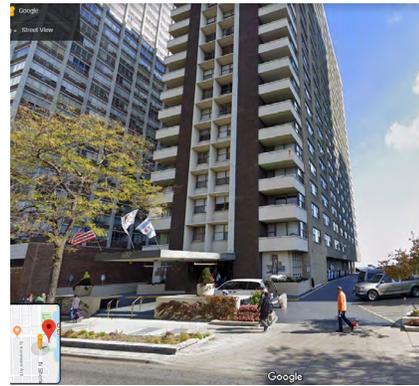
Ownership	Private
Number of Units	286 Units
Vulnerability Index	2
01/11/20 Flooding	No
Construction Date	1960
Floors Above Grade	25
Floors Below Grade	1
Flood Insurance	Unable to answer

Structural Vulnerability	1	Structure Type	Structural steel
Building Evac. Plan	Yes	Cladding Type	Masonry
Flood Access Impact	No	# of Egress Impacted	Unknown
Min. 50% Assistance	No	Elevator Termination	Unknown
Occupancy Notes	3-4 mobility impaired. Condos mix of owner occupied and rented.		
Building Construction	1 level of garage below grade, plus boiler room sub level. 268 units, condos are a mix of owner occupied and rented. Scissor stairs.		
Flooding Impact History	No flooding. 1/11/20 event there was some minor intrusion of water at the east wall of the parking garage, through wall joints.

Coastal Vulnerability	3	O&M Shore Protection	No
Wave Overtopping	Yes	Foundation Type	Not discernable
Shore Protection	rubble mound with concrete wall	Crest Over Shore Protection	> 6 feet above grade
Shore Protection Notes	>6 ft crest relative to top of deck Sand accumulations on parking deck suggest wave overtopping.

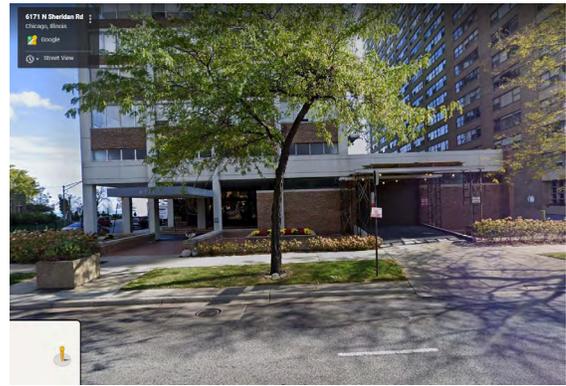
Ownership	Private
Number of Units	312 Units
Vulnerability Index	5
01/11/20 Flooding	Yes
Construction Date	1962
Floors Above Grade	30
Floors Below Grade	1
Flood Insurance	Yes

Structural Vulnerability	3	Structure Type	Cast in place concrete
Building Evac. Plan	Yes	Cladding Type	Masonry
Flood Access Impact	No	# of Egress Impacted	Unknown
Min. 50% Assistance	No	Elevator Termination	At grade
Occupancy Notes	4% of population might need assistance, mostly middle-aged		
Building Construction	312 condo units.		
Flooding Impact History	No previous flooding. Water intrusion into the building occurred at a vertical crack located at the SE corner basement wall of the parking garage. Water intrusion also occurred at a door along the east face of the building. The door has been sandbagged. Afterward, had to jet the sand from floor drains to clear them.

Coastal Vulnerability	4	O&M Shore Protection	No
Wave Overtopping	Yes	Foundation Type	Not discernable
Shore Protection	See shore protection type notes	Crest Over Shore Protection	> 6 feet above grade
Shore Protection Notes	Crest is >6 ft from top of deck. 4-6 feet at rubble mound. 10/19, an approx. 3ft x 4ft x 8ft concrete block (shore protection) was lifted by wave action and pushed into a metal fence. The metal fence (approx. 30 LF) was running east-west along the south property line, from the east face of the building to the lake. The fence was destroyed by the waves and then afterward dismantled by owner. It is now stockpiled adjacent to its previous installed location. Ice buildup on shoreline. Staining on north and east sides of building.

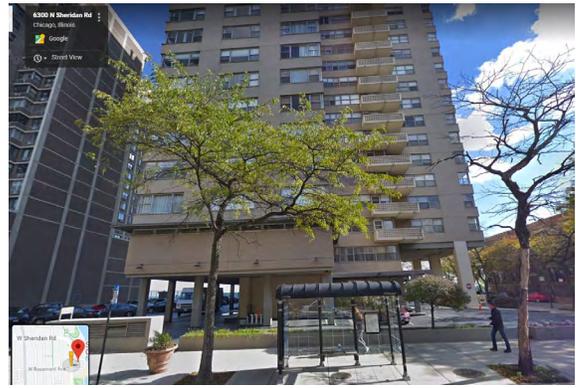
Ownership	Private
Number of Units	136 Units
Vulnerability Index	3
01/11/20 Flooding	Yes
Construction Date	1963
Floors Above Grade	26
Floors Below Grade	1
Flood Insurance	Yes

Structural Vulnerability	2	Structure Type	Cast in place concrete
Building Evac. Plan	Yes	Cladding Type	Glass curtain wall
Flood Access Impact	Yes	# of Egress Impacted	0
Min. 50% Assistance	No	Elevator Termination	Below grade (basement)
Occupancy Notes	None		
Building Construction	None		
Flooding Impact History	Typically multiple flooding events per year. 1/11/20 noted flooding, severe roadway flooding.

Coastal Vulnerability	4	O&M Shore Protection	Yes
Wave Overtopping	Yes	Foundation Type	Concrete Wall
Shore Protection	See below	Crest Over Shore Protection	4 - 6 feet above grade
Shore Protection Notes	From North of property to south 0' - 4.5' wide concrete seawall. 40' steel piling with jersey wall 30' behind landscaped section. Jersey wall initially behind fence. 2' wide stone barrier in front of sea wall. Top of parking garage wall at lake level. Seawall extends from basement to 4' above grade. South and East garage walls were leaking. Above grade shore protection has repaired cracks that extend up and over the sea wall.

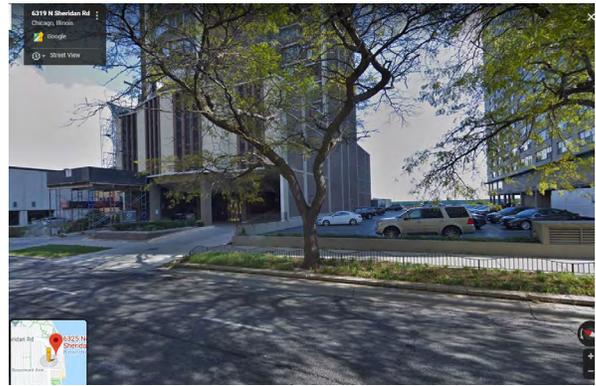
Ownership	Private
Number of Units	Over 10 Units
Vulnerability Index	2
01/11/20 Flooding	No
Construction Date	Unknown
Floors Above Grade	Unknown
Floors Below Grade	Unknown
Flood Insurance	Yes

Structural Vulnerability	1	Structure Type	Unknown
Building Evac. Plan	Yes	Cladding Type	Unknown
Flood Access Impact	No	# of Egress Impacted	Unknown
Min. 50% Assistance	No	Elevator Termination	At grade
Occupancy Notes	Mostly able-bodied residents. About 25% Loyola students		
Building Construction	None		
Flooding Impact History	No flooding. During 1/11/20 event there was some minor intrusion of water at the east wall of the parking garage, through wall joints. The wind was carrying water toward the building as high as the fifth floor, no damage.

Coastal Vulnerability	3	O&M Shore Protection	Unknown
Wave Overtopping	Unknown	Foundation Type	Unknown
Shore Protection	Rubble mount with sheet pile wall	Crest Over Shore Protection	Unknown
Shore Protection Notes	Signs of overtopping: Ice buildup on deck behind seawall. Ice buildup on fence along top of seawall. Sand accumulations on pool deck at seawall and past the pool.

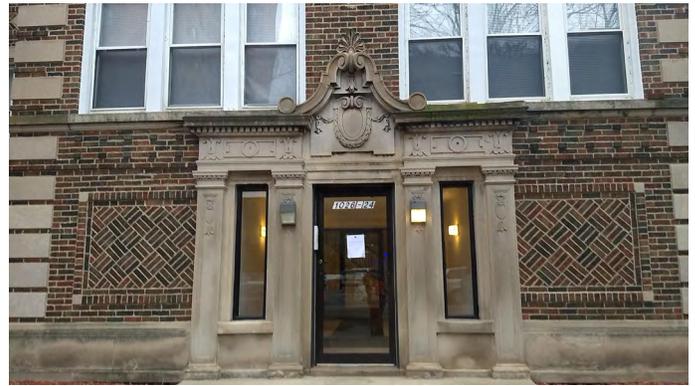
Ownership	Private
Number of Units	46 Units
Vulnerability Index	1
01/11/20 Flooding	No
Construction Date	1920
Floors Above Grade	4
Floors Below Grade	0
Flood Insurance	Unable to answer

Structural Vulnerability	1	Structure Type	Cast in place concrete
Building Evac. Plan	Yes	Cladding Type	Masonry
Flood Access Impact	No	# of Egress Impacted	Unknown
Min. 50% Assistance	No	Elevator Termination	Unknown
Occupancy Notes	Residential for students, professors and other professionals		
Building Construction	Courtyard building, point load entrances, 49 rental units		
Flooding Impact History	No previous flooding. On 1/11/20 waves were coming over alley and up to building, however no water inside. Entrances off Loyola Ave are raised from the street therefore, no flooding into the entrance. Noted about 12" of water on the street. Alley was inaccessible during flooding

Systems Vulnerability	3
Building System Notes	Boiler is in the basement. Mechanical room has windows on aisle which is damaged by water erosion. Electrical service and/or electrical panels are below grade. Domestic Water Heater is below grade.

Coastal Vulnerability	2	O&M Shore Protection	No
Wave Overtopping	Yes	Foundation Type	Unknown
Shore Protection	Other or combination	Crest Over Shore Protection	Unknown
Shore Protection Notes	Building is not on the immediate shore line; there is another building east of it. Building manager indicated during 1/11/20 event, waves overtopped the public alley to the north and washed against the north face of the building wall. During this same event, the public street (Loyola Avenue) to the south of the building flooded with up to a foot of water.

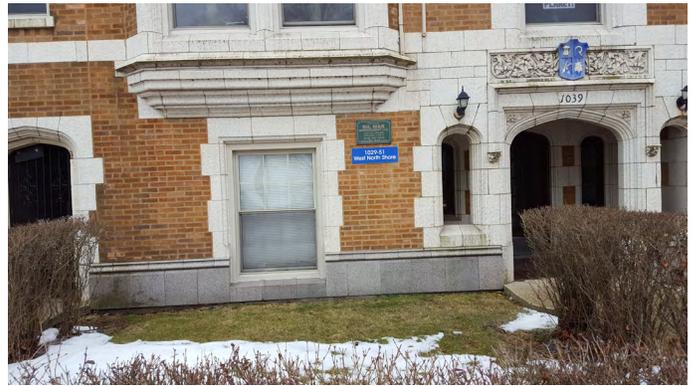
Ownership	Private
Number of Units	Over 10 Units
Vulnerability Index	2
01/11/20 Flooding	No
Construction Date	1920s
Floors Above Grade	4
Floors Below Grade	1
Flood Insurance	Unable to answer

Structural Vulnerability	1	Structure Type	Bearing wall
Building Evac. Plan	No	Cladding Type	Masonry
Flood Access Impact	No	# of Egress Impacted	0
Min. 50% Assistance	Unable to answer	Elevator Termination	Unknown
Occupancy Notes	None		
Building Construction	None		
Flooding Impact History	No flooding.

Coastal Vulnerability	3	O&M Shore Protection	Unknown
Wave Overtopping	Unknown	Foundation Type	Concrete Wall
Shore Protection	rubble mound with concrete wall	Crest Over Shore Protection	Unknown
Shore Protection Notes	No flooding issues. Visible portion from outside property in good condition. 4' rubble mound with 2' wide 4' high concrete wall.

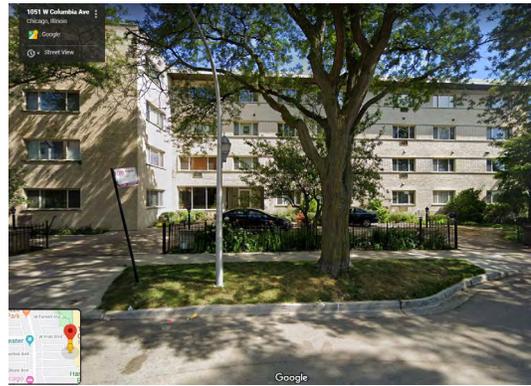
Ownership	Private (Loyola)
Number of Units	Unknown
Vulnerability Index	N/A
01/11/20 Flooding	No
Construction Date	1963
Floors Above Grade	4
Floors Below Grade	1
Flood Insurance	No

Structural Vulnerability	1	Structure Type	Masonry
Building Evac. Plan	No	Cladding Type	Masonry
Flood Access Impact	No	# of Egress Impacted	0
Min. 50% Assistance	No	Elevator Termination	At grade
Occupancy Notes	Humanities Building Loyola		
Building Construction	4-story masonry building with basement		
Flooding Impact History	Experienced significant flooding in late 1980s; added pumps.. Multiple events in the past year. Had clogged drain tile that has been repaired recently.

Systems Vulnerability	3
Building System Notes	All major MEPFP equipment (electrical service/panels, boilers/water heaters, pumps, fire alarm panel) below grade potentially at risk of flood damage. Flood protection limited to sump pump(s) at lowest level at multiple locations.

Coastal Vulnerability	2	O&M Shore Protection	Unknown
Wave Overtopping	Unknown	Foundation Type	Masonry Wall
Shore Protection	None	Crest Over Shore Protection	Unknown
Shore Protection Notes	No visible shore protection, may be covered by snow. Building 70' from shoreline 150' property width 2' high berm at shoreline.
