**CHICAGO PARK DISTRICT
&
CHICAGO DEPARTMENT OF TRANSPORTATION**

**LAKE MICHIGAN HIGH WATER LEVEL
SHORELINE ASSESSMENT**

FINAL REPORT

SMITHGROUP
35 E. Wacker Drive #900
Chicago, IL
Project Number: 12153

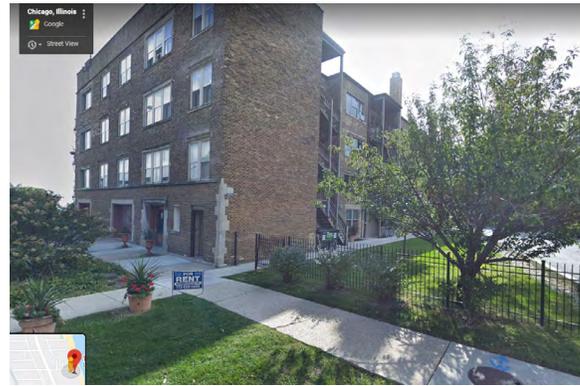
Ownership	Private
Number of Units	Over 10 Units
Vulnerability Index	3
01/11/20 Flooding	Unknown
Construction Date	Unknown
Floors Above Grade	4
Floors Below Grade	0
Flood Insurance	Unknown

Structural Vulnerability	1	Structure Type	Masonry
Building Evac. Plan	Unknown	Cladding Type	Masonry
Flood Access Impact	Unknown	# of Egress Impacted	Unknown
Min. 50% Assistance	Unknown	Elevator Termination	Unknown
Occupancy Notes	None. Only limited surveying was performed at the exterior.		
Building Construction	None		
Flooding Impact History	3 story masonry building has seepage but no structural damage. It set back 50ft from retaining wall, 100 ft setback from sea wall. Basement has groundwater infiltration from all sides.

Coastal Vulnerability	5	O&M Shore Protection	No
Wave Overtopping	No	Foundation Type	Concrete Wall. Pile Foundation
Shore Protection	Rubble mound with concrete wall, stone revetment, concrete seawall	Crest Over Shore Protection	2 - 4 feet above grade
Shore Protection Notes	50ft setback from retaining wall and 100 ft setback from sea wall. 100' rubble mound armor stone with 4' high concrete. Stone revetment held by steel piling and concrete seawall. Additional seawall behind first wall (damaged) 40' landscaped section 4' high concrete wall. Southern portion of property protected by 50' rubbermound armor stone and sheet piles 40' sand section 4' high concrete wall. East concrete seawall damaged in several places. Does not appear to be connected with rebar at damaged locations. Steel piling visible under stone.

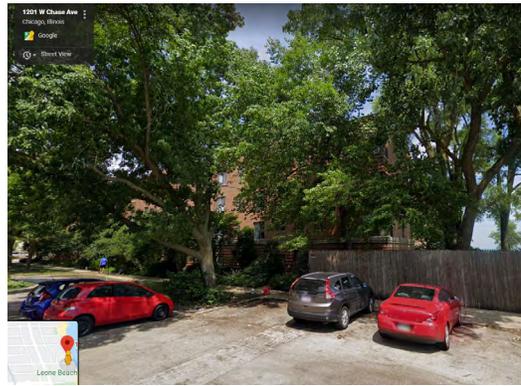
Structural Vulnerability	N/A	Structure Type	Bearing wall
Building Evac. Plan	No	Cladding Type	Masonry
Flood Access Impact	Yes	# of Egress Impacted	1
Min. 50% Assistance	No	Elevator Termination	Unknown
Occupancy Notes	None		
Building Construction	None		
Flooding Impact History	No previous flooding.

Coastal Vulnerability	5	O&M Shore Protection	Unknown
Wave Overtopping	Unknown	Foundation Type	Unknown
Shore Protection	Unknown	Crest Over Shore Protection	Unknown
Shore Protection Notes	None

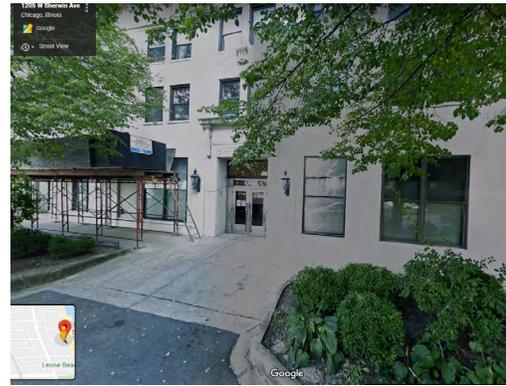
Structural Vulnerability	3	Structure Type	Masonry bearing wall
Building Evac. Plan	No	Cladding Type	Masonry
Flood Access Impact	Yes	# of Egress Impacted	2
Min. 50% Assistance	No	Elevator Termination	Below grade (basement)
Occupancy Notes	None		
Building Construction	None		
Flooding Impact History	Experienced significant flooding in late 1980s. On 1/11/20 boat room under east terrace flooded. 1/11/20 storm flooded the beach storage and caused large amounts of sand to be forced inside. Storage area has pits to collect water and portable pumps. Flooding was as high as 18 " but was completely dry at time of inspection. No structural damage. Flooding enters on south end of property into basement, which is 3' below grade. Steel piling is submerged during large rain events.

Systems Vulnerability	4
Building System Notes	All/most MEPFP equipment (electrical service/panels, boilers/water heaters, pumps, gas meter, fire pump) below grade at risk of flood damage. Flood protection limited to duplex sump pump(s) at lowest level in the mechanical room. Recently experienced flood damage with much sand forced into the building.

Coastal Vulnerability	3	O&M Shore Protection	No
Wave Overtopping	Yes	Foundation Type	Concrete Wall
Shore Protection	Concrete seawall	Crest Over Shore Protection	4 - 6 feet above grade
Shore Protection Notes	Approx. 50ft set back from shore line. 150' length of concrete seawall. 60' from seawall to the water. No damage to shore protection. South of property is unprotected.

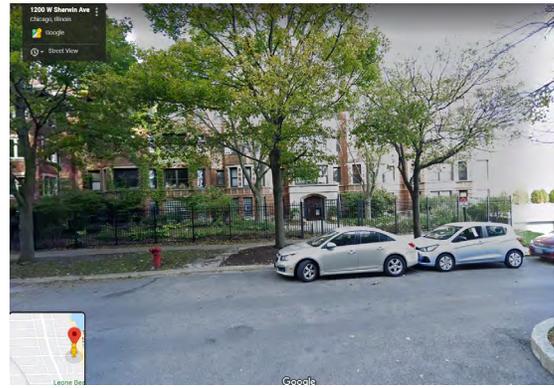
Structural Vulnerability	5	Structure Type	Bearing wall / Cast in place concrete
Building Evac. Plan	No	Cladding Type	Precast concrete / Masonry
Flood Access Impact	No	# of Egress Impacted	0
Min. 50% Assistance	No	Elevator Termination	Unknown
Occupancy Notes	None		
Building Construction	Underground parking garage with terrace roof was constructed in 2006.		
Flooding Impact History	Multiple events in the past year. Street drains into underground parking. 1/11/20 storm caused major flooding, 8ft of water; damage (\$75,000 and damage to 3 cars) to enclosed parking due its location being below grade and the lake water level. The sump pumps were overwhelmed and flood level reached several feet above parking floor slab. Various locations of 2" standing water. No structural damage. Minor erosion of lake front. Trench drain currently full and not draining. Parking lot currently has water. Trench drain in front of garage full and not draining.

Systems Vulnerability	5
Building System Notes	All major MEPFP equipment (electrical service/panels, boilers/water heaters, pumps, gas meter, fire alarm panel) in main building or parking garage below grade at risk of flood damage. Flood protection limited to triplex sump pump(s) at garage level. Recent \$75,000 flood damage to parking garage including mech/electrical equipment (sump pumps could not keep up).

Coastal Vulnerability	3	O&M Shore Protection	No
Wave Overtopping	Yes	Foundation Type	Concrete Wall
Shore Protection	Concrete seawall	Crest Over Shore Protection	4 - 6 feet above grade
Shore Protection Notes	Significant shoreline erosion. Unprotected sand shore eroded away. 150' concrete seawall 5' high. Water within 5' of concrete wall.

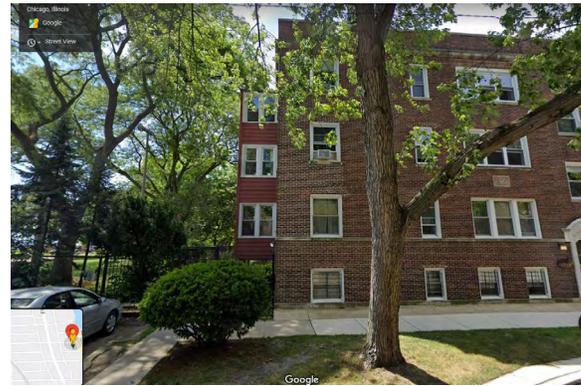
Structural Vulnerability	1	Structure Type	Masonry bearing wall
Building Evac. Plan	No	Cladding Type	Masonry
Flood Access Impact	No	# of Egress Impacted	Unknown
Min. 50% Assistance	Unknown	Elevator Termination	Unknown
Occupancy Notes	None		
Building Construction	None		
Flooding Impact History	No flooding.

Systems Vulnerability	3
Building System Notes	All MEP equipment (electrical service/panels, AHUs, boilers/water heaters, pumps) below grade potentially at risk of flood damage.

Coastal Vulnerability	3	O&M Shore Protection	Unknown
Wave Overtopping	Unknown	Foundation Type	Concrete Wall
Shore Protection	None	Crest Over Shore Protection	Unknown
Shore Protection Notes	Right of way protected by steel piles east-west 5' high. North-South concrete seawall.

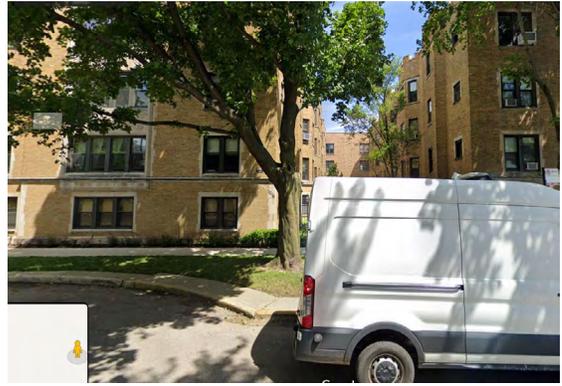
Structural Vulnerability	4	Structure Type	Bearing wall
Building Evac. Plan	No	Cladding Type	Masonry
Flood Access Impact	No	# of Egress Impacted	Unknown
Min. 50% Assistance	No	Elevator Termination	Unknown
Occupancy Notes	None		
Building Construction	North exterior wall was completely rebuilt following storm damage in 1987.		
Flooding Impact History	Experienced significant flooding in late 1980s; structures to mitigate waves and jersey barriers near building. On 1/11/2020 Residents took temporary measures to prevent flooding in garden units and soil washout. Some seepage occurred through service door going into water tank room.

Coastal Vulnerability	2	O&M Shore Protection	Unknown
Wave Overtopping	Unknown	Foundation Type	Concrete Wall
Shore Protection	Rubble mound w/ sheet pile wall	Crest Over Shore Protection	Unknown
Shore Protection Notes	70 ft setback from lake. Rubble mound 2' wide. 2-layer concrete seawall west of seawall. Sheet pile wall with fence attached to top. 60' between seawalls. 2' high concrete walls installed in late 80's to address flooding. Water got to building during Jan 11 storm.

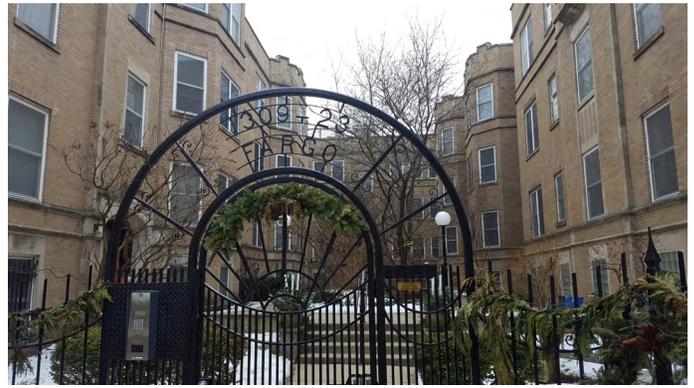
Structural Vulnerability	4	Structure Type	Masonry bearing wall
Building Evac. Plan	No	Cladding Type	Masonry
Flood Access Impact	Yes	# of Egress Impacted	4
Min. 50% Assistance	Unable to answer	Elevator Termination	Unknown
Occupancy Notes	None		
Building Construction	None		
Flooding Impact History	No previous flooding. On 1/11/20 flooding noted. Some seepage in mechanical room but no structural damage. Water came up to units during Jan 11th storm.

Coastal Vulnerability	4	O&M Shore Protection	Unknown
Wave Overtopping	Yes	Foundation Type	Concrete Wall
Shore Protection	Steel Sheet bulkhead	Crest Over Shore Protection	Unknown
Shore Protection Notes	Building set back 70 ft from lake. 2' sand beach. Steel sheet pile. Concrete seawall in poor condition. No weephole or outlet for storm water.

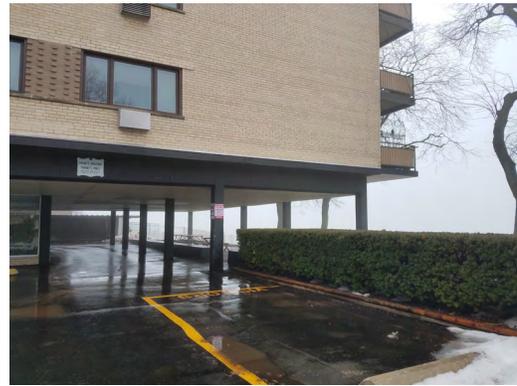
Structural Vulnerability	2	Structure Type	Cast in place concrete
Building Evac. Plan	Yes	Cladding Type	Masonry
Flood Access Impact	No	# of Egress Impacted	2
Min. 50% Assistance	Unable to answer	Elevator Termination	At grade
Occupancy Notes	1st floor lobby, mechanical and laundry room - 2nd thru 5th floor residential.		
Building Construction	None		
Flooding Impact History	Beach waterfront has eroded. Past storm events: water has washed up to front of building, but not entered. Site and adjoining walls are settling due to continuous erosion. A concrete retaining wall protects property, but being breached frequently.

Coastal Vulnerability	4	O&M Shore Protection	No
Wave Overtopping	Yes	Foundation Type	Pile Foundation
Shore Protection	Concrete seawall	Crest Over Shore Protection	Crest is below grade
Shore Protection Notes	Stepped concrete seawall. Three levels visible. Lowest level of concrete seawall is below water by approximately 6 inches. Building manager indicated waves from the north wash over neighboring property and into their property.

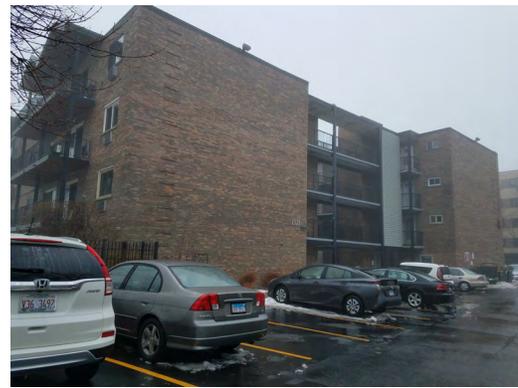
Structural Vulnerability	1	Structure Type	Bearing wall
Building Evac. Plan	Yes	Cladding Type	Masonry
Flood Access Impact	No	# of Egress Impacted	0
Min. 50% Assistance	No	Elevator Termination	At grade
Occupancy Notes	Condo building.		
Building Construction	None		
Flooding Impact History	Water washes up to doorways but has not entered the building. Two concrete retaining walls help protect property.

Coastal Vulnerability	4	O&M Shore Protection	No
Wave Overtopping	Yes	Foundation Type	Slab on Grade
Shore Protection	Concrete seawall	Crest Over Shore Protection	2 - 4 feet above grade
Shore Protection Notes	Rubblemound in front of concrete seawall has been washed away in some locations. Seawall installed approximately 40 years ago.

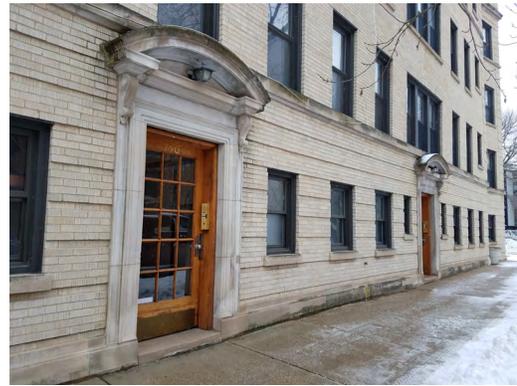
Structural Vulnerability	2	Structure Type	Bearing wall
Building Evac. Plan	Yes	Cladding Type	Masonry
Flood Access Impact	No	# of Egress Impacted	0
Min. 50% Assistance	No	Elevator Termination	Unknown
Occupancy Notes	None		
Building Construction	None		
Flooding Impact History	No flooding. East side of complex protected by adjacent building.

Coastal Vulnerability	2	O&M Shore Protection	No
Wave Overtopping	Yes	Foundation Type	Concrete Wall
Shore Protection	Rubblemound armor stone revetment	Crest Over Shore Protection	Crest is below grade
Shore Protection Notes	Rubblemound is directly adjacent to concrete walkway approximately 7' wide with north building face on other side of walk. Concrete blocks directly adjacent to property that may be owned by the park neighboring the property show clear signs of shifting with erosion occurring behind blocks. Concrete pathway/patio show signs of overtopping. Visible manhole in pathway directly adjacent to shoreline protection could indicate a potential storm outfall not visible.

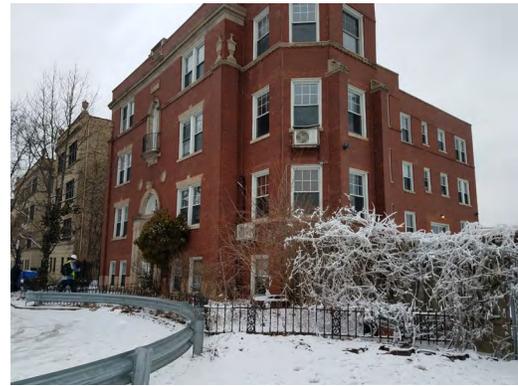
Structural Vulnerability	2	Structure Type	Bearing wall / Light framing
Building Evac. Plan	Yes	Cladding Type	Masonry
Flood Access Impact	No	# of Egress Impacted	1
Min. 50% Assistance	No	Elevator Termination	Unknown
Occupancy Notes	None		
Building Construction	Building construction appears quite robust. Masonry, mortar, doors, and windows withstood the elements quite well. North exterior wall at garage has masonry fractures and is bulging outward.		
Flooding Impact History	Property faces lake with high level of exposure. Lakefront flooding is eroding site and beachfront areas. On 1/11/20 damage to barrier fence and gates occurred. Minor water seepage into the basement utility room from an east-facing door.

Coastal Vulnerability	2	O&M Shore Protection	Unknown
Wave Overtopping	Unknown	Foundation Type	Concrete Wall
Shore Protection	Rubble mound w/ concrete wall	Crest Over Shore Protection	Unknown
Shore Protection Notes	Lakefront along building on two sides. Concrete wall on east side of building only. Rubblemound on both sides. Management indicated north side rubblemound was installed a month ago. East side of property has a 4 foot high wall with outdoor lawn/patio that has wave overtopping up to entry doors leaving behind sand and ice. Patio area drains through wall scupper back to lake.

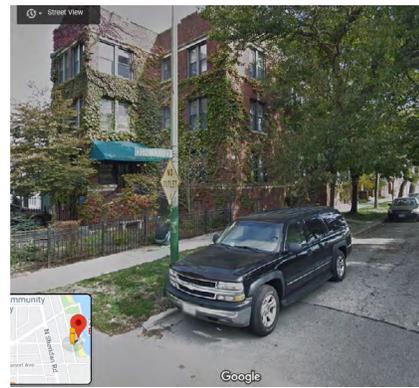
Structural Vulnerability	4	Structure Type	Bearing wall / Cast in place concrete / Light framing
Building Evac. Plan	No	Cladding Type	Masonry
Flood Access Impact	Unknown	# of Egress Impacted	1 to 3
Min. 50% Assistance	No	Elevator Termination	Unknown
Occupancy Notes	All rental units.		
Building Construction	Back entries to apartment units are unusable when areaway access get flooded at ground level. East foundation wall at window is fractured below glass block window. North porch egress would be obstructed by flooding		
Flooding Impact History	Previous flooding, typically one per year. Multiple events in the past year. 1/11/20 East basement door blown out by lake water. East foundation wall features ice built up. Large crack in east concrete foundation wall. Section of concrete foundation wall under glass block window washed away. East access door to Lakefront terrace blown out. Flood water levels reach west exterior porch.

Coastal Vulnerability	3	O&M Shore Protection	No
Wave Overtopping	Yes	Foundation Type	Masonry Wall
Shore Protection	Steel Sheet bulkhead	Crest Over Shore Protection	0 - 2 feet above grade
Shore Protection Notes	Large steel sheet pile 30x30 with assumed concrete behind sheetpile covered in ice. Due to location and ice cover, unclear damage extent. No shore protection on north edge of building visible.

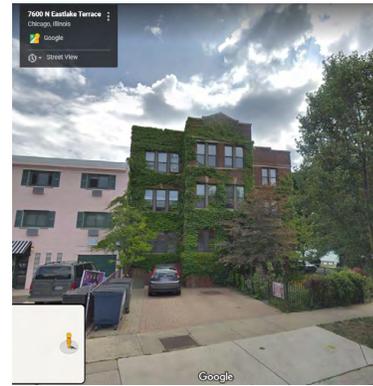
Structural Vulnerability	1	Structure Type	Masonry bearing wall
Building Evac. Plan	No	Cladding Type	Masonry
Flood Access Impact	No	# of Egress Impacted	0
Min. 50% Assistance	No	Elevator Termination	Unknown
Occupancy Notes	None		
Building Construction	None		
Flooding Impact History	Original seawall failed during 1/11/20 storm. Owner trying to make repairs.

Systems Vulnerability	3
Building System Notes	Minor MEP equipment (electric water heaters with no concrete pad, electric baseboard) on grade. Electric baseboard at entrance poses egress electrocution hazard. Utility transformer is padpoint on lake side; electrical service 24" above grade. All-electric building with limited common spaces on grade and some resident units on grade.

Coastal Vulnerability	3	O&M Shore Protection	No
Wave Overtopping	Yes	Foundation Type	Concrete Wall
Shore Protection	Steel Sheet bulkhead	Crest Over Shore Protection	Crest is below grade
Shore Protection Notes	Steel sheet piles No visible stone. 2' high concrete seawall 10' from steel sheet pile. Seawall failure noted. Bathometric survey conducted 6 months ago Building plans to build an addition. Put on hold until seawall is built.

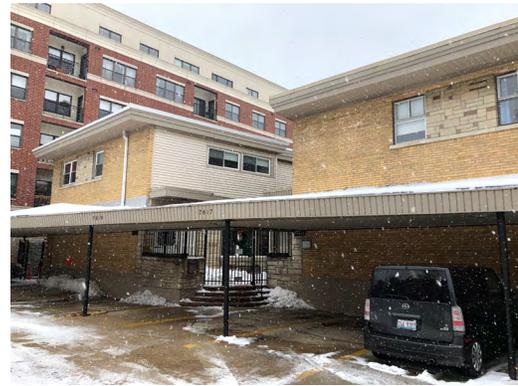
Structural Vulnerability	3	Structure Type	Masonry bearing wall
Building Evac. Plan	Yes	Cladding Type	Masonry
Flood Access Impact	Yes	# of Egress Impacted	1
Min. 50% Assistance	No	Elevator Termination	Unknown
Occupancy Notes	Condo units		
Building Construction	Exterior wall is covered with plywood. Unable to gain entry to verify interior conditions		
Flooding Impact History	Previous flooding, one event in the last year.

Coastal Vulnerability	3	O&M Shore Protection	No
Wave Overtopping	Yes	Foundation Type	Concrete Wall
Shore Protection	Steel Sheet bulkhead	Crest Over Shore Protection	Crest is below grade
Shore Protection Notes	Minor damage to shore protection visible in snow. Clearly sheetpile with approximately 12' concrete backing up to it. Most likely attached to structure foundation. Chainlink fence along perimeter of sheetpile, severely damaged. Clear signs of overtopping reaching individual condo unit doors and windows. Overtopping waves leaving behind debris, sand, and ice.

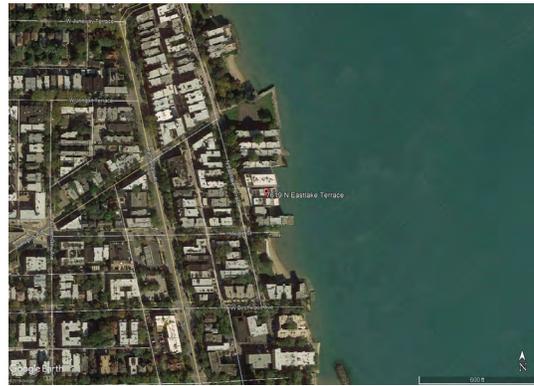
Structural Vulnerability	3	Structure Type	Bearing wall
Building Evac. Plan	No	Cladding Type	Masonry
Flood Access Impact	No	# of Egress Impacted	1
Min. 50% Assistance	No	Elevator Termination	Unknown
Occupancy Notes	None		
Building Construction	Building's exterior walls show no structural damage at time of inspection. Unit F north deck has been removed, exterior door has 2x4 installed obstructing egress. Unable to gain entry to verify seepage in basement. See adjacent property notes for 7617 N Eastlake Terrace.		
Flooding Impact History	Previous flooding, one event in the last year.

Coastal Vulnerability	3	O&M Shore Protection	Unknown
Wave Overtopping	Unknown	Foundation Type	Unknown
Shore Protection	Unknown	Crest Over Shore Protection	Unknown
Shore Protection Notes	None

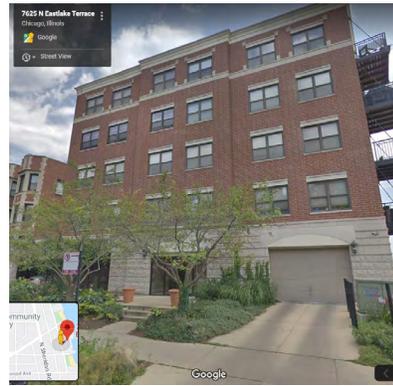
Structural Vulnerability	2	Structure Type	Cast in place concrete
Building Evac. Plan	Yes	Cladding Type	Masonry
Flood Access Impact	No	# of Egress Impacted	Unknown
Min. 50% Assistance	No	Elevator Termination	At grade
Occupancy Notes	Condo units. Mixed demographic.		
Building Construction	Garage areas are below grade.		
Flooding Impact History	Previous flooding, typically one per year. Multiple events in the past year. Cracks in east water front concrete terrace. Water seepage at west side of garage from floor slab (about 12 feet below grade) and south foundation wall. Exterior wall at east has repairs made at bottom.

Systems Vulnerability	3
Building System Notes	Minor MEP equipment (water heating) below grade. Lakeside louvers for lower garage 24" above grade 6' from lake; lower garage well below grade. RTU above garage leaks into upper garage ductwork when wave spray hits it. Pad-mount transformer on street side; electrical service at grade.

Coastal Vulnerability	3	O&M Shore Protection	No
Wave Overtopping	Yes	Foundation Type	Concrete Wall
Shore Protection	Concrete seawall	Crest Over Shore Protection	Crest is below grade
Shore Protection Notes	Multi-level concrete wall second level not visible at time of visit. Concrete seawall is only shoreline protection. Building management indicated there is cracking on the front of wall which is only visible from the lake side. Concrete seawall frozen ice. Spray reaches up to second level balconies.

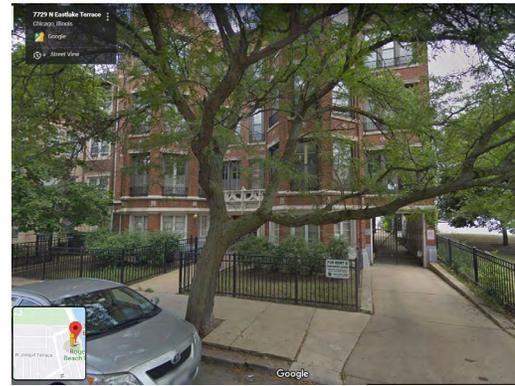
Structural Vulnerability	2	Structure Type	Bearing wall
Building Evac. Plan	Yes	Cladding Type	Masonry
Flood Access Impact	No	# of Egress Impacted	1
Min. 50% Assistance	No	Elevator Termination	Unknown
Occupancy Notes	6 unit building. Gutted for remodel. Currently vacant building. Property currently undergoing renovations. No occupants.		
Building Construction	None		
Flooding Impact History	Previous and 1/11/20 flooding noted.

Coastal Vulnerability	3	O&M Shore Protection	No
Wave Overtopping	Yes	Foundation Type	Masonry / Concrete wall
Shore Protection	Rubblemound armor stone revetment	Crest Over Shore Protection	Crest is below grade
Shore Protection Notes	Rubblemound surrounding two sides of property. Rubblemound directly adjacent to garage wall/foundation and concrete driveway.

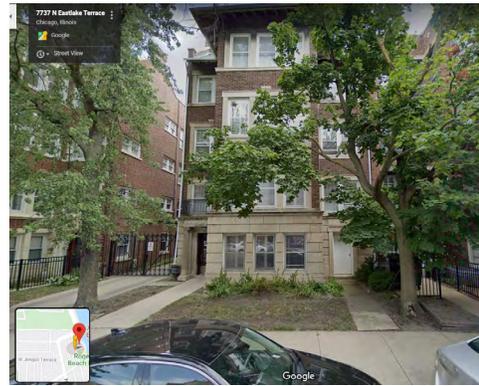
Structural Vulnerability	2	Structure Type	Heavy timber / Bearing wall
Building Evac. Plan	Yes	Cladding Type	Masonry
Flood Access Impact	No	# of Egress Impacted	1
Min. 50% Assistance	No	Elevator Termination	Unknown
Occupancy Notes	Rental unit.		
Building Construction	Exterior damage to concrete drive and patio area. Unable to determine structure under drive/patio at shoreline. Rock break wall installed in front of drive/patio area. Damage to east metal fence at shoreline.		
Flooding Impact History	Previous flooding, one event in the last year.

Coastal Vulnerability	3	O&M Shore Protection	No
Wave Overtopping	Yes	Foundation Type	Masonry Wall
Shore Protection	Rubblemound armor stone revetment	Crest Over Shore Protection	Crest is below grade
Shore Protection Notes	Rubblemound stone is directly adjacent to concrete parking area. Unclear if shore protection, concrete patio, and foundation are connected. Assumed shore protection is rubblemound only that is directly adjacent to concrete patio. Building connected to building next door. Visible cracking in wall from wave damage.

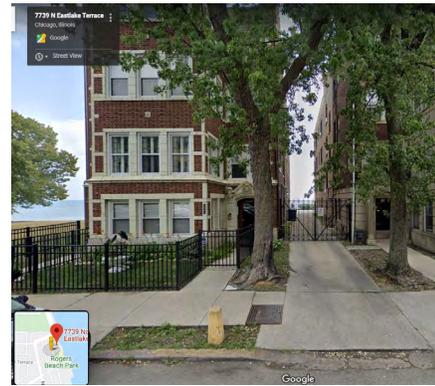
Structural Vulnerability	2	Structure Type	Light framing structure
Building Evac. Plan	Unknown	Cladding Type	Masonry
Flood Access Impact	No	# of Egress Impacted	1
Min. 50% Assistance	Unknown	Elevator Termination	Unknown
Occupancy Notes	None		
Building Construction	Lower level unoccupied boathouse below parking garage flooded with severe damage to north foundation wall and footing. Footing no longer bearing on soil and has separated from the foundation wall. Active Building Department Court Case from November 19 Inspection.		
Flooding Impact History	Previous flooding, multiple events in past year.

Coastal Vulnerability	3	O&M Shore Protection	Unknown
Wave Overtopping	Unknown	Foundation Type	Masonry Wall
Shore Protection	rubble mound with concrete wall	Crest Over Shore Protection	Unknown
Shore Protection Notes	Wave overtopping icing over stone, fence, and patio/parking area. Waves have broken patio fence. Boathouse beneath building now inaccessible.

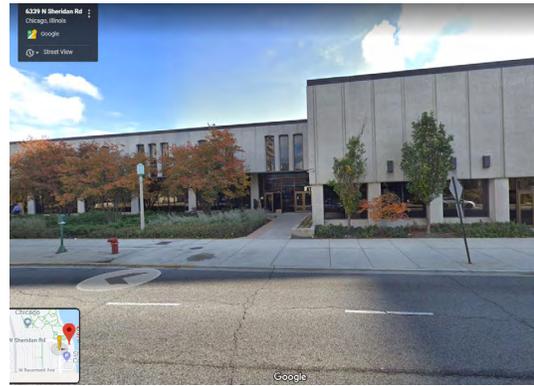
Structural Vulnerability	1	Structure Type	Unknown
Building Evac. Plan	Yes	Cladding Type	Precast concrete
Flood Access Impact	No	# of Egress Impacted	Unknown
Min. 50% Assistance	No	Elevator Termination	Unknown
Occupancy Notes	Sullivan Center for Student Services. Occupancy is administration offices and storage in lower level; one auditorium and classrooms.		
Building Construction	None		
Flooding Impact History	No flooding. Some past groundwater seepage lower level. Has basement, no past history of flooding, some past groundwater seepage lower level.

Coastal Vulnerability	4	O&M Shore Protection	No
Wave Overtopping	Yes	Foundation Type	Not discernable
Shore Protection	Unknown	Crest Over Shore Protection	Unknown
Shore Protection Notes	The vegetation along the east edge of the Sullivan Center is also bent backward away from the lake.

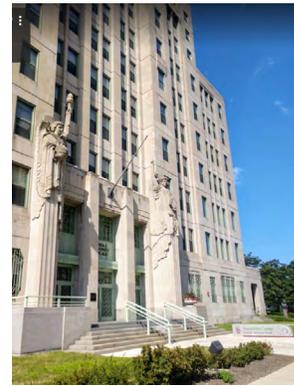
Structural Vulnerability	1	Structure Type	Cast in place concrete
Building Evac. Plan	Yes	Cladding Type	Masonry
Flood Access Impact	No	# of Egress Impacted	Unknown
Min. 50% Assistance	Unable to answer	Elevator Termination	At grade
Occupancy Notes	Performing arts center and educational facility		
Building Construction	Historic Building. Foundation drain system feeds into former boiler room and was installed sometime during renovations in mid 2000's. Connected to pumps on power- loss of power could create secondary hazard of flooding in mechanical room. Even with system in place water seeping into mech room at anchors in concrete.		
Flooding Impact History	Past flooding from groundwater and sewage backups. Lower mechanical level was raised up around 3 feet around year 07.

Coastal Vulnerability		O&M Shore Protection	No
Wave Overtopping	Yes	Foundation Type	Not discernable
Shore Protection	Unknown	Crest Over Shore Protection	Unknown
Shore Protection Notes	None

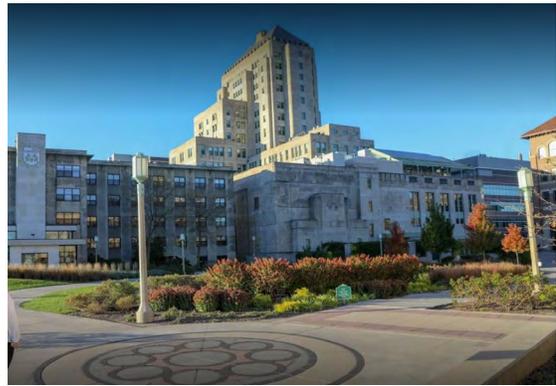
Structural Vulnerability	1	Structure Type	Cast in place concrete
Building Evac. Plan	Yes	Cladding Type	Masonry
Flood Access Impact	No	# of Egress Impacted	Unknown
Min. 50% Assistance	Unknown	Elevator Termination	Unknown
Occupancy Notes	None		
Building Construction	Site consists of 2 buildings. Piper is an historic home, on the register of historic places. Coffey is newer, built for dormitories and later converted to office/classroom space. Large glass windows at first floor face toward lake, raised about 3' from ground level.		
Flooding Impact History	Past flooding from sewer backup at lower level. Some past groundwater intrusion in lower level mechanical area.

Coastal Vulnerability		O&M Shore Protection	No
Wave Overtopping	Yes	Foundation Type	Not discernable
Shore Protection	Unknown	Crest Over Shore Protection	Unknown
Shore Protection Notes	East of Coffey Hall: At northeast corner of Coffey Hall, the sheetpile terminates and switches to concrete seawall going south. The concrete seawall is spalling and rebar is showing. There is sand on the bottom rail along the seawall. At the rain gardens along the lake, there is sand, some minor erosion and the vegetation is bent backward away from the lake.

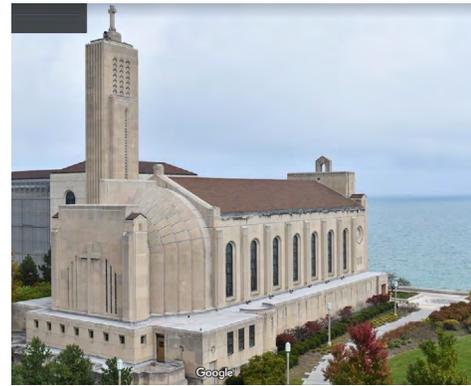
Structural Vulnerability	1	Structure Type	Cast in place concrete
Building Evac. Plan	Unknown	Cladding Type	Masonry
Flood Access Impact	Yes	# of Egress Impacted	1
Min. 50% Assistance	No	Elevator Termination	Unknown
Occupancy Notes	Loyola Chapel		
Building Construction	Historic Building. No history of flooding, but front door faces lake, potential in a more dramatic storm event for waves to prohibit access to the front door. Basement floor is unfinished sand.		
Flooding Impact History	No flooding.

Coastal Vulnerability		O&M Shore Protection	No
Wave Overtopping	Yes	Foundation Type	Not discernable
Shore Protection	Unknown	Crest Over Shore Protection	Unknown
Shore Protection Notes	None

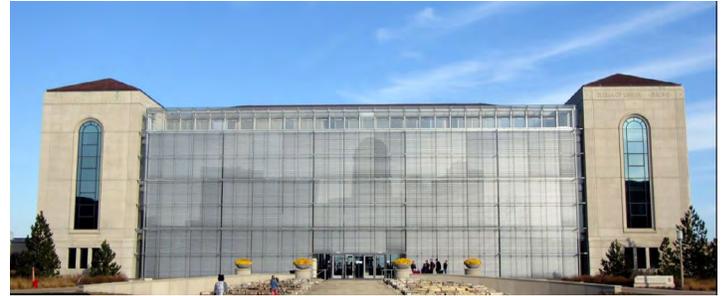
Structural Vulnerability	1	Structure Type	Cast in place concrete / Structural steel
Building Evac. Plan	Unknown	Cladding Type	Glass curtain wall
Flood Access Impact	No	# of Egress Impacted	1
Min. 50% Assistance	No	Elevator Termination	At grade
Occupancy Notes	Several offices, electronic study/library, cafe		
Building Construction	Operable panels are fritted with motors at mullions line beneath. They are similar to doors- and are made to open, so they leak. Ground floor is raised access floor-leaks would not be visible. Entire east side is curtain wall. Connected to natural air automated systems (LEED), contributes to water infiltration and wear on gaskets/seals.		
Flooding Impact History	No flooding. Potential for water intrusion at east glass face during driving rain events.

Coastal Vulnerability		O&M Shore Protection	No
Wave Overtopping	Yes	Foundation Type	Not discernable
Shore Protection	Unknown	Crest Over Shore Protection	Unknown
Shore Protection Notes	East of Loyola Commons: Washed up dock on top of rocks.

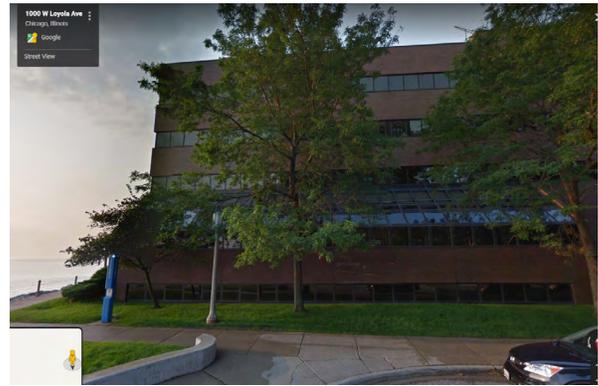
Structural Vulnerability	1	Structure Type	Cast in place concrete
Building Evac. Plan	Unknown	Cladding Type	Masonry
Flood Access Impact	No	# of Egress Impacted	1
Min. 50% Assistance	No	Elevator Termination	At grade
Occupancy Notes	Crown Hall Loyola. Occupancy is office and lecture halls.		
Building Construction	None		
Flooding Impact History	No previous flooding. Endures a lot of weather-dependent damage from driving wind and rain. No flooding from lake.

Coastal Vulnerability	5	O&M Shore Protection	No
Wave Overtopping	Yes	Foundation Type	Not discernable
Shore Protection	Unknown	Crest Over Shore Protection	Unknown
Shore Protection Notes	East of Crown Center: Sand on paved walkway behind sheetpile and on top of revetment stone.

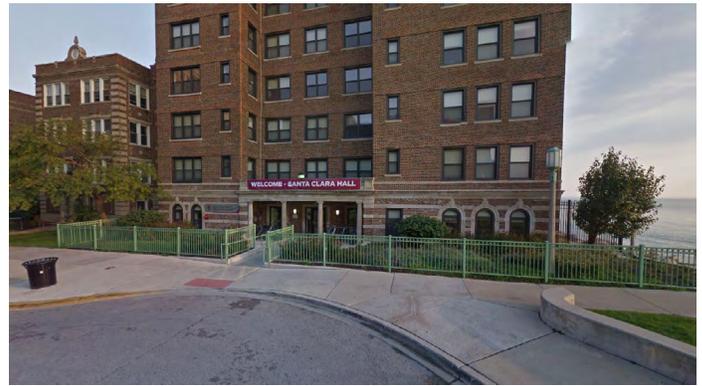
Structural Vulnerability	4	Structure Type	Cast in place concrete
Building Evac. Plan	Yes	Cladding Type	Masonry
Flood Access Impact	Yes	# of Egress Impacted	2
Min. 50% Assistance	No	Elevator Termination	At grade
Occupancy Notes	Santa Clara Hall (Dormitory) Loyola. Occupied by students, mix of professors and other professionals		
Building Construction	Courtyard building with point-loaded entrances.		
Flooding Impact History	No previous flooding. Street floods from sewer clogs, water flows towards front door. Evidence of sand in windows at ground floor common spaces. Sand in sills and screens indicating waves crashing up to windows. Lower pit level in Mech room was filling with water, no drain. Alley was inaccessible during 1/11/20 flooding. Water enters the mechanical louvers on the building, east face, northeast corner, from wave action. Water enters south doors via overland flow path at curb cut off of the public street. Loyola uses sandbags to limit water entry.

Systems Vulnerability	5
Building System Notes	All/most MEPFP equipment below grade potentially at risk of flood damage. Electrical service and/or electrical panels is below grade. Heating boilers and hydronic pumps are in the basement. Chiller and MAU are on the roof. Louvers are low above grade exposed to the lake. Electrical service and/or electrical panels is below grade. Emergency Generator is below grade, and louvers are low, exposed to the Lake. DWHs and Booster pumps are in the Basement. Flood protection limited to sump pump(s) at lowest level. Fire Pump is at grade. Fire Alarm Panel is above grade.

Coastal Vulnerability	5	O&M Shore Protection	No
Wave Overtopping	Yes	Foundation Type	Not discernable
Shore Protection	Unknown	Crest Over Shore Protection	Unknown
Shore Protection Notes	Major damage at alley north of Santa Clara Hall. At Santa Clara Hall - facilities indicated ice was built up on the metal fence to the east of the building, sand buildup on pavement at east side of building and at first floor windows, sandbagging of south door. Alley to north of Santa Clara Hall - collapsed public alley north of the building. At east end of Loyola Avenue right of way, there were two concrete benches that were displaced by waves and have since been reinstalled.

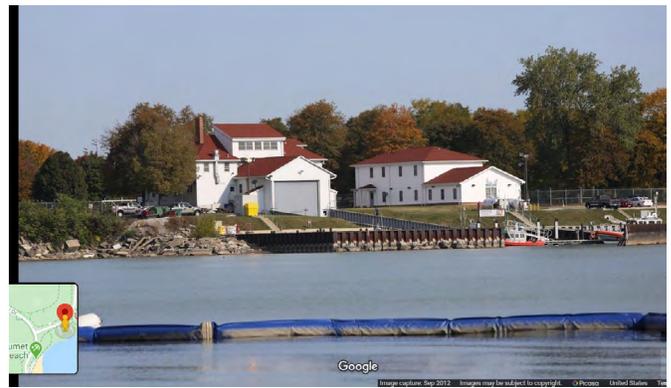
Structural Vulnerability	5	Structure Type	Light framing structure
Building Evac. Plan	No	Cladding Type	Siding
Flood Access Impact	No	# of Egress Impacted	Unknown
Min. 50% Assistance	No	Elevator Termination	Unknown
Occupancy Notes	Jackson Harbor Station. 9 employees on regular basis park district office		
Building Construction	Originally built as emergency/fire response before Coast Guard, then WestRec, then CPD within past 4 years. Built with rooms for overnight stays with kitchens, etc.		
Flooding Impact History	Flooding noted on 1/11/20.

Coastal Vulnerability	4	O&M Shore Protection	Unknown
Wave Overtopping	Unknown	Foundation Type	Unknown
Shore Protection	Unknown	Crest Over Shore Protection	Unknown
Shore Protection Notes	None

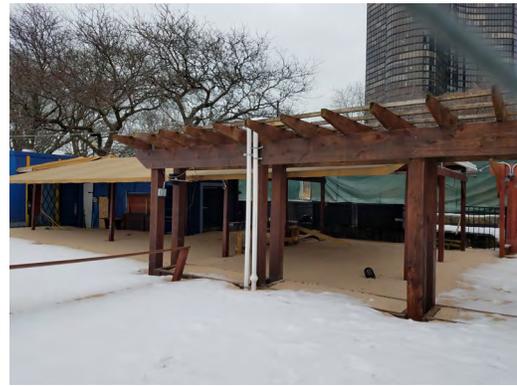
Structural Vulnerability	3	Structure Type	Unknown
Building Evac. Plan	Unknown	Cladding Type	Unknown
Flood Access Impact	Unknown	# of Egress Impacted	Unknown
Min. 50% Assistance	Unknown	Elevator Termination	Unknown
Occupancy Notes	None		
Building Construction	None		
Flooding Impact History	Unknown

Coastal Vulnerability	3	O&M Shore Protection	Unknown
Wave Overtopping	Unknown	Foundation Type	Slab on Grade
Shore Protection	None	Crest Over Shore Protection	Unknown
Shore Protection Notes	Sand Beach.

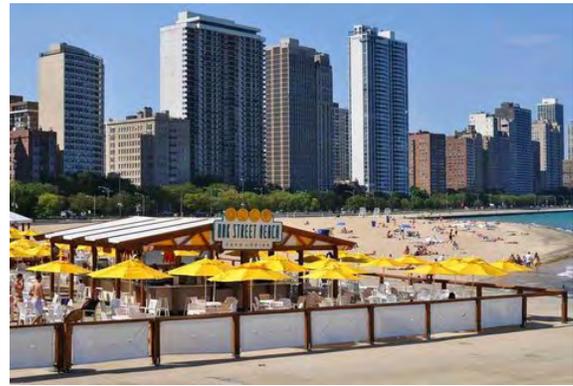
Structural Vulnerability	3	Structure Type	Light framing structure
Building Evac. Plan	Yes	Cladding Type	Siding
Flood Access Impact	No	# of Egress Impacted	Unknown
Min. 50% Assistance	No	Elevator Termination	Unknown
Occupancy Notes	Unoccupied structure. Seasonal summer use. Gazebo concession structure and patio.		
Building Construction	Light framed wood structure. Rotting at framing base due to water damage. Stair railings and protective barriers that were destroyed from storm has made area unsafe and will require repairs.		
Flooding Impact History	Previous flooding. Multiple events in past year.

Systems Vulnerability	4
Building System Notes	All plumbing and kitchen equipment is in portable trailers removed for winter. Grade connections to domestic and sanitary for temporary restaurant building and portable kitchen and restroom trailers have been damaged, including freestanding electrical panel knocked down.

Coastal Vulnerability	2	O&M Shore Protection	Unknown
Wave Overtopping	Unknown	Foundation Type	Unknown
Shore Protection	Unknown	Crest Over Shore Protection	Unknown
Shore Protection Notes	None

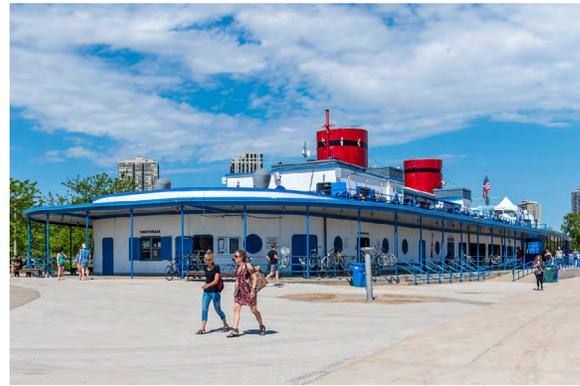
Structural Vulnerability	3	Structure Type	Light framing structure
Building Evac. Plan	Yes	Cladding Type	Siding
Flood Access Impact	No	# of Egress Impacted	0
Min. 50% Assistance	No	Elevator Termination	Unknown
Occupancy Notes	Unoccupied structure. Seasonal summer use. Complex of multiple light framed seasonal concession and restrooms facilities.		
Building Construction	None		
Flooding Impact History	Previous flooding. One event in past year.

Coastal Vulnerability	4	O&M Shore Protection	Unknown
Wave Overtopping	Unknown	Foundation Type	Slab on Grade
Shore Protection	None	Crest Over Shore Protection	Unknown
Shore Protection Notes	Sand beach only.

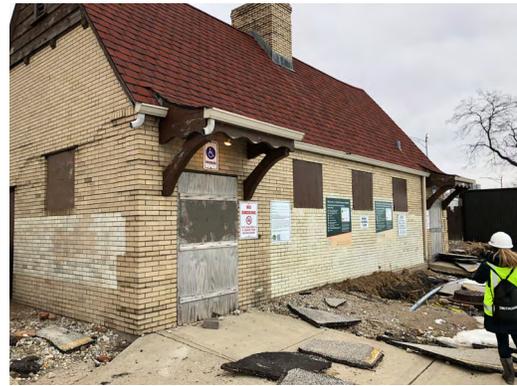
Structural Vulnerability	2	Structure Type	Bearing wall
Building Evac. Plan	Yes	Cladding Type	Masonry
Flood Access Impact	Yes	# of Egress Impacted	0
Min. 50% Assistance	Unable to answer	Elevator Termination	Unknown
Occupancy Notes	Unoccupied structure. Public Restroom facility used during summer.		
Building Construction	Historic building owned by Park District.		
Flooding Impact History	Previous flooding noted.

Coastal Vulnerability	4	O&M Shore Protection	No
Wave Overtopping	Yes	Foundation Type	Slab on Grade
Shore Protection	Concrete seawall	Crest Over Shore Protection	0 - 2 feet above grade
Shore Protection Notes	Building directly adjacent to lakeshore walking path with concrete seawall.

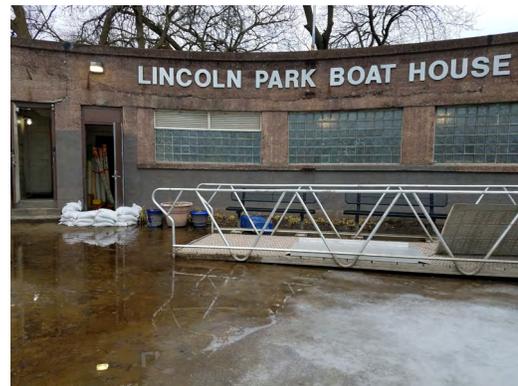
Structural Vulnerability	4	Structure Type	Cast in place concrete
Building Evac. Plan	Yes	Cladding Type	Cast in place concrete
Flood Access Impact	Yes	# of Egress Impacted	2
Min. 50% Assistance	Unable to answer	Elevator Termination	Unknown
Occupancy Notes	Low occupancy / usage		
Building Construction	Historic Building. A new elevated sidewalk was built to permit easier (and drier access into building) in response to last flooding events.		
Flooding Impact History	Previous flooding, multiple events in past year.

Coastal Vulnerability	4	O&M Shore Protection	Unknown
Wave Overtopping	Unknown	Foundation Type	Slab on Grade
Shore Protection	None	Crest Over Shore Protection	Unknown
Shore Protection Notes	No permanent shore protection. Currently using jersey barriers, sand bags and a pump to attempt to keep lagoon water off of concrete apron and building floor. It was indicated that water is coming up through plumbing and sewer connections. The concrete apron in the center of the building is potentially undermined with observed bubbles coming up within 2-4 feet of the building.

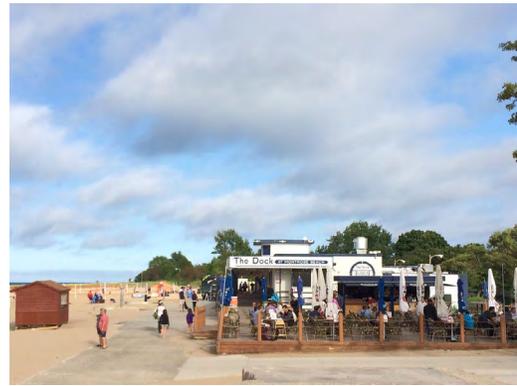
Structural Vulnerability	N/A	Structure Type	Structural steel
Building Evac. Plan	Yes	Cladding Type	Metal panel
Flood Access Impact	No	# of Egress Impacted	0
Min. 50% Assistance	No	Elevator Termination	Unknown
Occupancy Notes	Complex of seasonal concession, storage and patio areas. Unoccupied. Open summer months only.		
Building Construction	Light framing, wood		
Flooding Impact History	No flooding.

Coastal Vulnerability	1	O&M Shore Protection	No
Wave Overtopping	Yes	Foundation Type	Slab on Grade
Shore Protection	Unknown	Crest Over Shore Protection	0 - 2 feet above grade
Shore Protection Notes	Partially vegetated dune, partially sand beach.

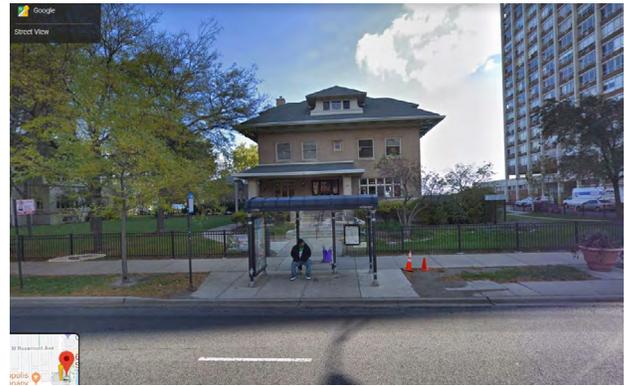
Structural Vulnerability	1	Structure Type	Non-combustible exterior/ Combustible framing
Building Evac. Plan	Yes	Cladding Type	Masonry
Flood Access Impact	No	# of Egress Impacted	Unknown
Min. 50% Assistance	No	Elevator Termination	Unknown
Occupancy Notes	None		
Building Construction	Site consists of 4 different historic structures which have been adapted to community spaces.		
Flooding Impact History	No flooding.

Coastal Vulnerability	3	O&M Shore Protection	No
Wave Overtopping	Yes	Foundation Type	Not discernable
Shore Protection	Rubblemound armor stone revetment	Crest Over Shore Protection	4 - 6 feet above grade
Shore Protection Notes	Public path right-of-way along lake obstructed by waves, sand rock from 1/11/20 event. Thick ice on ground behind revetment. Sand behind revetment. Per interview, revetment stones shifted during the 1/11/20 event, forward toward the lake. Sand and small rocks were washed up onto the path by waves during the 1/11/20 event and this has since been cleaned up.

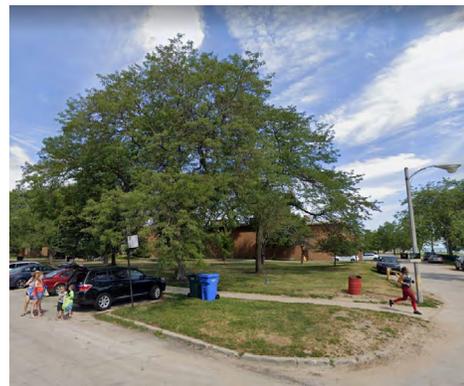
Structural Vulnerability	1	Structure Type	Cast in place concrete
Building Evac. Plan	Yes	Cladding Type	Masonry
Flood Access Impact	No	# of Egress Impacted	0
Min. 50% Assistance	No	Elevator Termination	Unknown
Occupancy Notes	Loyola Park Recreation Center. Fieldhouse and concession and toilet bldg. Large indoor and outdoor recreation and classroom complex.		
Building Construction	None		
Flooding Impact History	No previous flooding. Minor flooding in parking lot. Little to no damage observed. Concession stand has up to 10 inches of sand against walls.

Coastal Vulnerability	3	O&M Shore Protection	Unknown
Wave Overtopping	Unknown	Foundation Type	Slab on Grade
Shore Protection	None - Building setback	Crest Over Shore Protection	Unknown
Shore Protection Notes	Building set back from beach approximately 100 feet. Set back from sand beach that is partially vegetated.

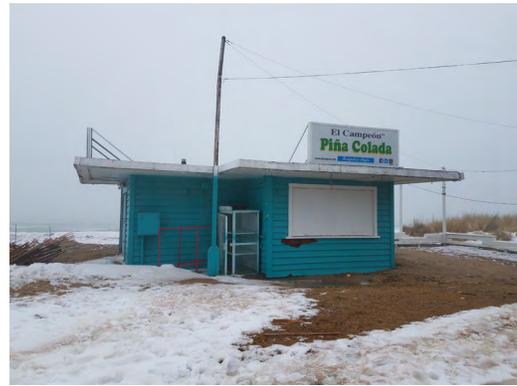
Structural Vulnerability	N/A	Structure Type	Light framing structure
Building Evac. Plan	No	Cladding Type	Siding
Flood Access Impact	Yes	# of Egress Impacted	1
Min. 50% Assistance	No	Elevator Termination	Unknown
Occupancy Notes	Small seasonal concession stand located on beach front.		
Building Construction	Light framed wood structure.		
Flooding Impact History	Previous flooding. One event in past year.

Coastal Vulnerability		O&M Shore Protection	Unknown
Wave Overtopping	Yes	Foundation Type	Slab on Grade
Shore Protection	None	Crest Over Shore Protection	Unknown
Shore Protection Notes	Building directly on sand beach. No vegetation.

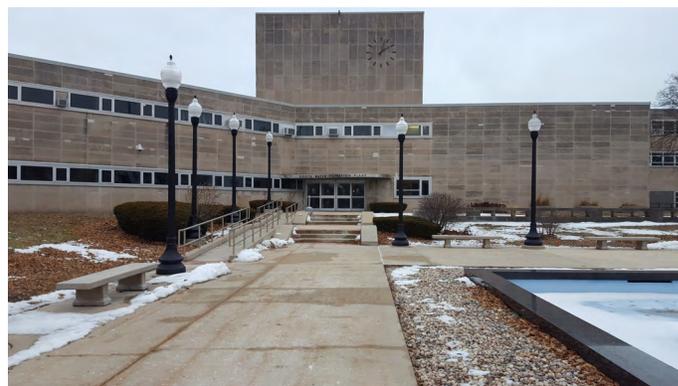
Structural Vulnerability	1	Structure Type	Cast in place concrete
Building Evac. Plan	Yes	Cladding Type	Masonry
Flood Access Impact	Yes	# of Egress Impacted	0
Min. 50% Assistance	No	Elevator Termination	Below grade (basement)
Occupancy Notes	None		
Building Construction	WPP facility is very large w/ many buildings and many floor levels%2C including sub-sub basements and not all equipment types could be confirmed. Only portions of buildings closest to lake were visited.		
Flooding Impact History	Flooding noted on 1/11/20.

Systems Vulnerability	5
Building System Notes	Large/critical facility w/ MEPFP (electrical panels, boilers/water heaters, pumps, gas pressure booster) and process equipment (water treatment & chemical injection) throughout, some approx. -30' below lake level, potentially at risk of flood damage, however facility has flood protection measures (rip-rap, walls, sump pumps). Backup generators w/ redundancy and diesel fuel belly tanks are outside in elevated enclosures. Boilers are dual fuel. Low pressure gas service is being upgraded to medium pressure. Existence and height of equipment housekeeping pads and dikes vary. Limited fire protection (carpenter area, chemical agent for control room)

Coastal Vulnerability	2	O&M Shore Protection	Yes
Wave Overtopping	Yes	Foundation Type	Concrete Wall
Shore Protection	Concrete seawall	Crest Over Shore Protection	2 - 4 feet above grade
Shore Protection Notes	20' of concrete seawall missing, south end of property. Significant erosion 40' from current edge of water. 400' of shore protection is stone or slope wall. 100' of concrete sea wall significantly damaged. Intake wall becomes seawall during intake. Interior wall is in good condition. Lake elevation +3 North side of building has 6' concrete wall and 300' beach. Majority of wall protected by off shore stone break wall. Most damage at southern portion not covered by breakwall. Broken / damaged trees on backslope toward property. Broken, damaged, fencing and shore protection. Rusted steel sheet pile.

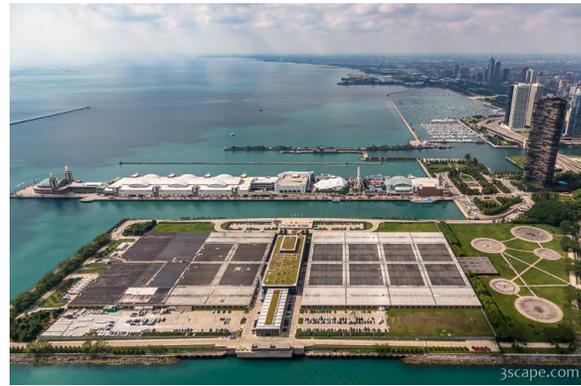
Structural Vulnerability	3	Structure Type	Cast in place concrete
Building Evac. Plan	Yes	Cladding Type	Cast in place concrete w/ misc.
Flood Access Impact	Yes	# of Egress Impacted	Unknown
Min. 50% Assistance	No	Elevator Termination	Below grade (basement)
Occupancy Notes	None		
Building Construction	None		
Flooding Impact History	Previous and 1/11/20 flooding noted.

Systems Vulnerability	5
Building System Notes	Many pumps and panels at various levels, down to -15' from lake level. History of cofferdam failure allowing lake to flood void space below most of the man-made island, filling the -15' space up to the building final walls. Medium-voltage feed concrete-encased from Park east to ComEd vault above grade. New back-up generator plant on grade.

Coastal Vulnerability	3	O&M Shore Protection	No
Wave Overtopping	Yes	Foundation Type	Pile Foundation
Shore Protection	Varied based on location	Crest Over Shore Protection	Crest is below grade
Shore Protection Notes	Earthen cofferdam appears to be approximately 8 feet above current lake level. Concrete seawall approximately 3 feet above lake level. Clear signs of overtopping of earthen cofferdam causing small to large sinkholes behind concrete wall. Eroded earth and lawn along perimeter of earthen cofferdam. Displaced stone from rubblemound in some locations. Observed locations of cracks and breaking concrete wall specifically along transitions between earthen cofferdam and sheetpile bulkhead.
