GII, LLC Explosion

2004542.000

July 16, 2020

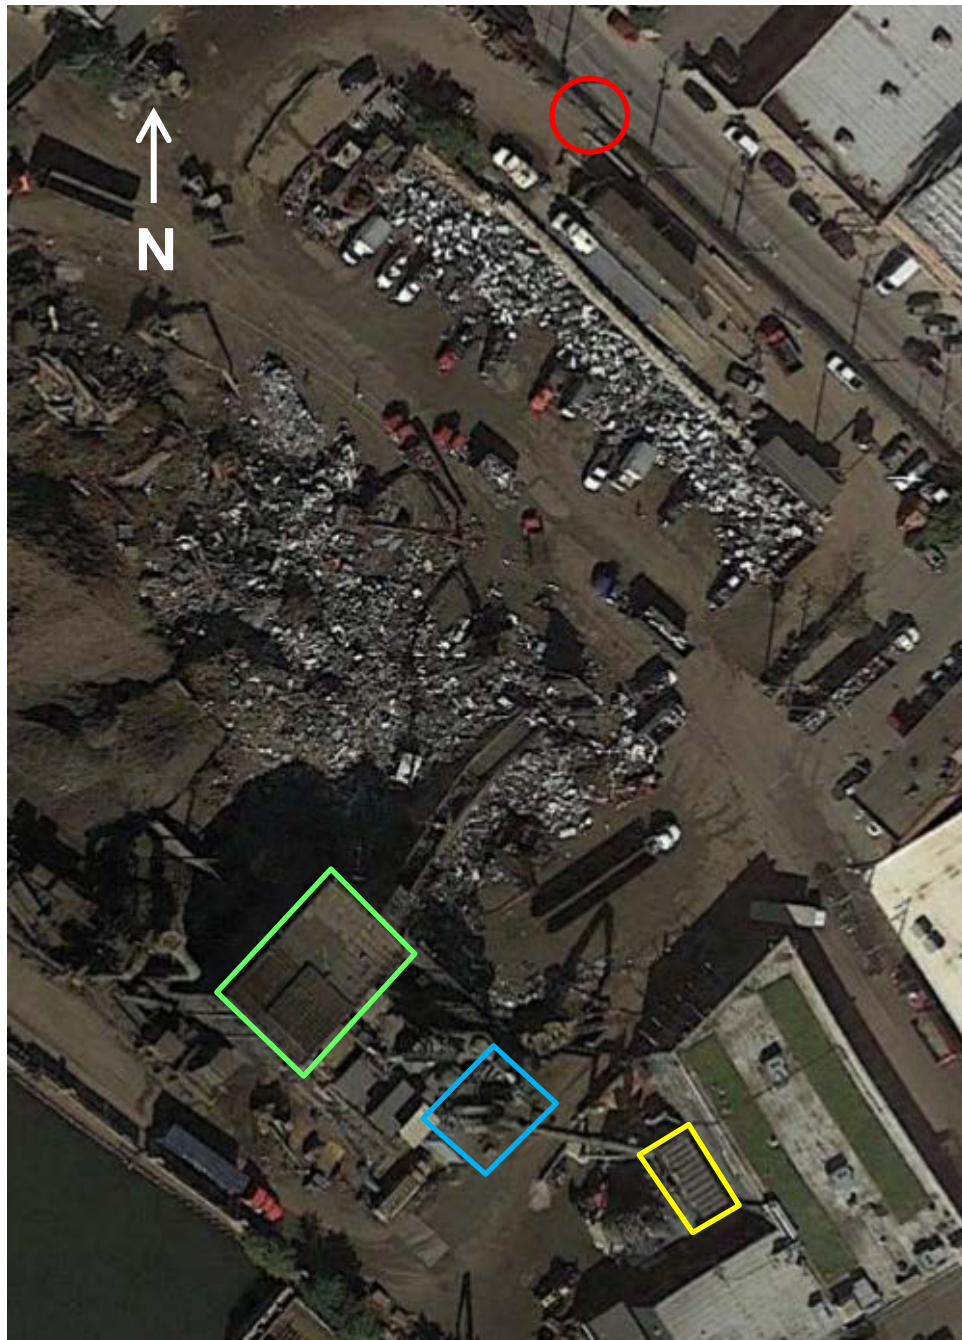
On Monday, May 18, 2020, an explosion occurred at the GII facility causing damage to the RTO, the roll-media filter, the ducting between them, the blower located adjacent to the RTO, and surrounding areas. An aerial view of the facility is shown in Figure 2.

Figure 2. Aerial view of the GII facility with the RTO location outlined in yellow, the filter in blue, and the shredder in green. The approximate camera location related to the video is circled in red.

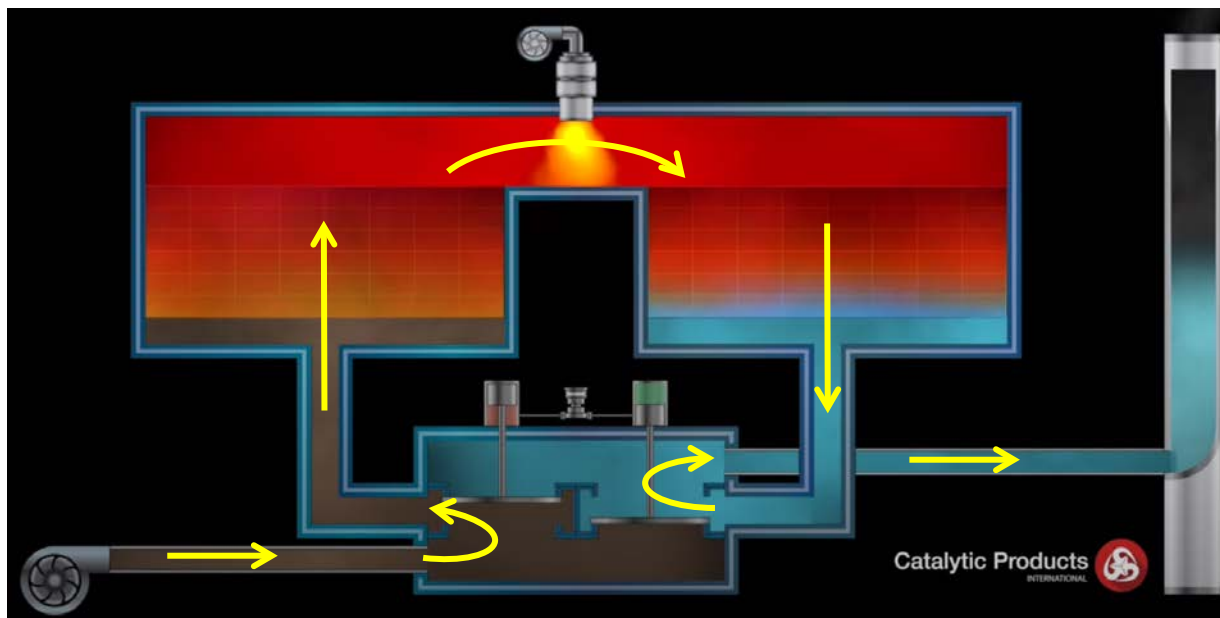
A brief overview of the RTO operation will be helpful to put the following analysis in context. A screenshot from a CPI video is shown in Figure 10 and depicts a simplified diagram of the RTO. The subject RTO contained two burners and two sets of poppet valves instead of the single set of poppet valves shown in the diagram. Based on the observations of damage to the

south poppet valves described above, the configuration shown in Figure 10 was likely the configuration of the subject RTO at the time of the incident (assuming that the left and right sides of Figure 11 correspond to the respective north and south sides of the subject RTO).

Figure 10. Screenshot from a video describing RTO operation on CPI's website. Yellow arrows were added by Exponent to show the flow for the depicted configuration.

Natural gas flow into the RTO from the burner occurred at approximately the half way point for the process flow through the RTO as is shown in Figure 10. This would mean a conservative approximation for the residence time of any unburnt natural gas from the burner would be between 5-17 seconds. This number is still well below the minimum time needed to accumulate the amount of gas calculated above to result in the observed damage to the system.

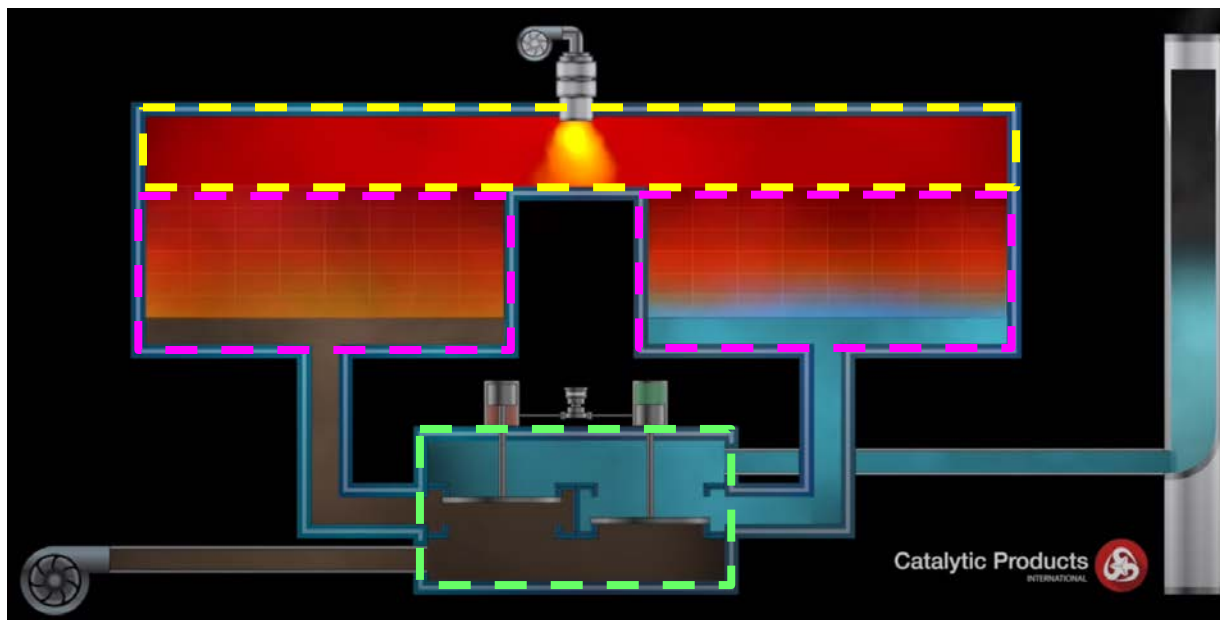
Volumes of various portions of the system were calculated based on provided drawings. Within the RTO, three separate volumes were considered. As shown in Figure 11, three subdivisions within the RTO were made. The combustion chamber, or plenum, was designated as the open area at the top of the RTO where the natural gas burners operated. The media chambers were defined as the areas of the RTO housing the ceramic media and the poppet housing area was defined as the manifolds above and below the poppet valves. Since it is likely that the poppet valves were both forced into the up position during the explosion, which would isolate the exhaust half of the manifold, half of the total poppet housing volume was used for purposes of the combustion analysis.

Figure 11. Drawing of the RTO with the combustion chamber indicated in yellow, the media chambers indicated in pink, and the poppet housing indicated in green.

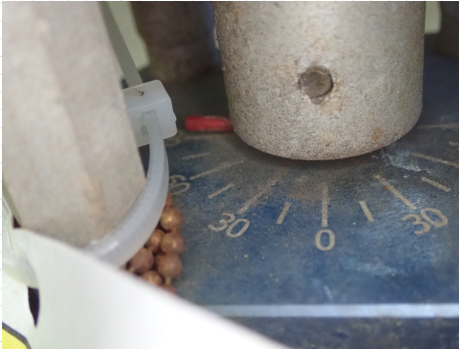
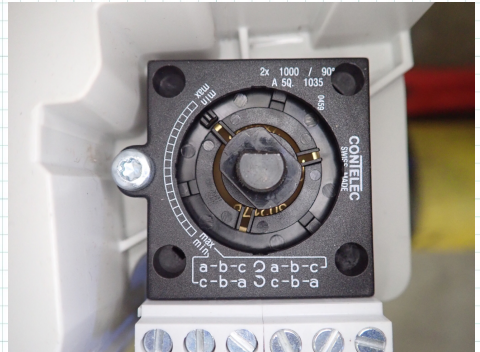
20 mA: Angle: 90

- Terminals 3 and 4 remain made for full range of motion from 0 to 20 mA
- Maintains position when power removed

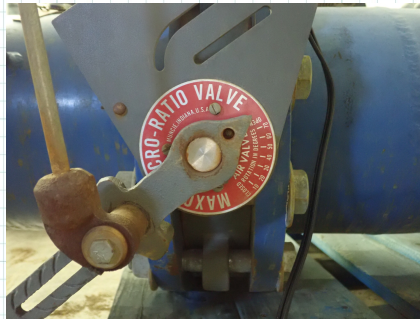
4 mA: Past Open, physically wide open

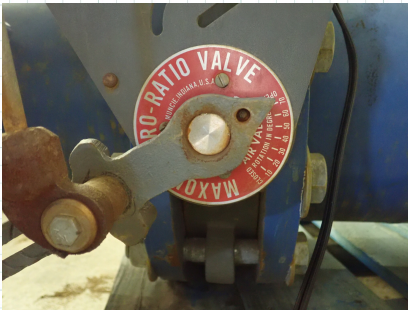
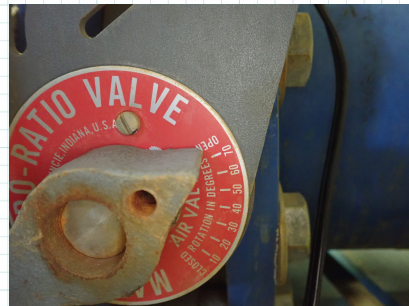
8 mA: On the open label

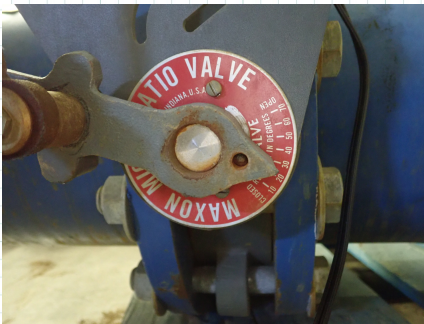
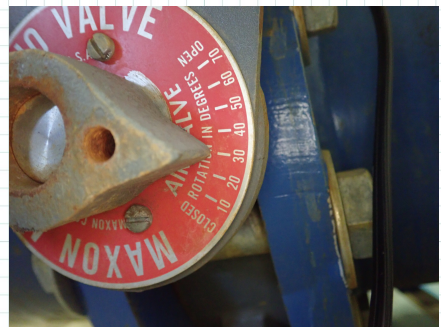
20 mA: Angle = 30

- Went to 24 mA → no change
- Return to 4 mA → return to 20 mA → Open loop: Returns to past open
- Loss of AC: holds position
