CITY OF CHICAGO

DEPARTMENT OF FLEET AND FACILITY MANAGEMENT

ASSESSMENT OF 1769 & 1819 W. PERSHING ROAD

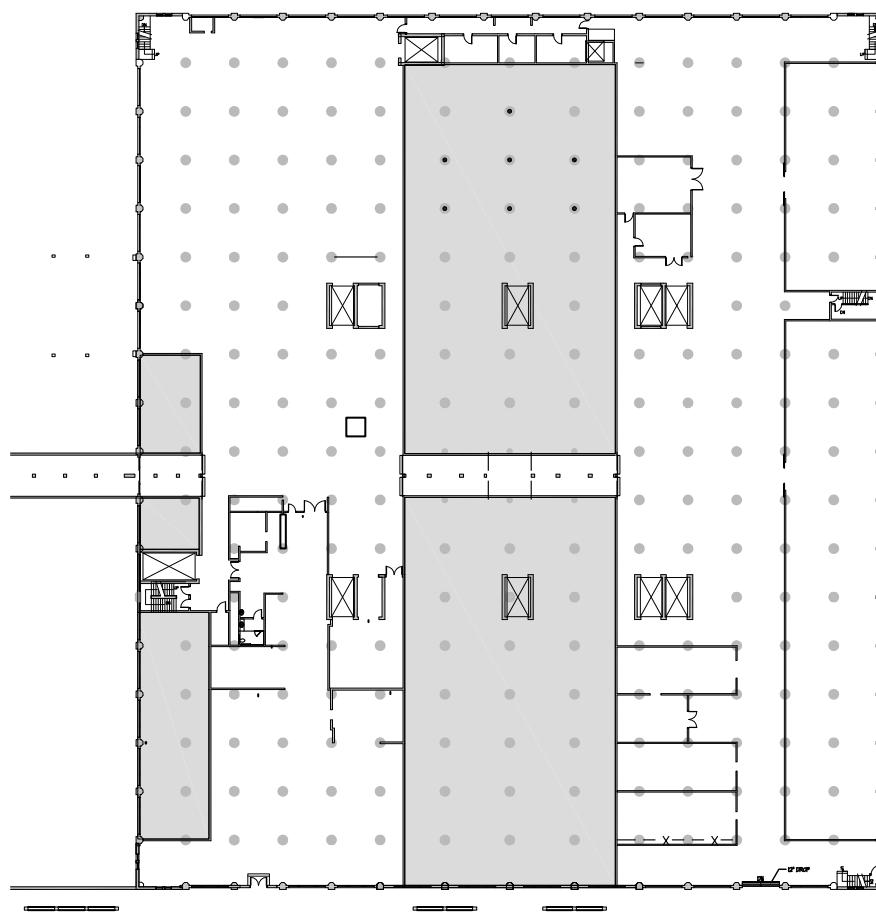
Floor Plan - Basement

Comments: In addition to the general state of dilapidation, there are significant health and life safety code violations that are considered minimal requirements for existing buildings. These include but are not limited to multiple breaches of the exterior wall; insufficient fire rated enclosures at the stairs; out of date or non-existent fire extinguishers; the accumulation of debris blocking exits and creating a fire hazard; malfunctioning or non-existent directional signage; and evidence of pest infiltration.

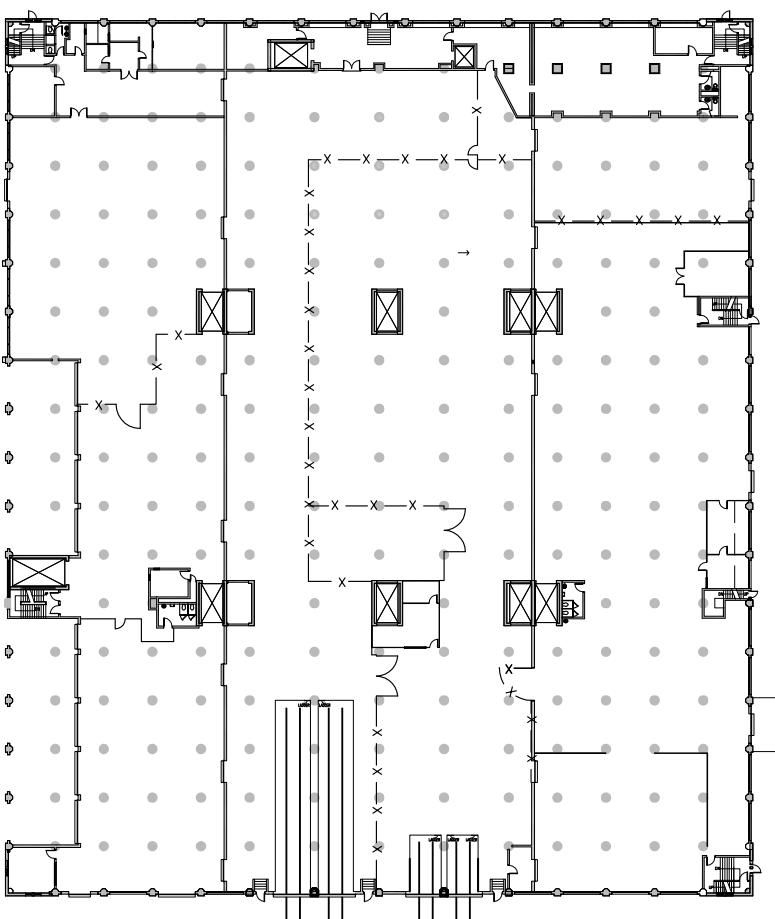
Floor Plan - 1st Floor

Comments: The unused northern areas are in a general state of dilapidation. There are significant amounts of debris and moisture damage and there is no accessible entrance into the building. In addition, there are significant health and life safety code violations that are considered minimal requirements for existing buildings. These include but are not limited to sealed and blocked exits required for egress; out of date or non-existent fire extinguishers; the accumulation of debris blocking exits and creating a fire hazard; malfunctioning or non-existent directional signage; and evidence of pest infiltration.

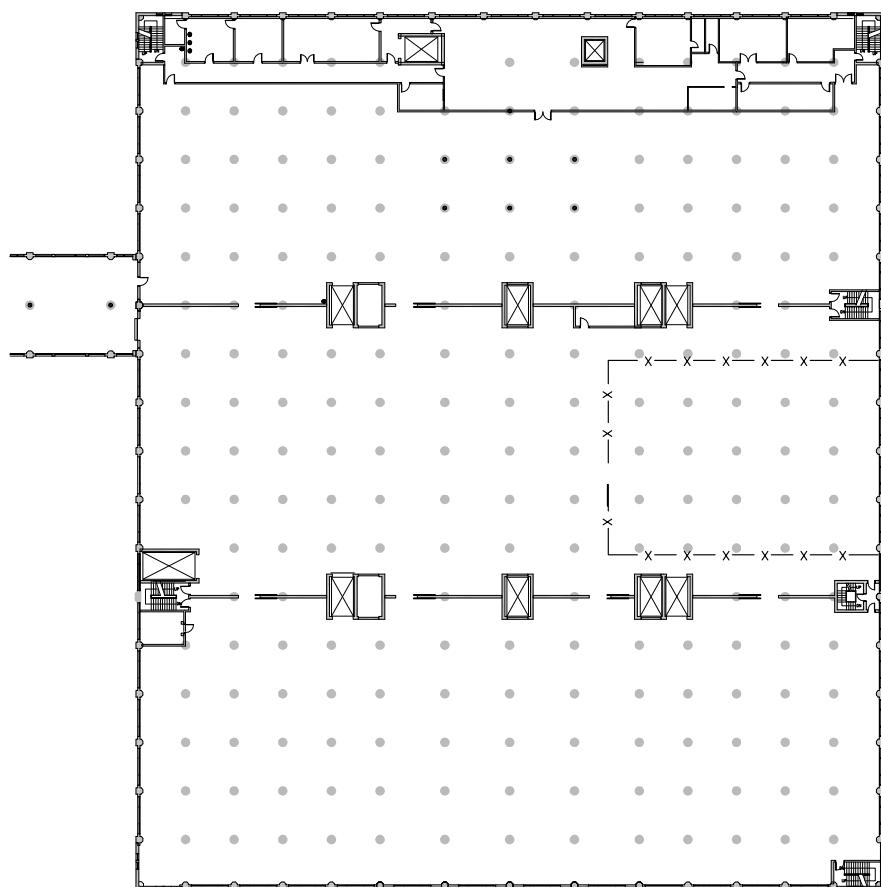
Floor Plan - 2nd Floor

Comments: The abandoned northern areas are in a general state of dilapidation. There are significant amounts of debris and moisture damage. Toilet room configurations no longer meet code standards. In addition, there are significant health and life safety code violations that are considered minimal requirements for existing buildings. These include but are not limited to sealed and blocked exits required for egress; out of date or non-existent fire extinguishers; the accumulation of debris blocking exits and creating a fire hazard; malfunctioning or non-existent directional signage; and evidence of pest infiltration.

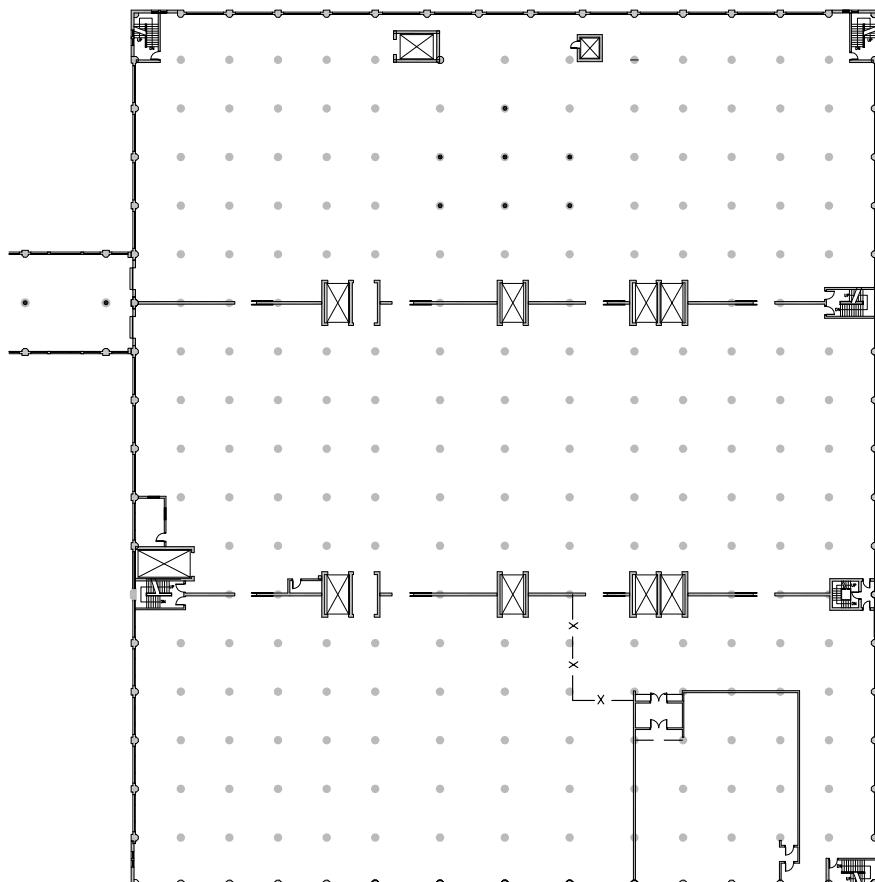
Floor Plan - 3rd Floor

Comments: There are significant amounts of debris and moisture damage. Toilet room configurations no longer meet code standards. In addition, there are significant health and life safety code violations that are considered minimal requirements for existing buildings. These include but are not limited to sealed and blocked exits required for egress; out of date or non-existent fire extinguishers; the accumulation of debris blocking exits and creating a fire hazard; malfunctioning or non-existent directional signage; and evidence of pest infiltration.

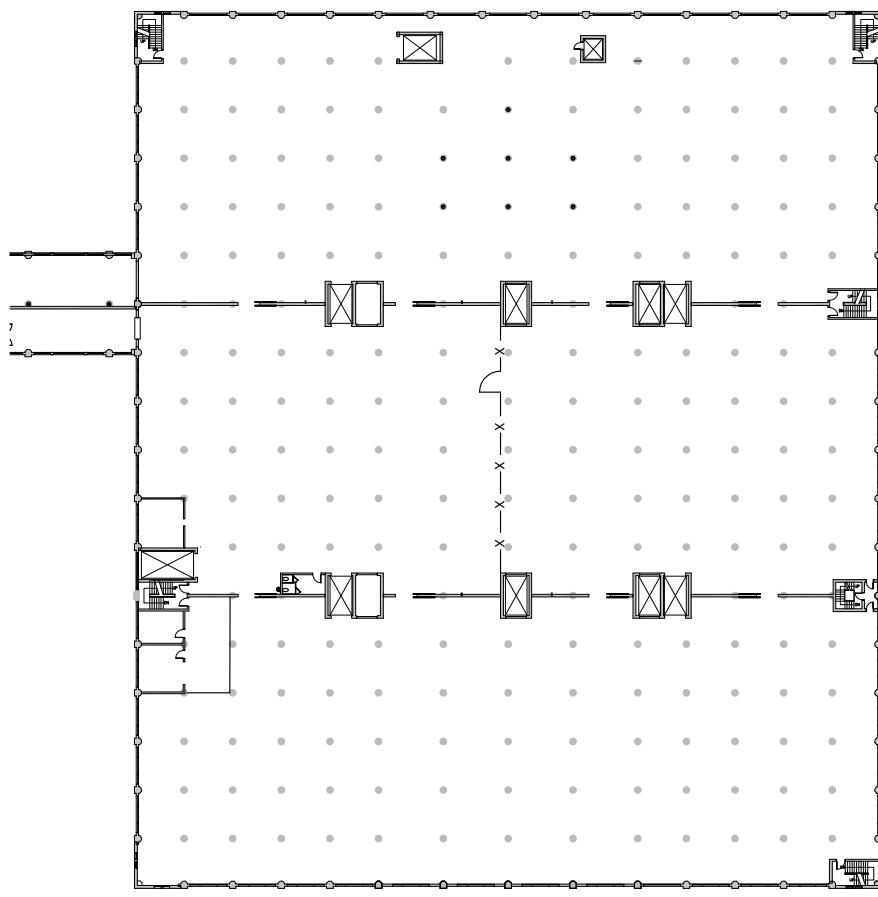
Floor Plan - 4th Floor

Comments: The unused northern areas are in a general state of dilapidation. There are significant amounts of debris and moisture damage. Toilet room configurations no longer meet code standards. In addition, there are significant health and life safety code violations that are considered minimal requirements for existing buildings. These include but are not limited to sealed and blocked exits required for egress; out of date or non-existent fire extinguishers; the accumulation of debris blocking exits and creating a fire hazard; malfunctioning or non-existent directional signage; and evidence of pest infiltration.

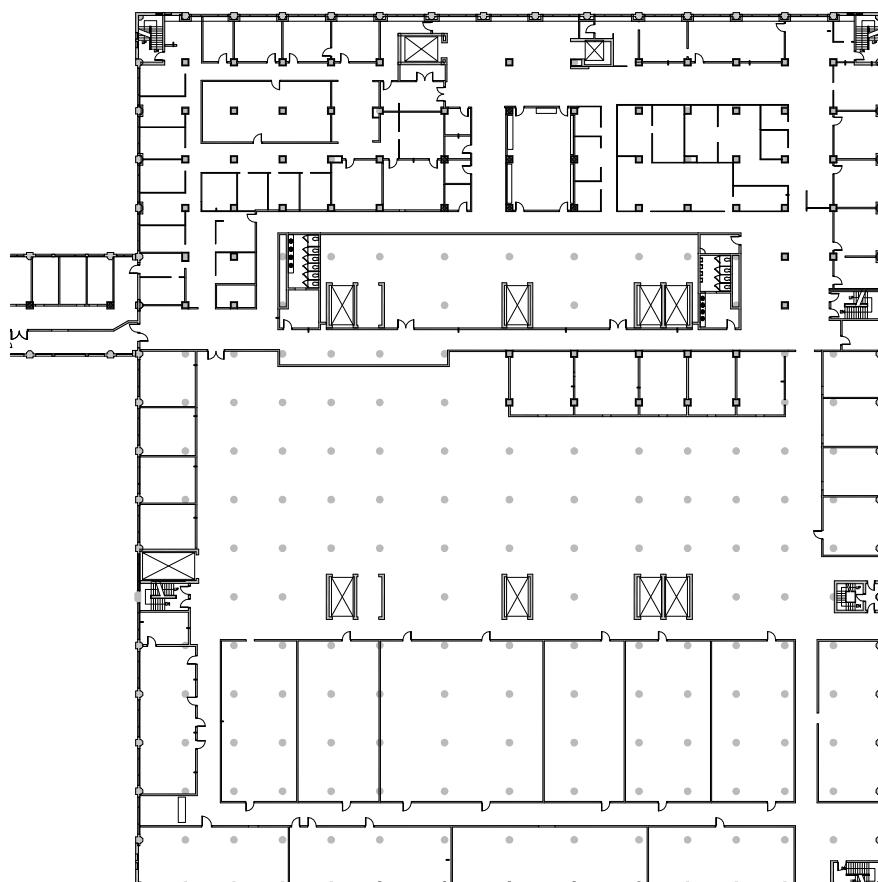
Floor Plan - 5th Floor

Comments: All of the abandoned built out areas are in a general state of dilapidation. There are significant amounts of debris and moisture damage as well as wreckage. Toilet room configurations no longer meet code standards. In addition, there are significant health and life safety code violations that are considered minimal requirements for existing buildings. These include but are not limited to sealed and blocked exits required for egress; doors open into hallways; out of date or non-existent fire extinguishers; the accumulation of debris blocking exits and creating a fire hazard; malfunctioning or non-existent directional signage; and there is significant evidence of pest infiltration mostly in the form of bird activity including droppings, at times 1 inch deep, and bird carcasses.

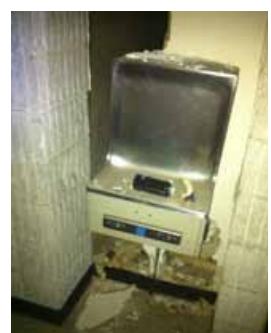
4. Drinking fountain

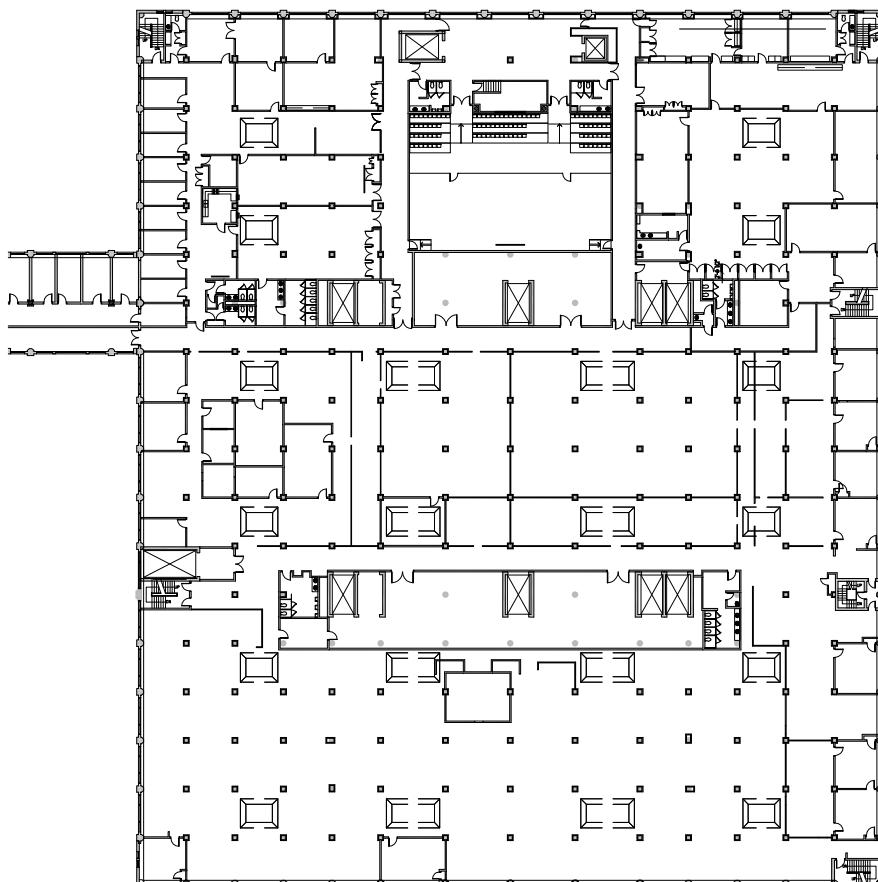
Floor Plan - 6th Floor

Comments: All of the abandoned built out areas are in a general state of dilapidation. There are significant amounts of debris and moisture damage as well as wreckage. Toilet room configurations no longer meet code standards. In addition, there are significant health and life safety code violations that are considered minimal requirements for existing buildings. These include but are not limited to sealed and blocked exits required for egress; doors open into hallways; out of date or non-existent fire extinguishers; the accumulation of debris blocking exits and creating a fire hazard; malfunctioning or non-existent directional signage; and there is evidence of pest infiltration.

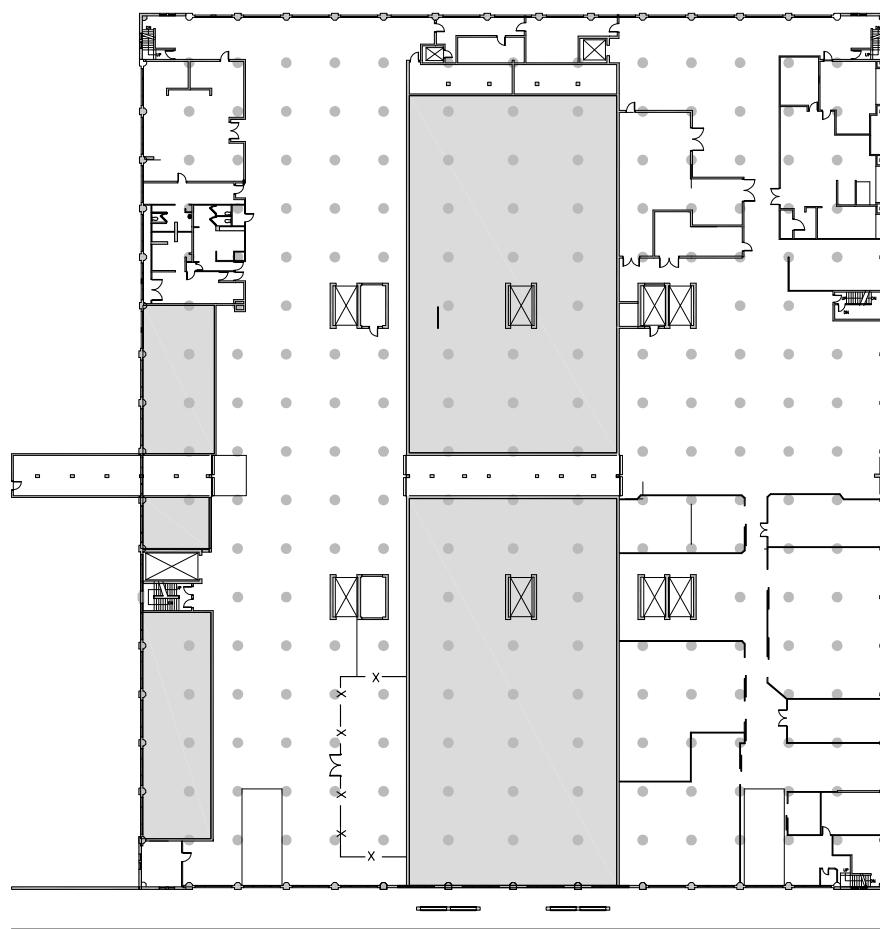
Floor Plan - Basement

Comments: In addition to the general state of dilapidation, there are significant health and life safety code violations that are considered minimal requirements for existing buildings. out of date or non-existent fire extinguishers; the accumulation of debris blocking exits and creating a fire hazard; malfunctioning or non-existent directional signage; standing water; out of date certifications, and evidence of pest infiltration.

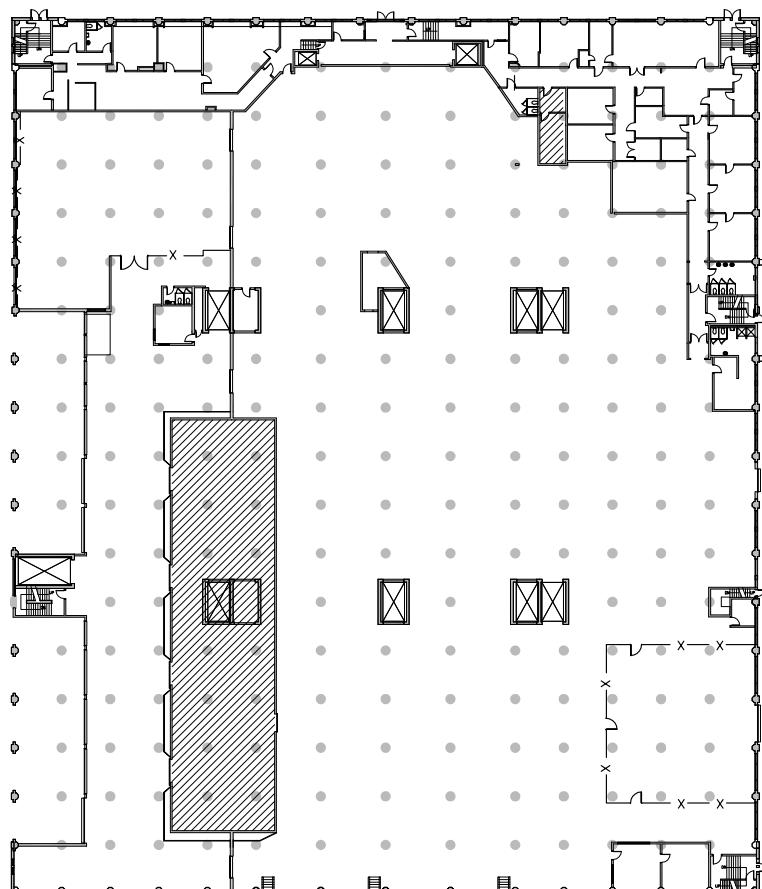
Floor Plan - 1st Floor

Comments: The unused northern areas are in a general state of dilapidation. There are significant amounts of debris and moisture damage and there is no accessible entrance into the building. In addition, there are significant health and life safety code violations that are considered minimal requirements for existing buildings. These include but are not limited to sealed and blocked exits required for egress; out of date or non-existent fire extinguishers; the accumulation of debris blocking exits and creating a fire hazard; malfunctioning or non-existent directional signage; and evidence of pest infiltration.

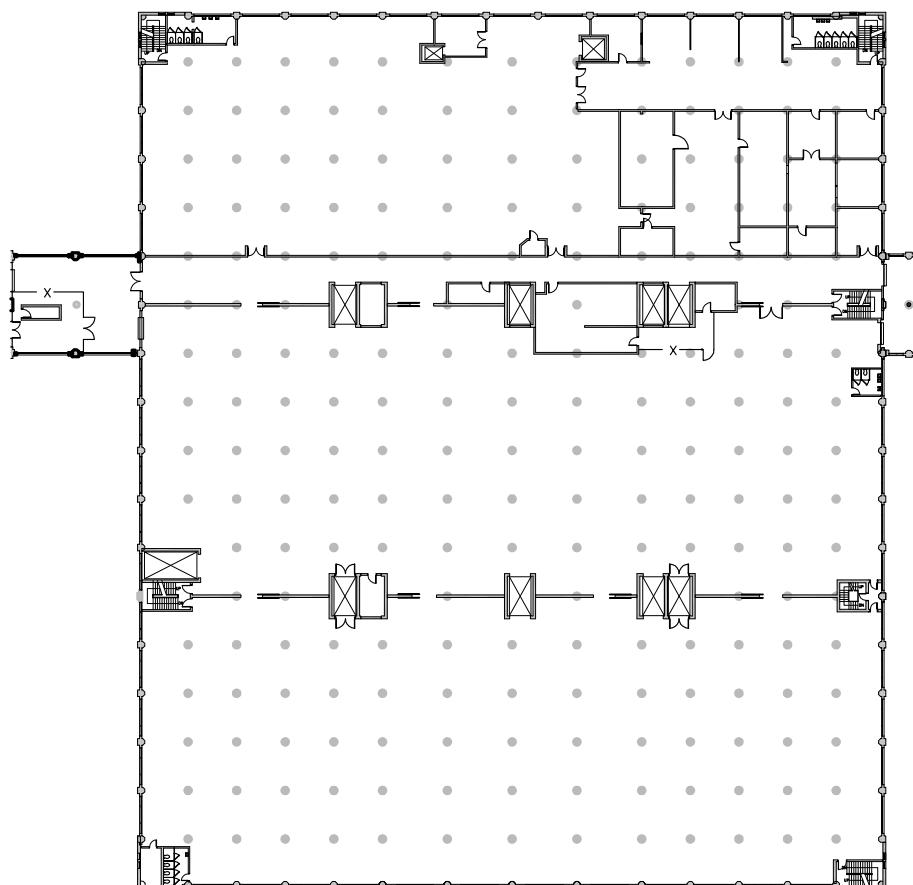
Floor Plan - 2nd Floor

Comments: Toilet room configurations no longer meet code standards. In addition, there are significant health and life safety code violations that are considered minimal requirements for existing buildings. These include but are not limited to sealed and blocked exits required for egress; out of date or non-existent fire extinguishers; the accumulation of debris blocking exits and creating a fire hazard; malfunctioning or non-existent directional signage; and evidence of pest infiltration.

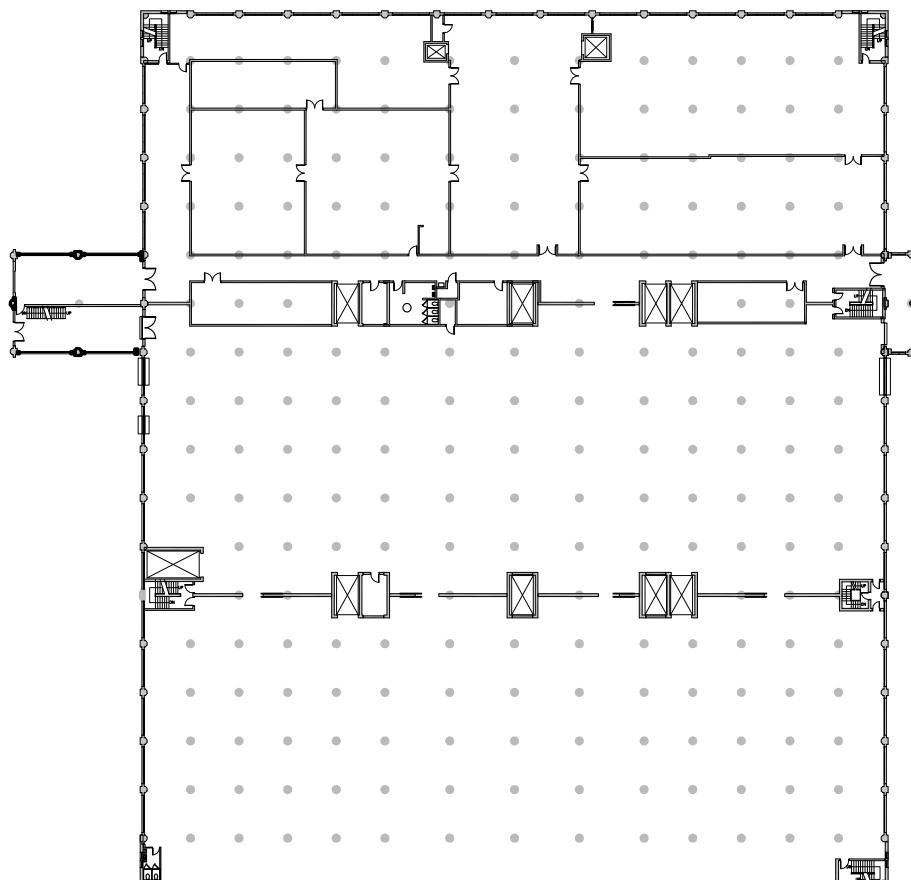
Floor Plan - 3rd Floor

Comments: There are significant amounts of debris. Toilet room configurations no longer meet code standards. In addition, there are significant health and life safety code violations that are considered minimal requirements for existing buildings. These include but are not limited to sealed and blocked exits required for egress; out of date or non-existent fire extinguishers; the accumulation of debris blocking exits and creating a fire hazard; malfunctioning or non-existent directional signage; and evidence of pest infiltration.

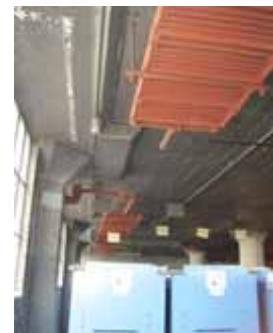
3. Ceiling steam radiator

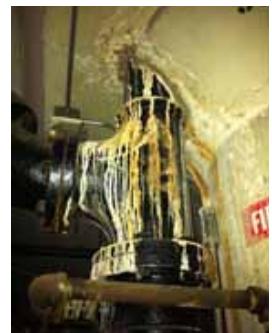
4. Plumbing fitting

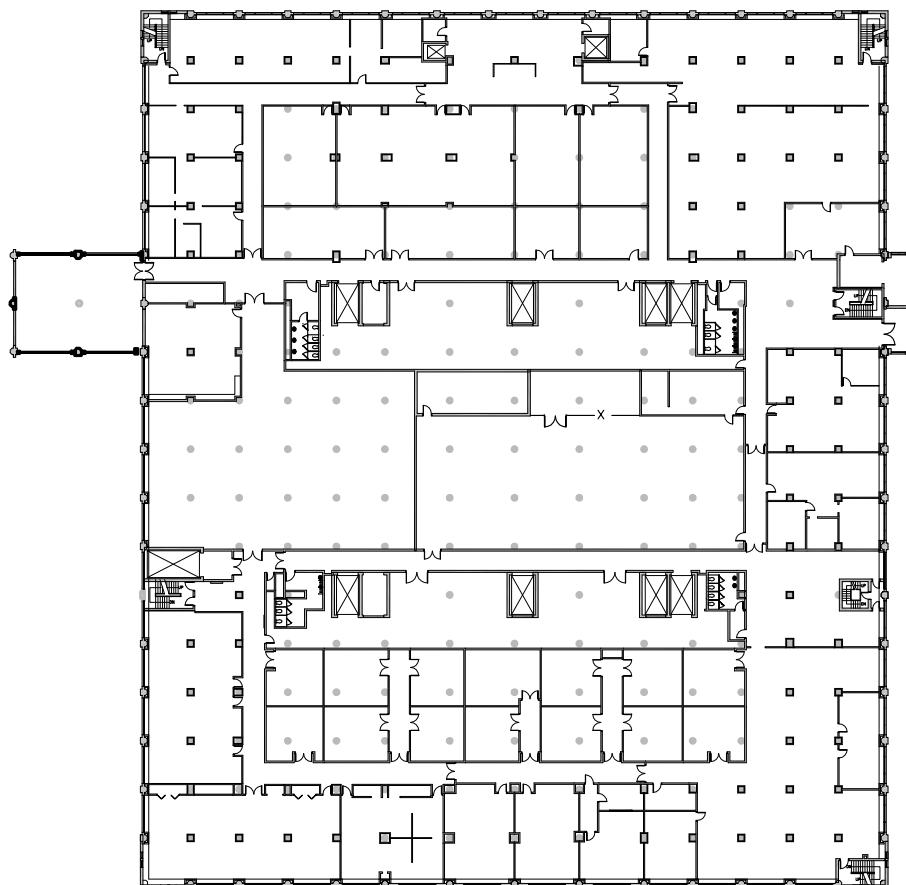
Floor Plan - 4th Floor

Comments: The built out areas are in a general state of dilapidation. There are significant amounts of debris and moisture damage. Toilet room configurations no longer meet code standards. In addition, there are significant health and life safety code violations that are considered minimal requirements for existing buildings. These include but are not limited to sealed and blocked exits required for egress; out of date or non-existent fire extinguishers; the accumulation of debris blocking exits and creating a fire hazard; malfunctioning or non-existent directional signage; and evidence of pest infiltration.

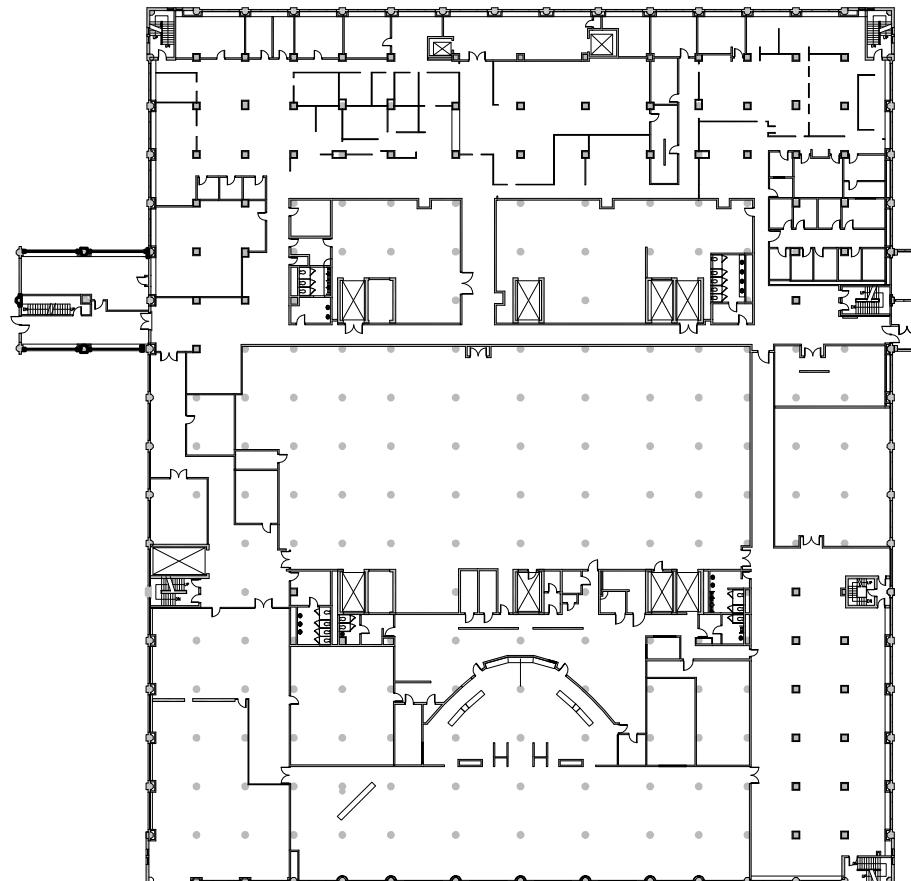
Floor Plan - 5th Floor

Comments: All of the abandoned built out areas are in a general state of dilapidation. There are significant amounts of debris and moisture damage as well as wreckage. Toilet room configurations no longer meet code standards. In addition, there are significant health and life safety code violations that are considered minimal requirements for existing buildings. These include but are not limited to sealed and blocked exits required for egress; doors open into hallways; out of date or non-existent fire extinguishers; the accumulation of debris blocking exits and creating a fire hazard; malfunctioning or non-existent directional signage.

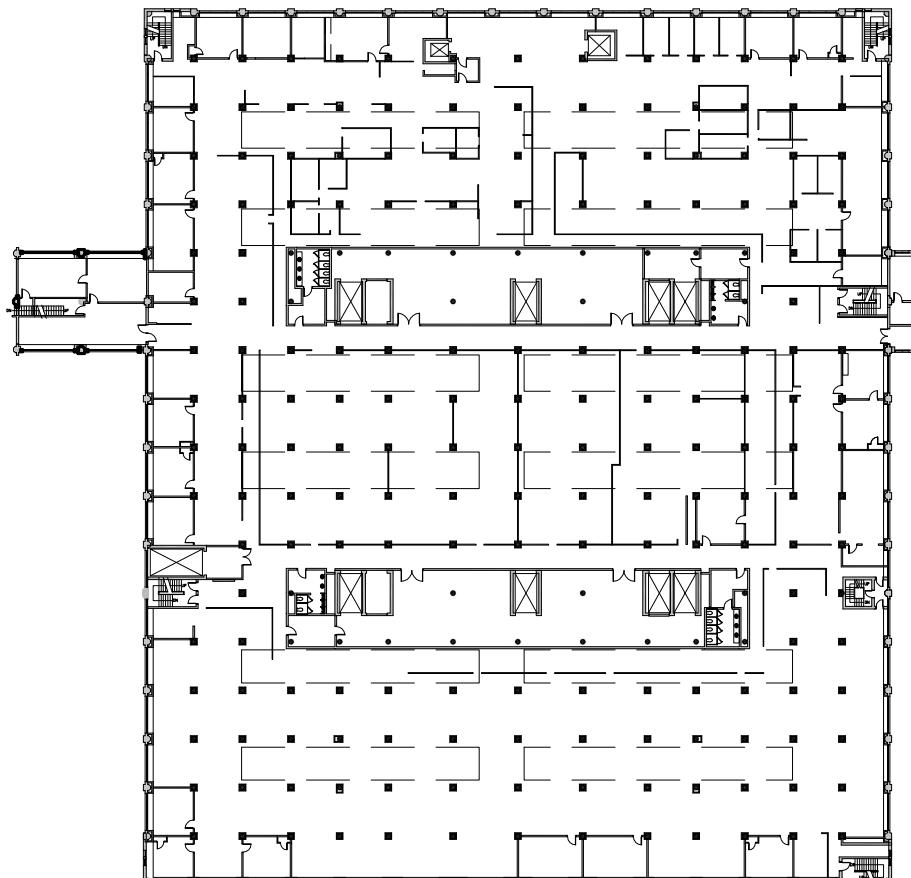
Floor Plan - 6th Floor

Comments: All of the abandoned built out areas are in a general state of dilapidation. There are significant amounts of debris and moisture damage as well as wreckage. Toilet room configurations no longer meet code standards. In addition, there are significant health and life safety code violations that are considered minimal requirements for existing buildings. These include but are not limited to sealed and blocked exits required for egress; doors open into hallways; out of date or non-existent fire extinguishers; the accumulation of debris blocking exits and creating a fire hazard; malfunctioning or non-existent directional signage; and there is evidence of pest infiltration.
