SITE INVESTIGATION REPORT-COMPREHENSIVE

**Columbia Pointe Phase II & III
Chicago, Illinois**

Pioneer Project #06-0499-102

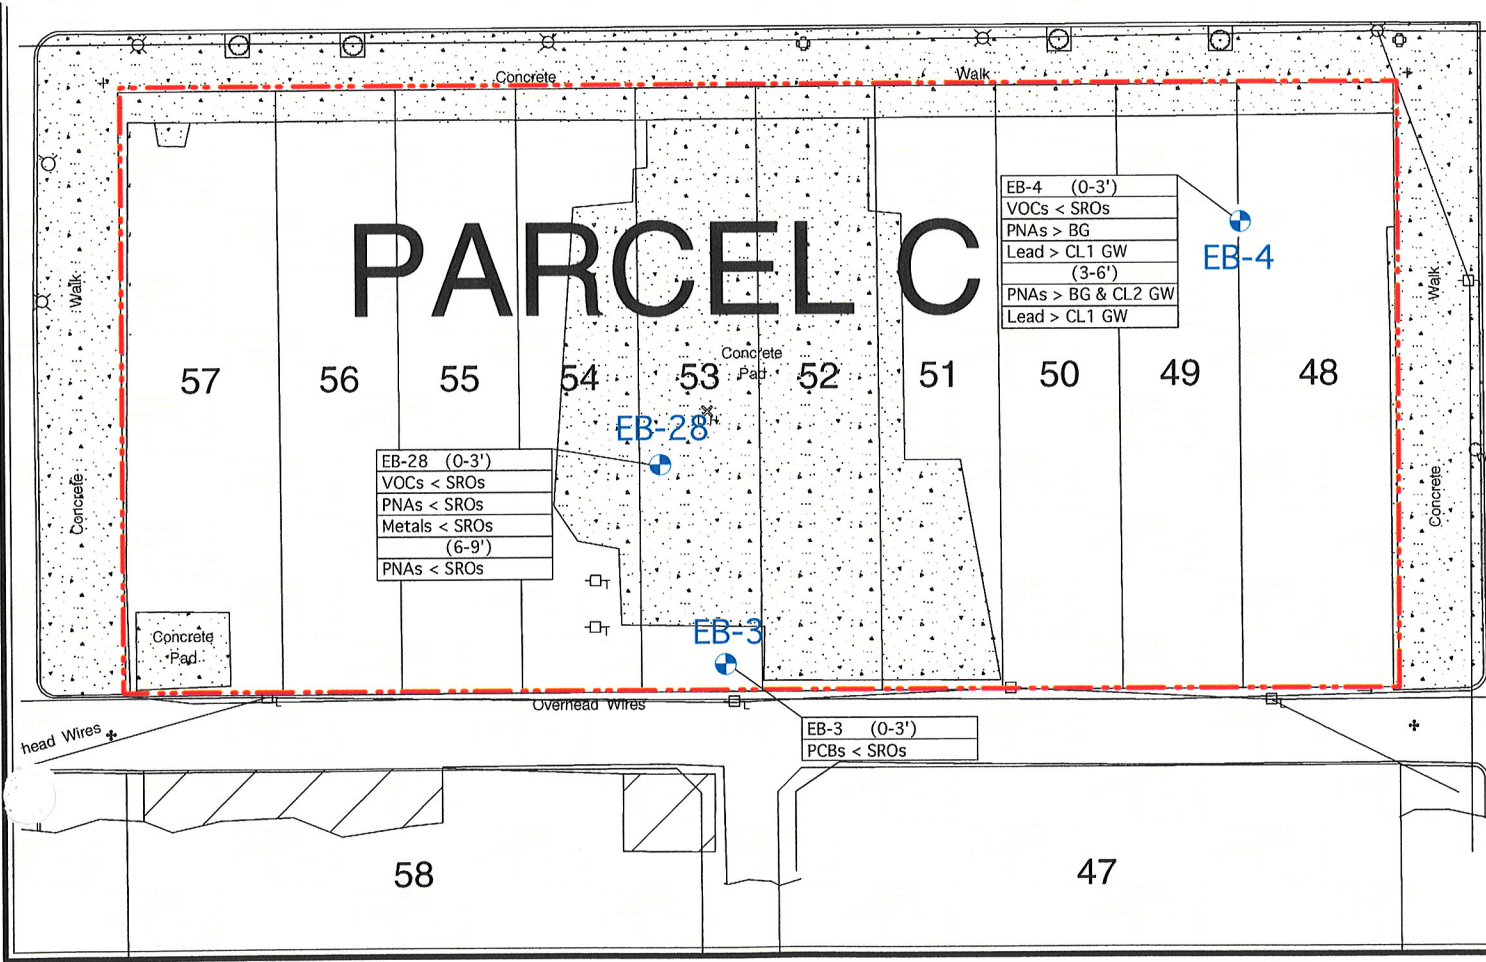
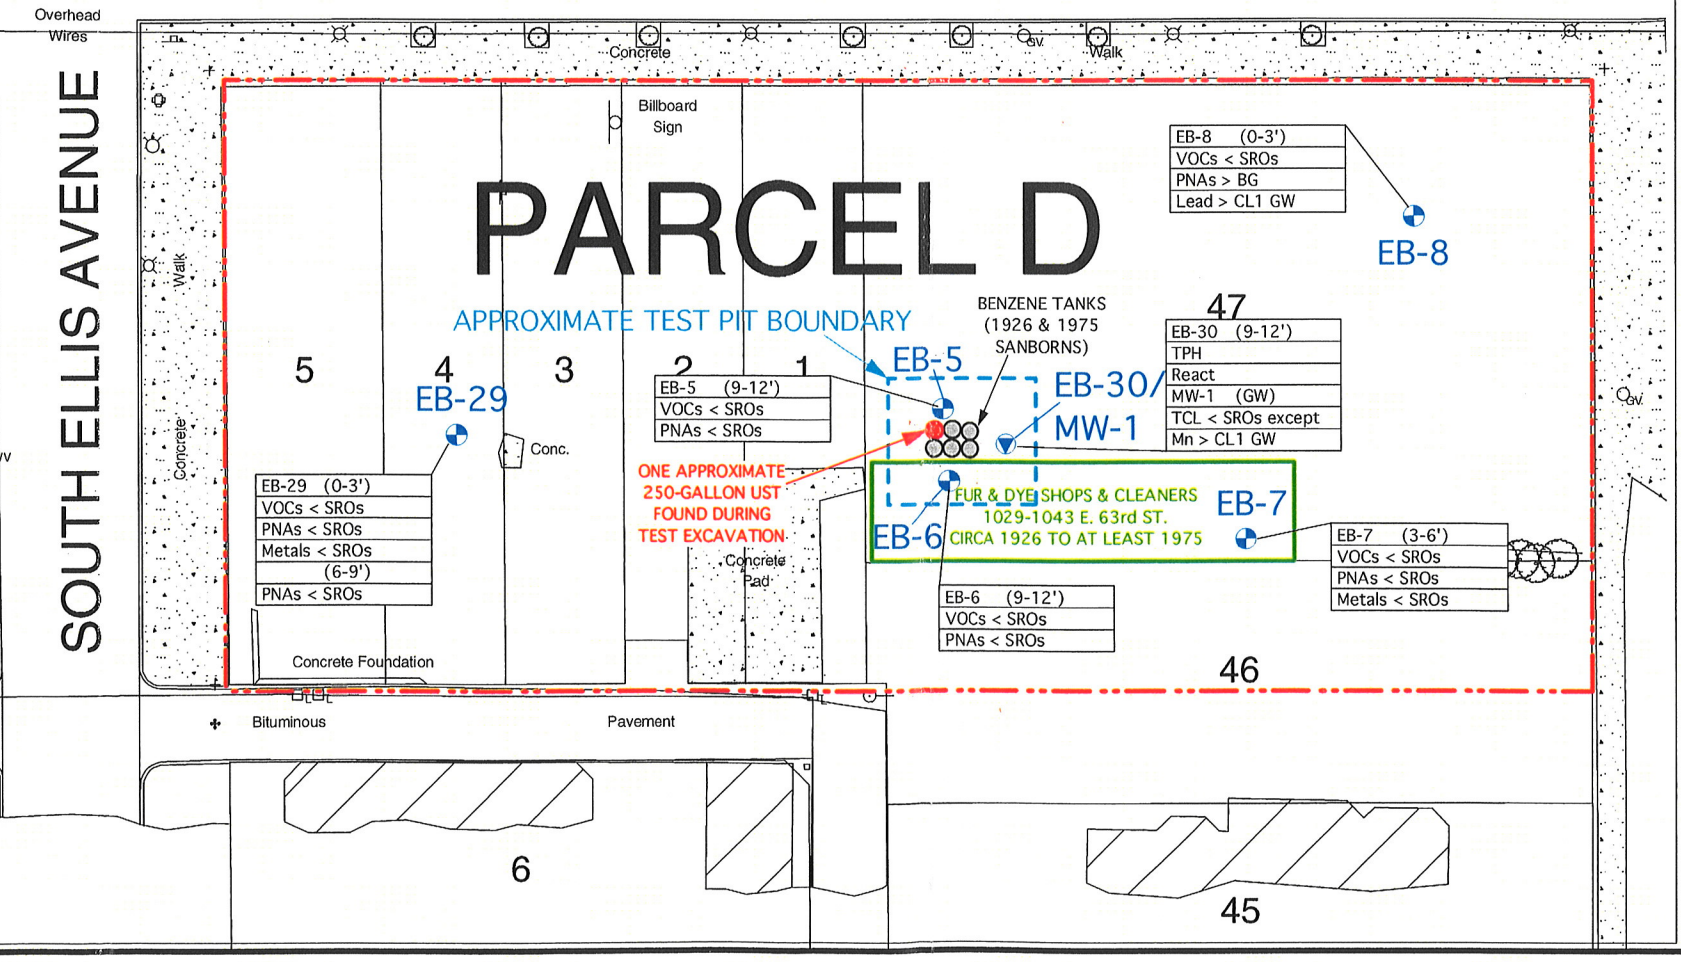
Figure 6
Parcel C, D
Boring Location & Analytical
Summary Diagram
Columbia Pointe Phase II & III
Chicago, IL

Fur Shop, Dye Shop, & Dry Cleaning

EAST 63rd STREET
